The Corporation of the City of Temiskaming Shores
Regular Meeting of Council
Tuesday, November 17, 2020 – 6:00 p.m.
City Hall – Council Chambers – 325 Farr Drive

City Staff have reviewed the report which included 13 roadway structures, as well as 3 roof inspections and below is a list of maintenance work required as well as additional Engineering investigations required. Not shown in the table below, is a recommendation to remove and replace the roofing membrane on both the New Liskeard Arena, as well as the Pool Fitness Centre within the next 1-5 years. The City was provided a budget cost in 2019 for the New Liskeard Arena (\$1,000,000.00) however we do not have a cost estimate at this time for the Pool Fitness Centre.

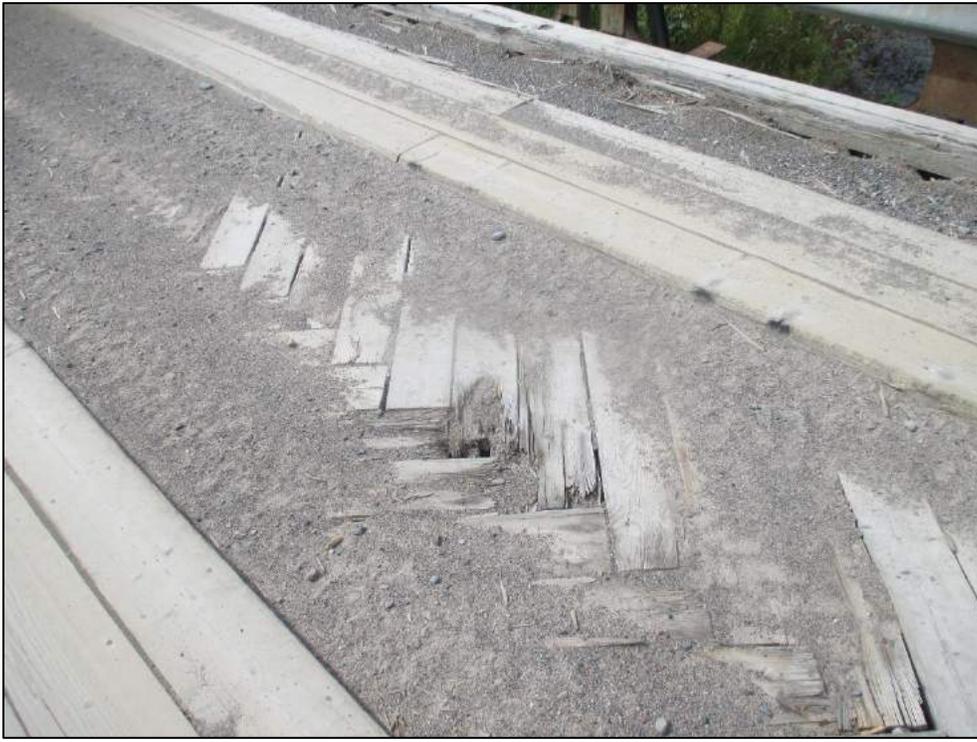
Structure Number: 01

Severely damaged deck top.

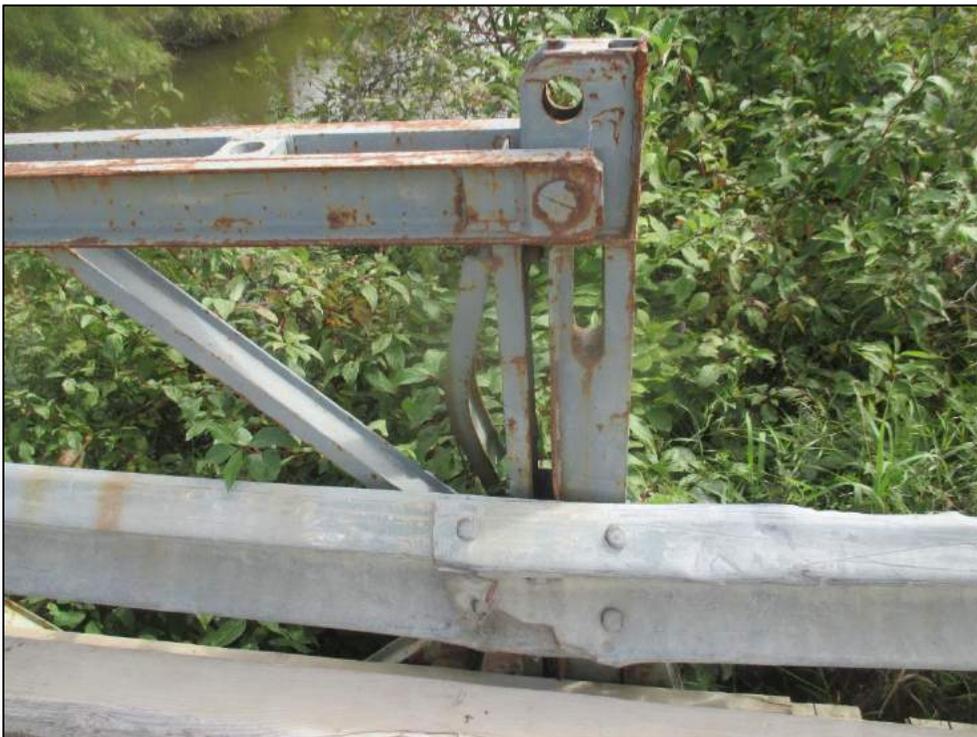
Impact damage on guiderrail, damaged bracing at southwest.

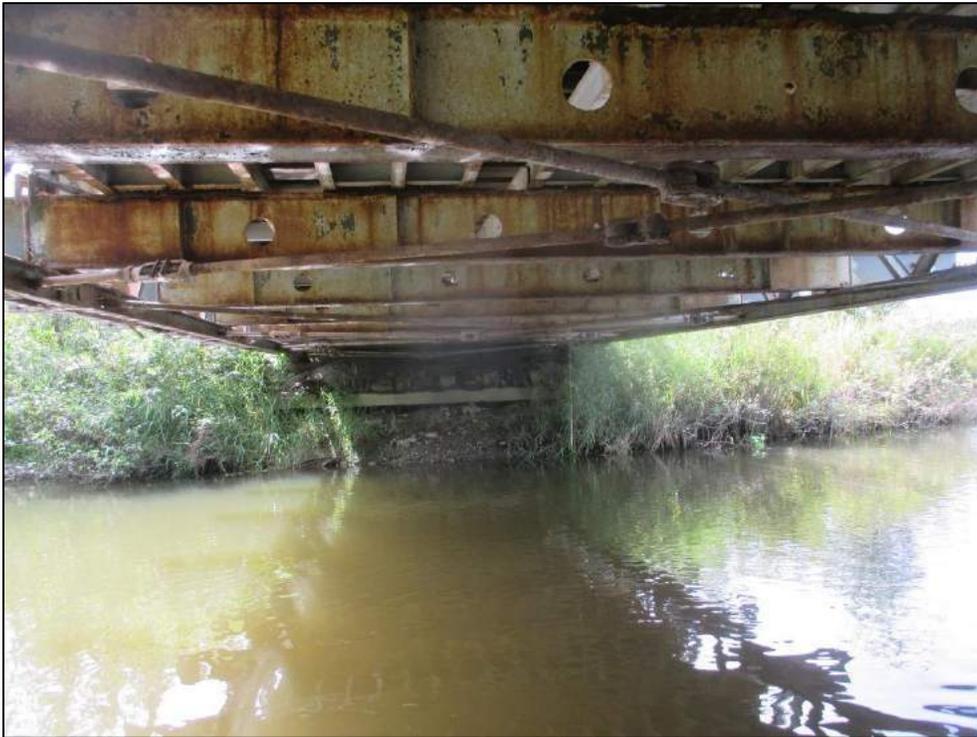
Structure Number: 01

Damaged bracing at southeast.

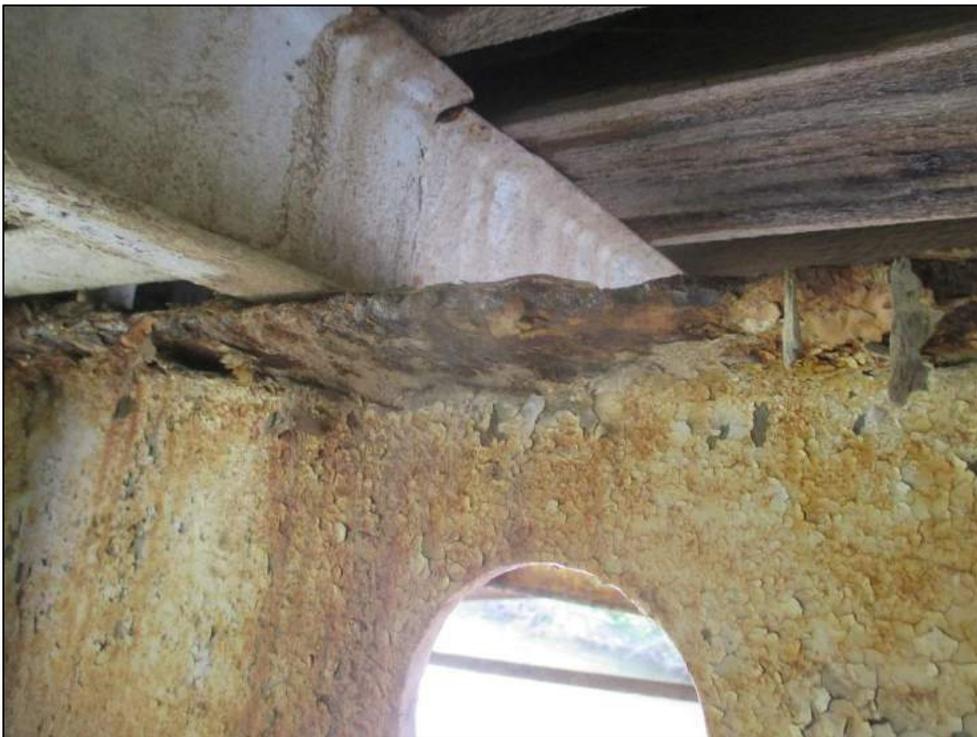
Underside looking south, severe corrosion of bracing and floor beams.

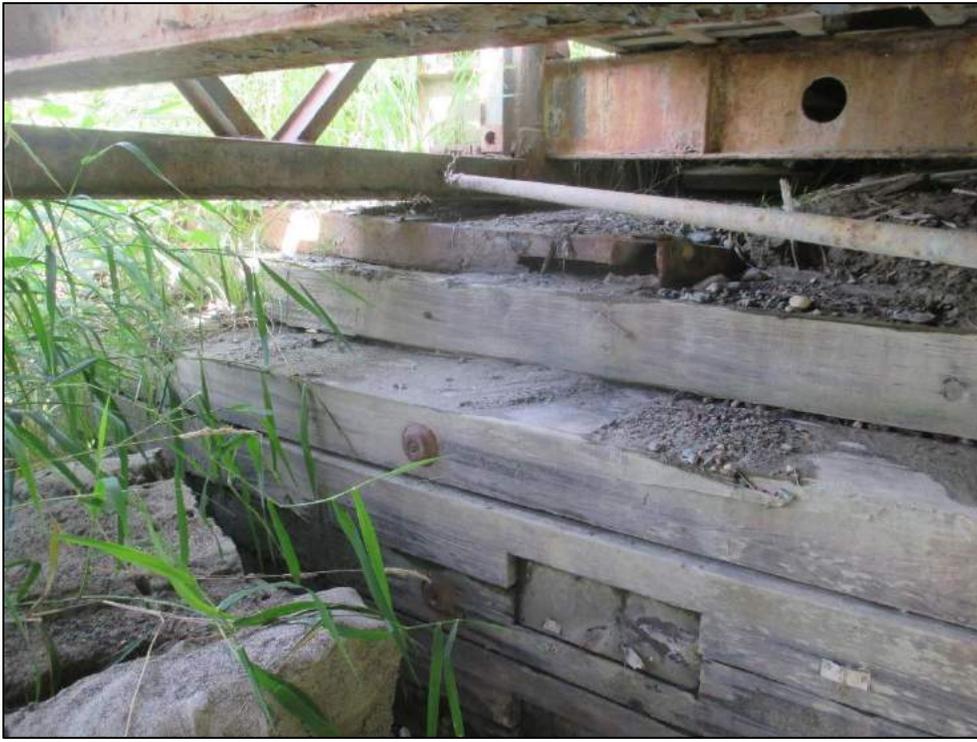
Structure Number: 01

Severe corrosion and section loss of floor beams, failure of coating.

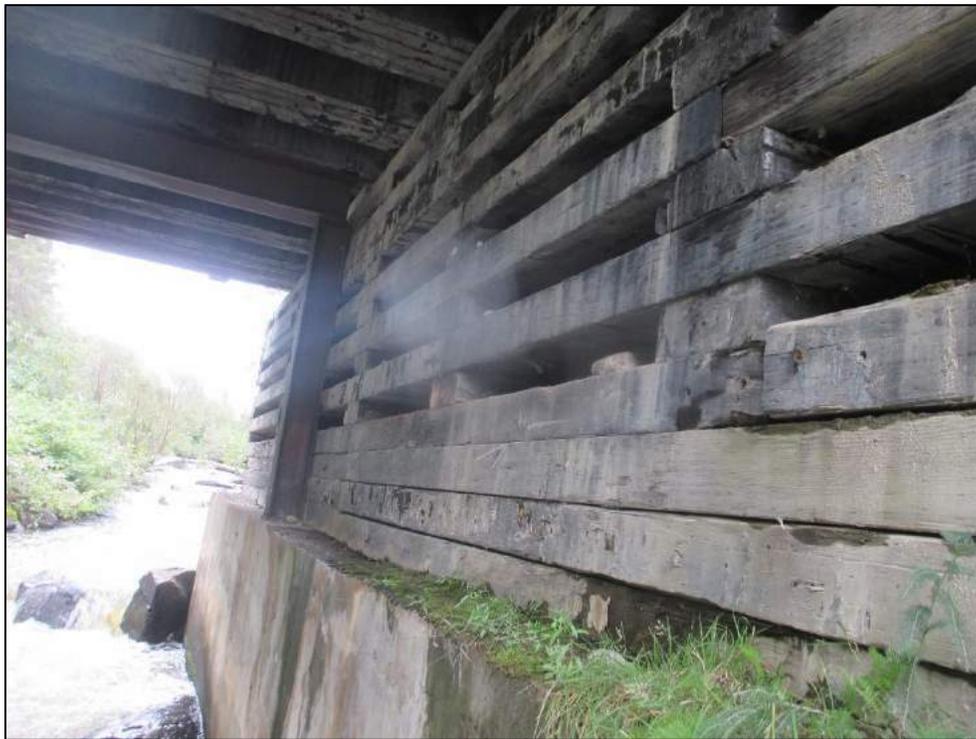
Structure Number: 02

Severe checks, light rot of timber beams.

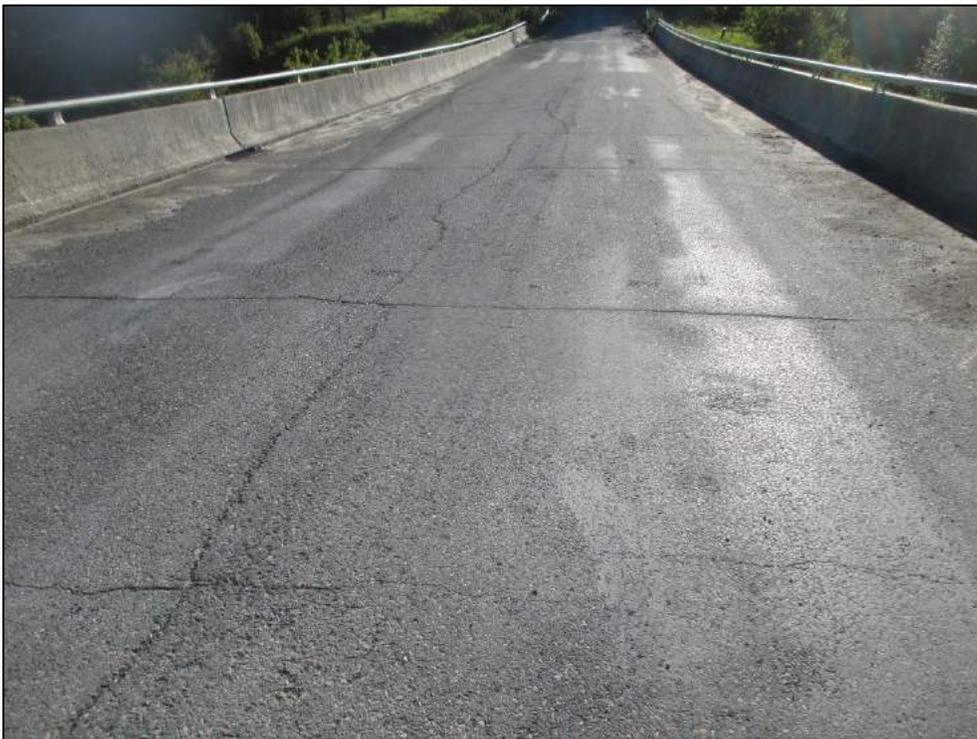
Wide cracks and dip at west approach with evidence of pooling water.

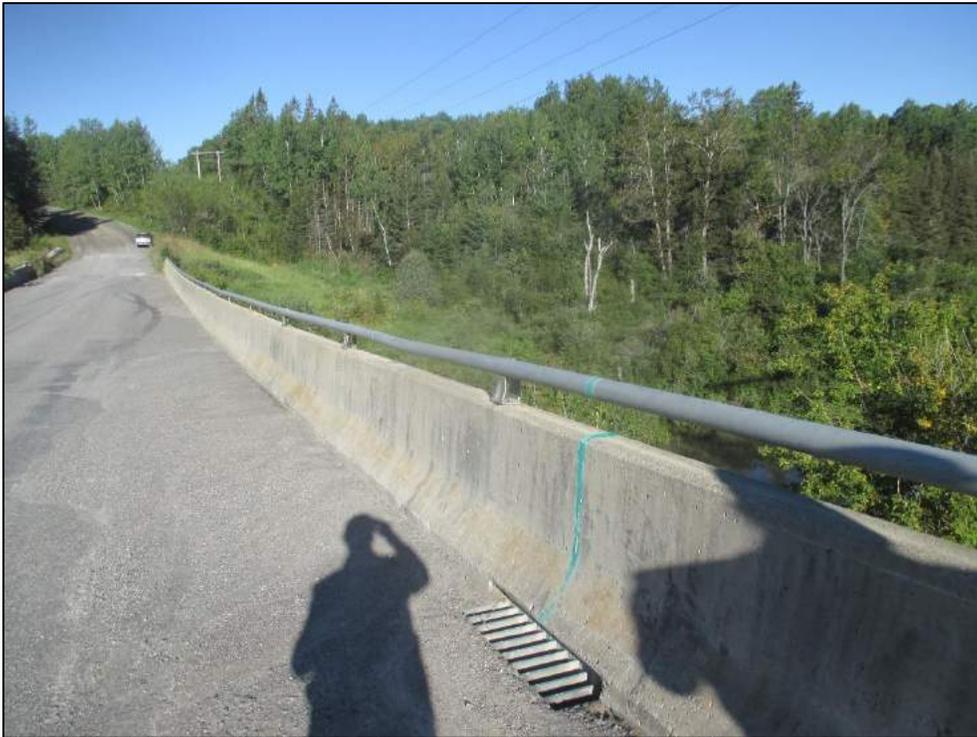
Structure Number: 03

Medium to severe scaling at north wall.

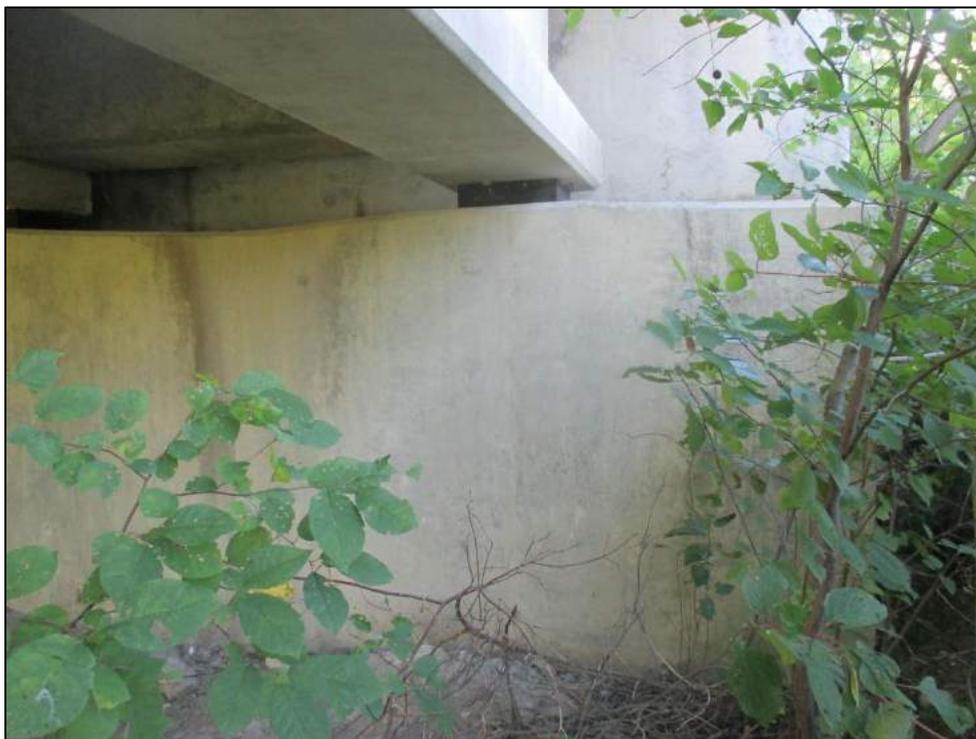
Bearing (typ.)

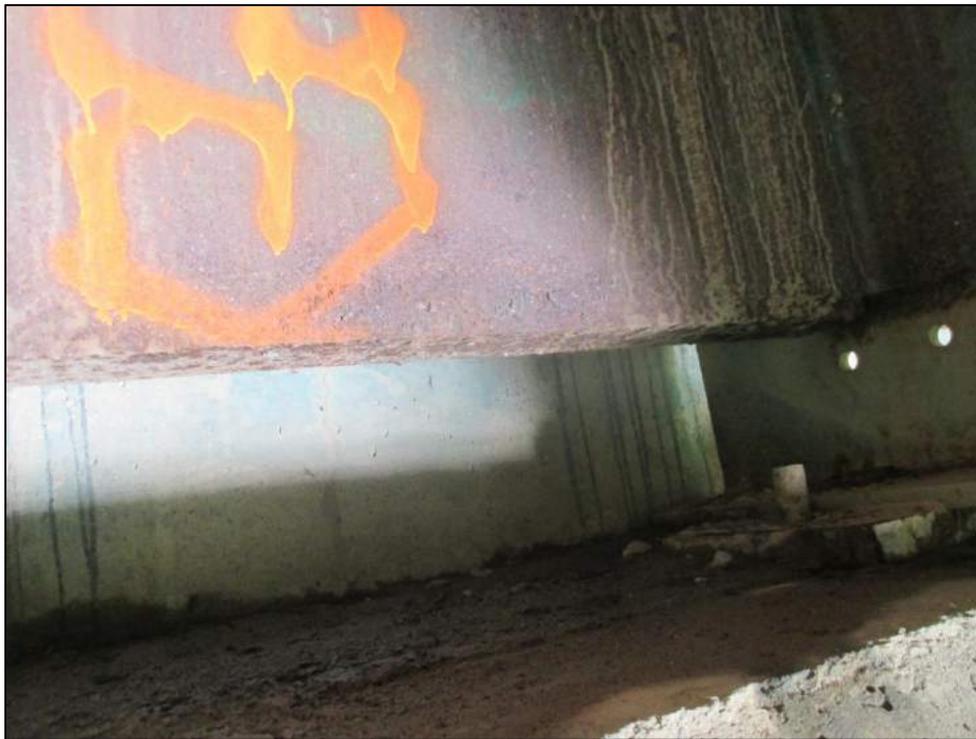
Structure Number: 04

Medium corrosion of bearing.

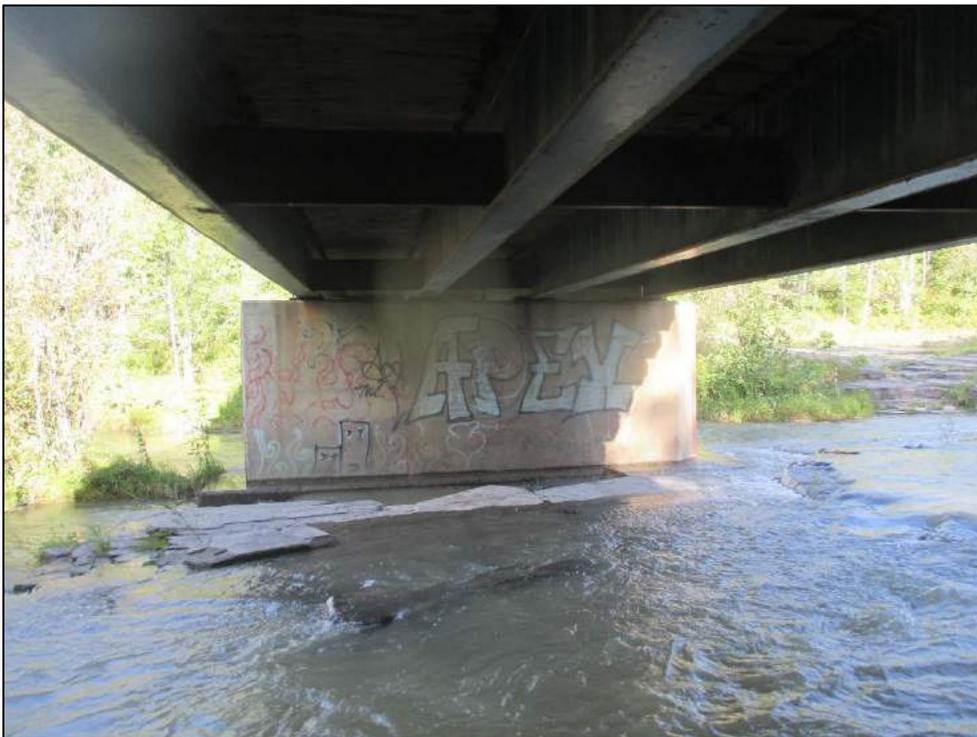
West span soffit, girders with wet stains and corrosion.

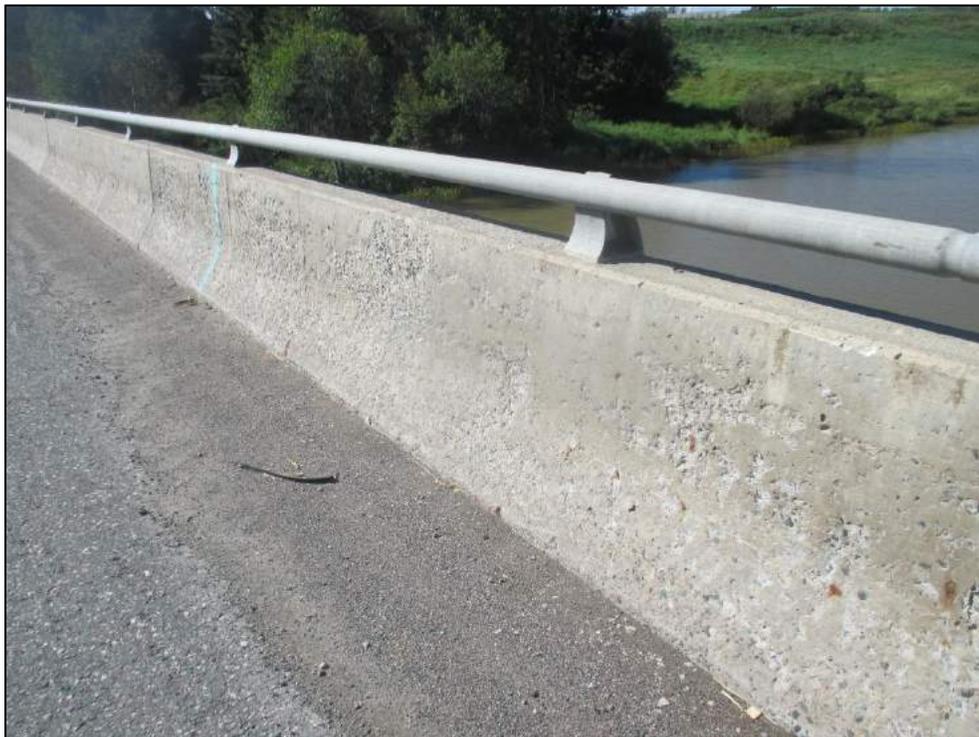
Delamination, cracking through previous patch at barrier wall

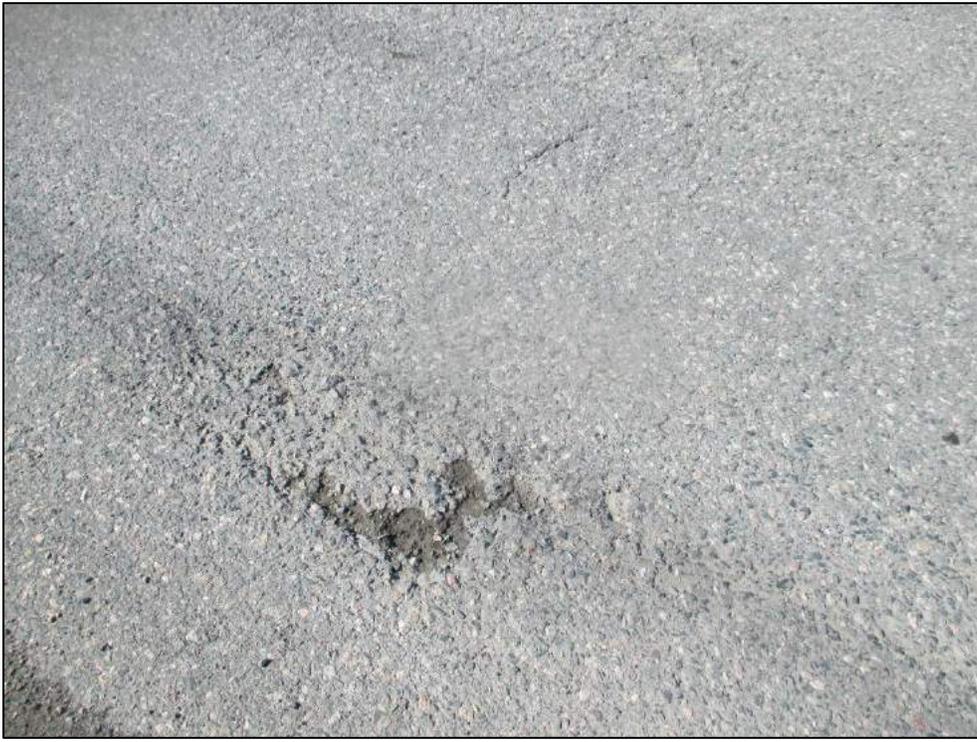
Structure Number: 06

Patched potholes on wearing surface.

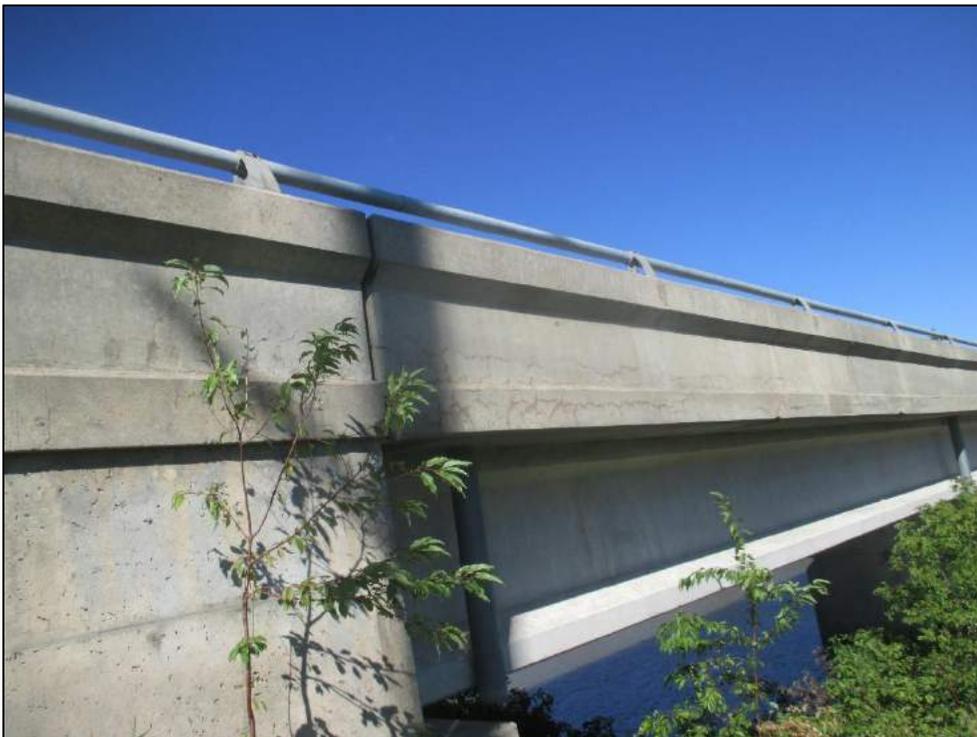
Bottom up defect.

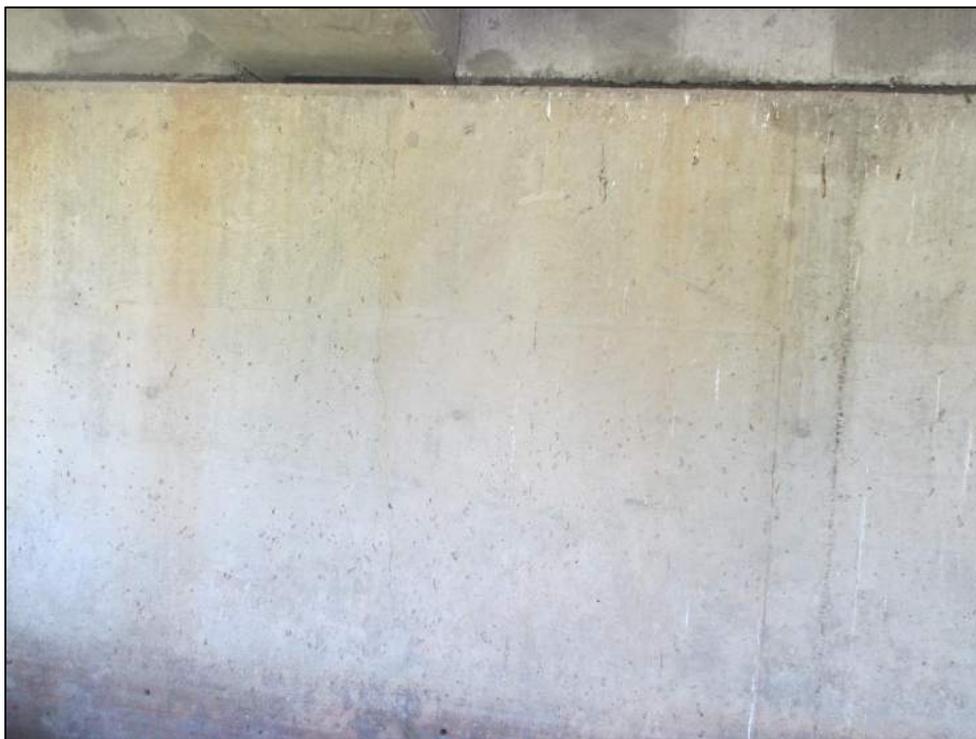
Crack, delamination at bearing seat and honeycombing of ballast wall.

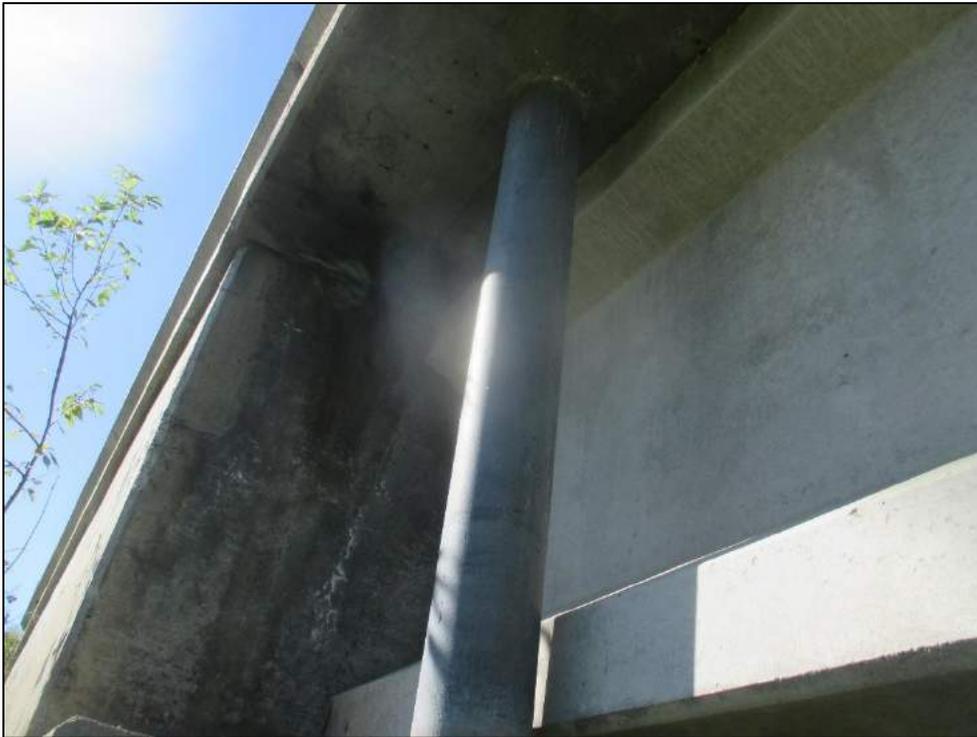
Structure Number: 06

Wide crack in northwest bearing.

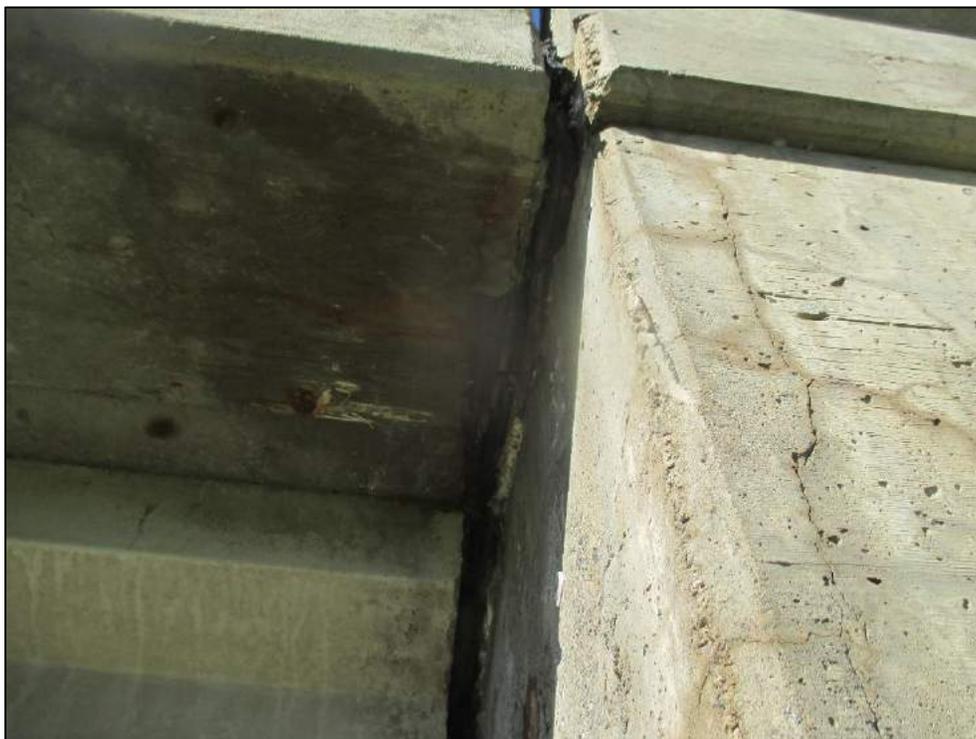
Map cracking, bugholes in southeast wingwall.

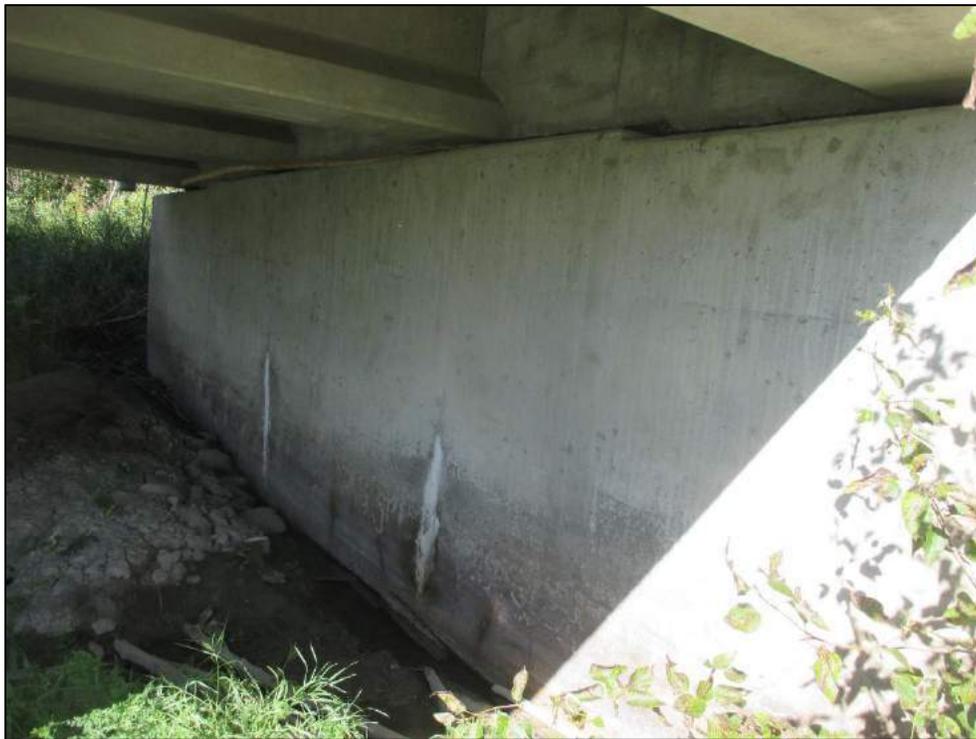
Structure Number: 06

Crack in southeast wingwall, evidence of joint leakage at east abutment.

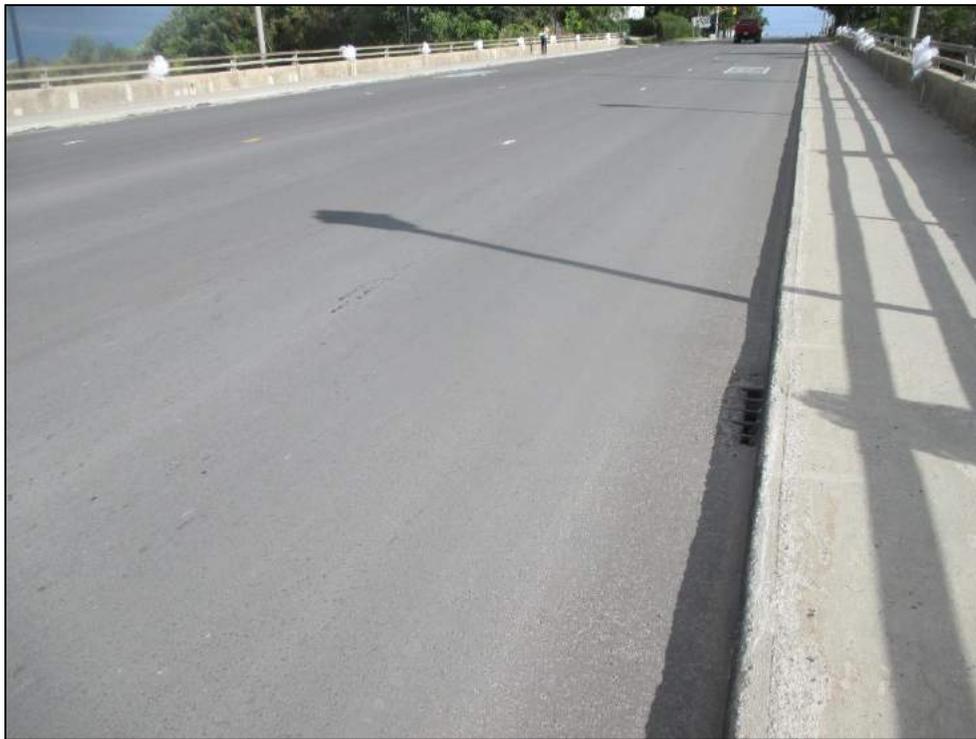
Structure Number: 07

Cracking on sidewalk.

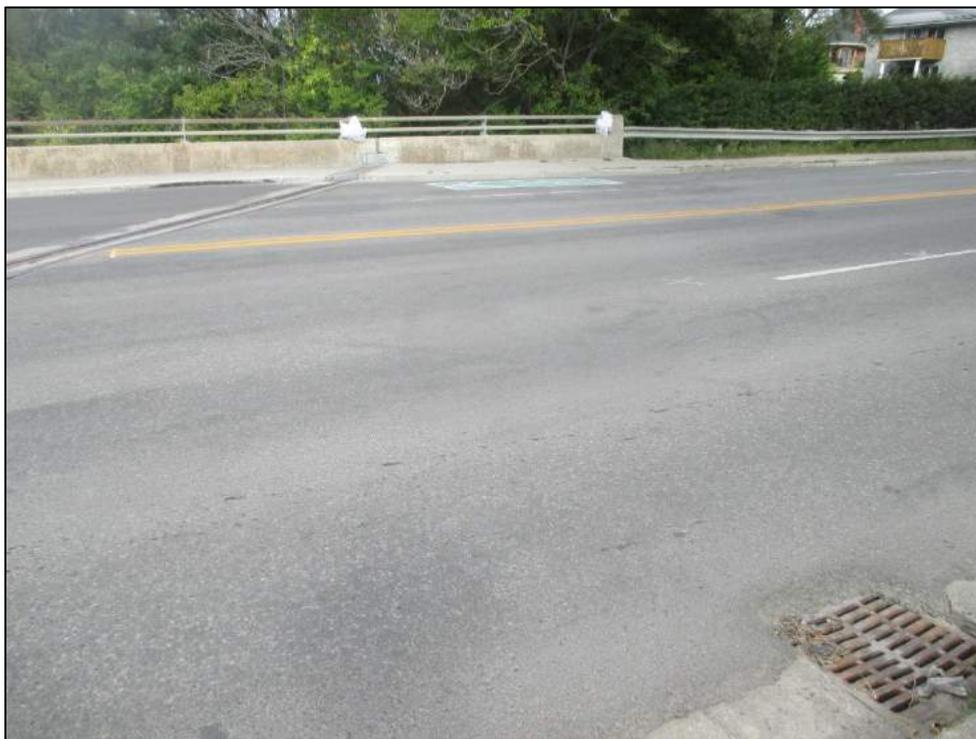
Wearing surface, rutting noted.

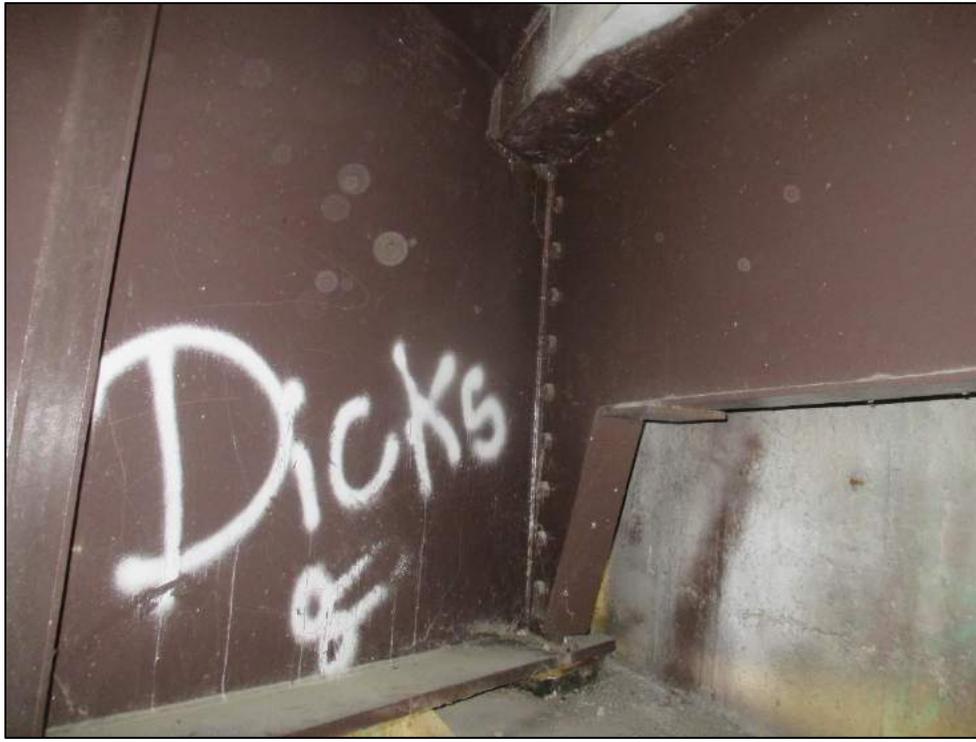
Structure Number: 07

South abutment wall.

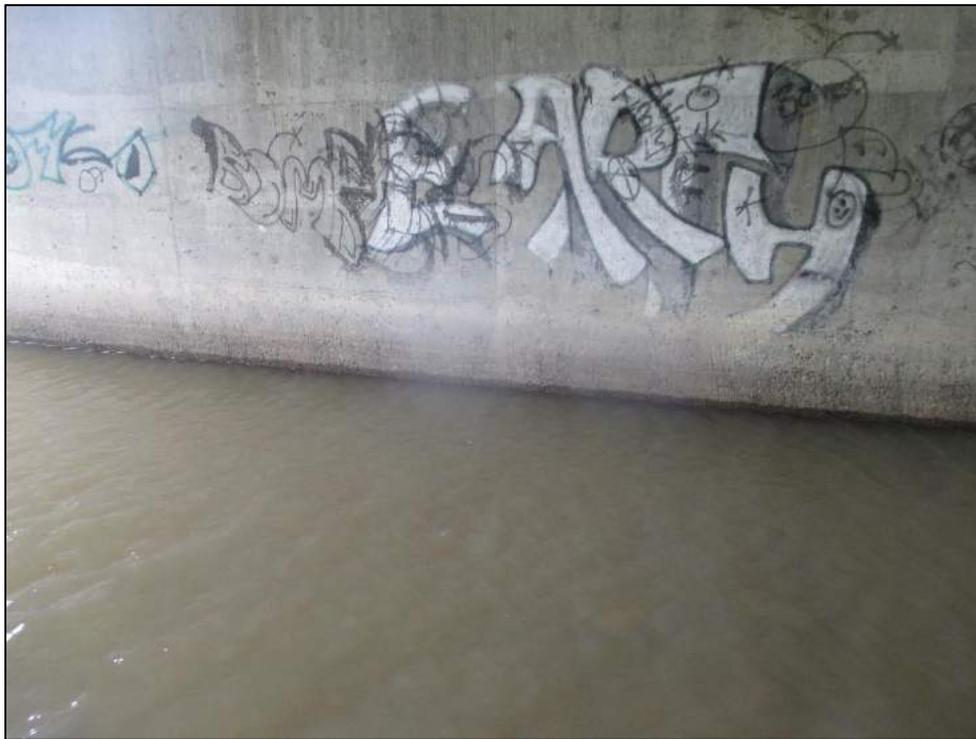
Structure Number: 07

Cracking and crack with spall at northwest abutment wall.

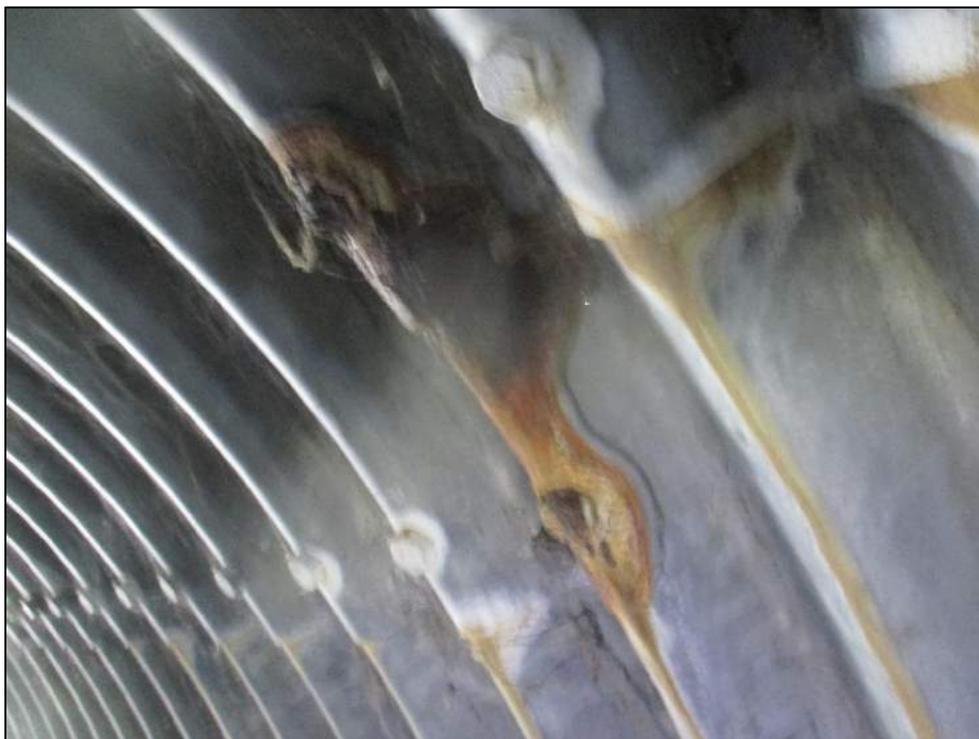
Barrel looking north, extensive corrosion along waterline.

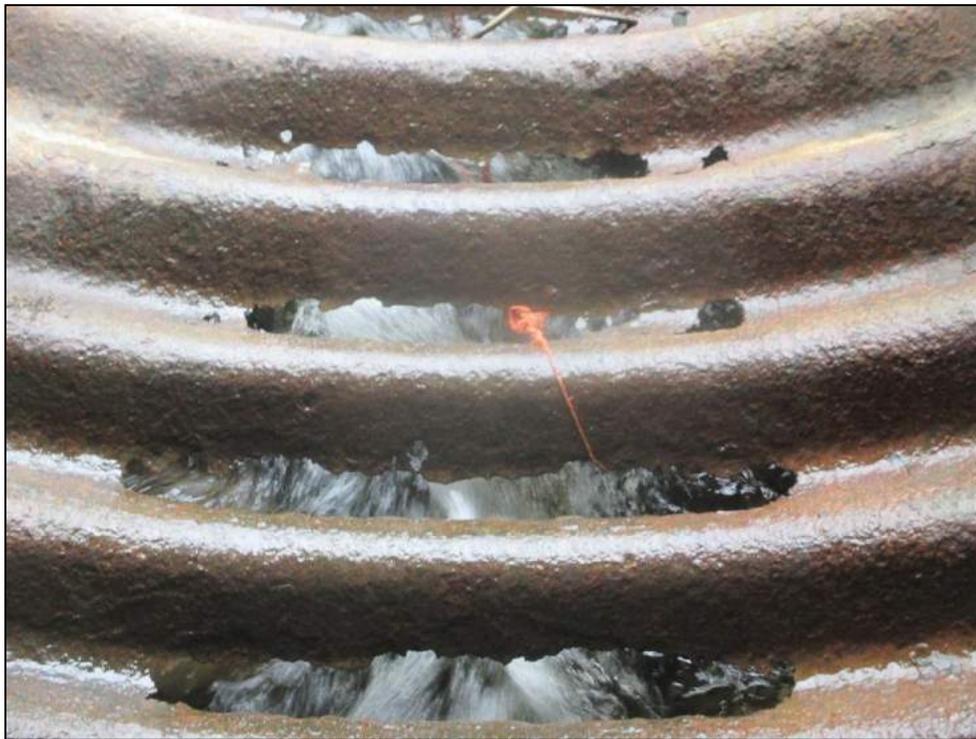
Structure Number: 09

Severe corrosion and section loss at top of barrel.

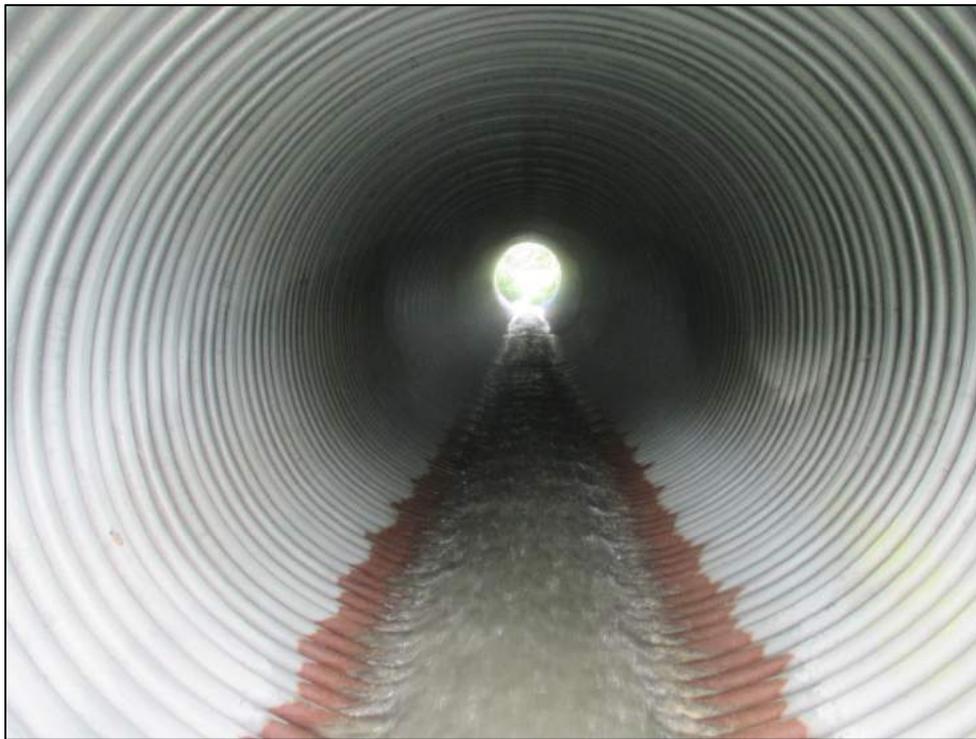
Structure Number: 11

East elevation.

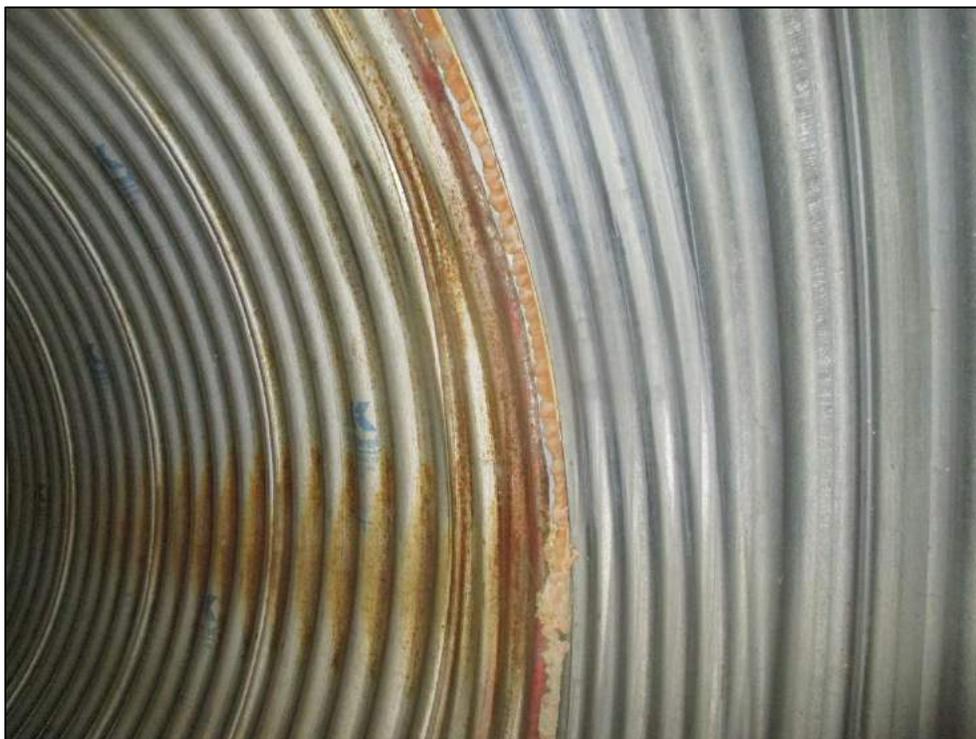
Barrel looking west, extensive light corrosion visible at culvert base.

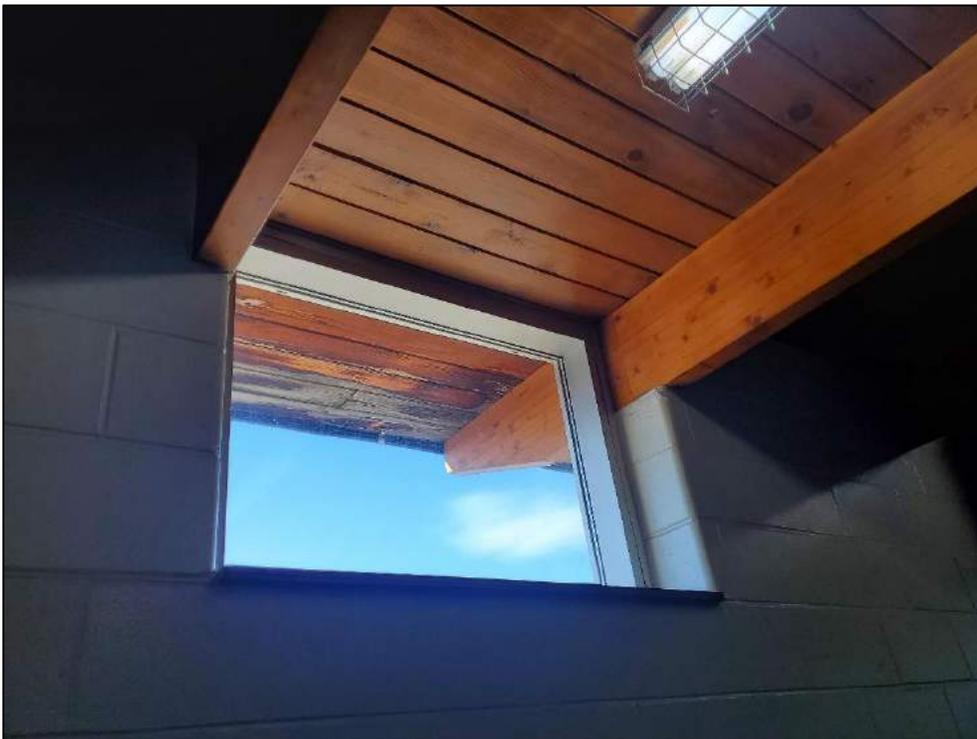
Underside of roof and ends of beams at building extension (south).

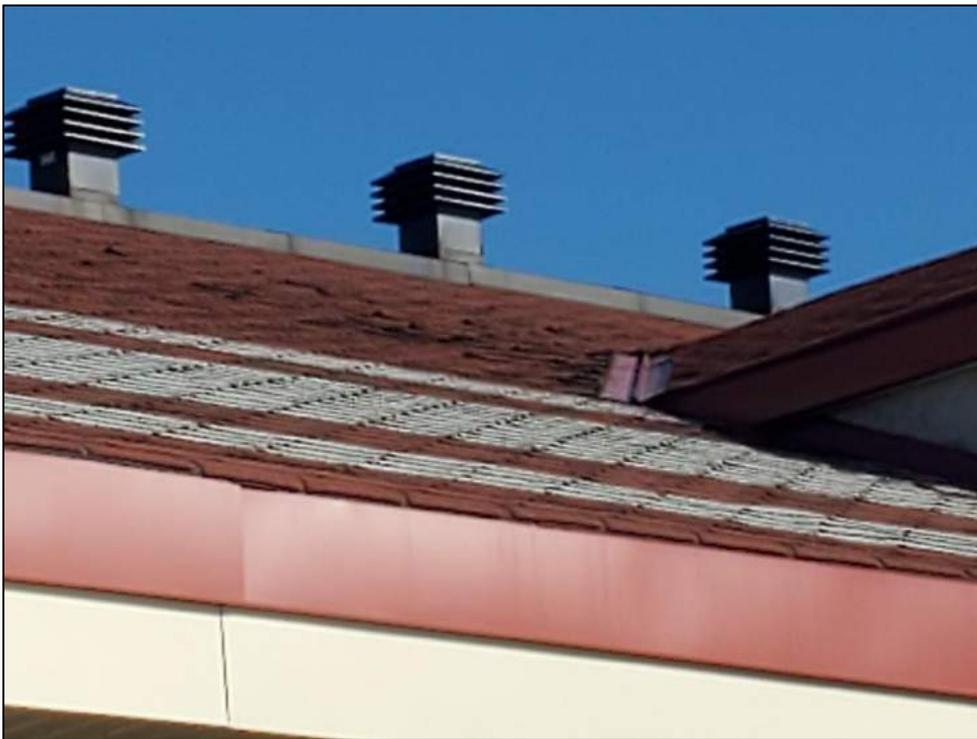
South corner of building.

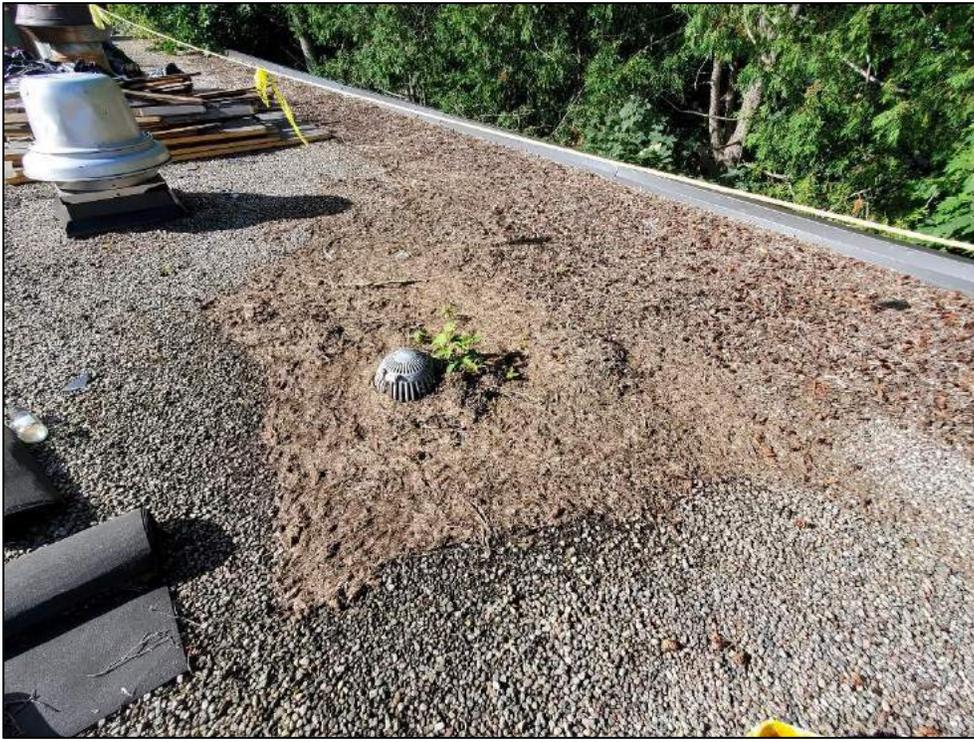
Structure Number: BLDG3

Roof in process of being replaced.

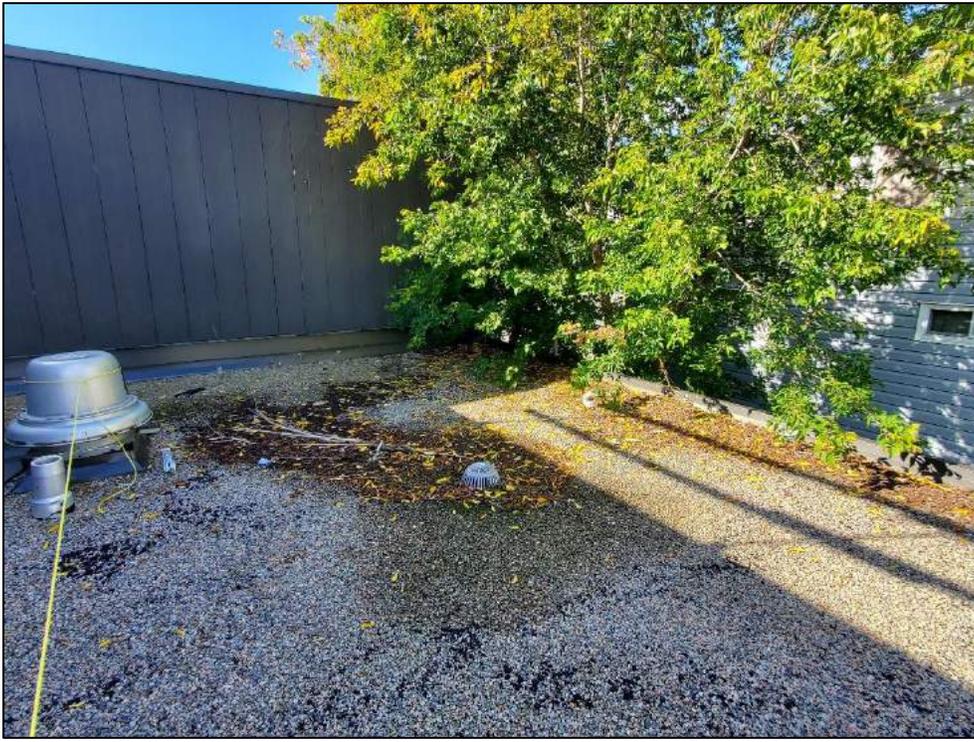
Structure Number: BLDG3

Displaced gravel and damaged tar coating due to runoff from upper roof.

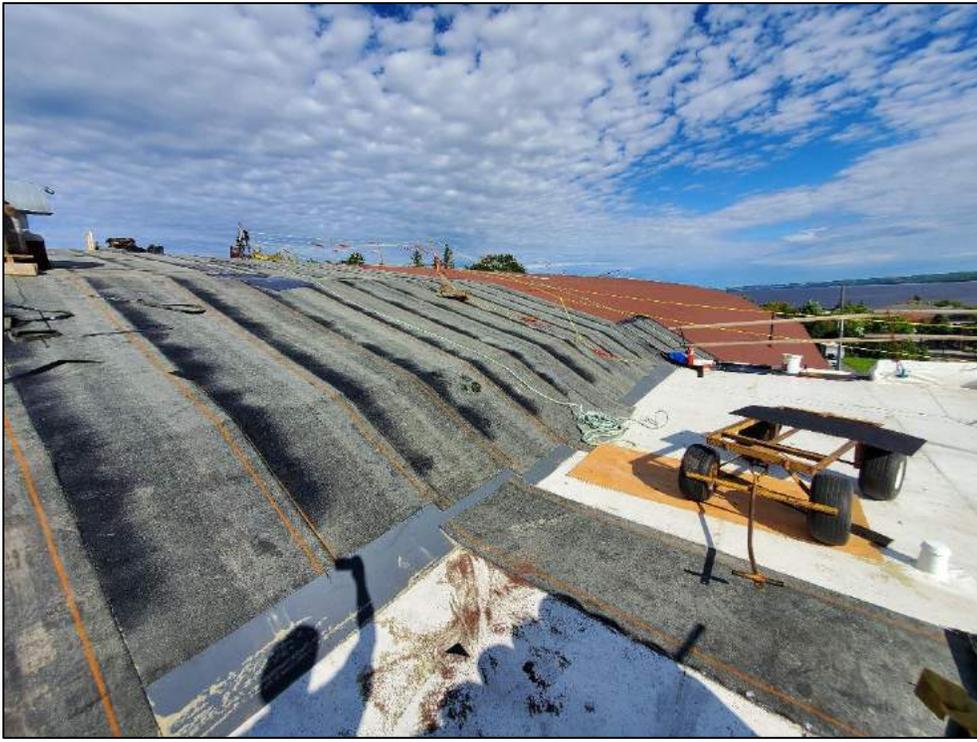
Structure Number: BLDG3

Construction debris on couth upper roof with new EDPM coating.
