The Corporation of the City of Temiskaming Shores
Regular Meeting of Council
Tuesday, November 17, 2020 – 6:00 p.m.
City Hall – Council Chambers – 325 Farr Drive

City Staff have reviewed the report which included 13 roadway structures, as well as 3 roof inspections and below is a list of maintenance work required as well as additional Engineering investigations required. Not shown in the table below, is a recommendation to remove and replace the roofing membrane on both the New Liskeard Arena, as well as the Pool Fitness Centre within the next 1-5 years. The City was provided a budget cost in 2019 for the New Liskeard Arena (\$1,000,000.00) however we do not have a cost estimate at this time for the Pool Fitness Centre.

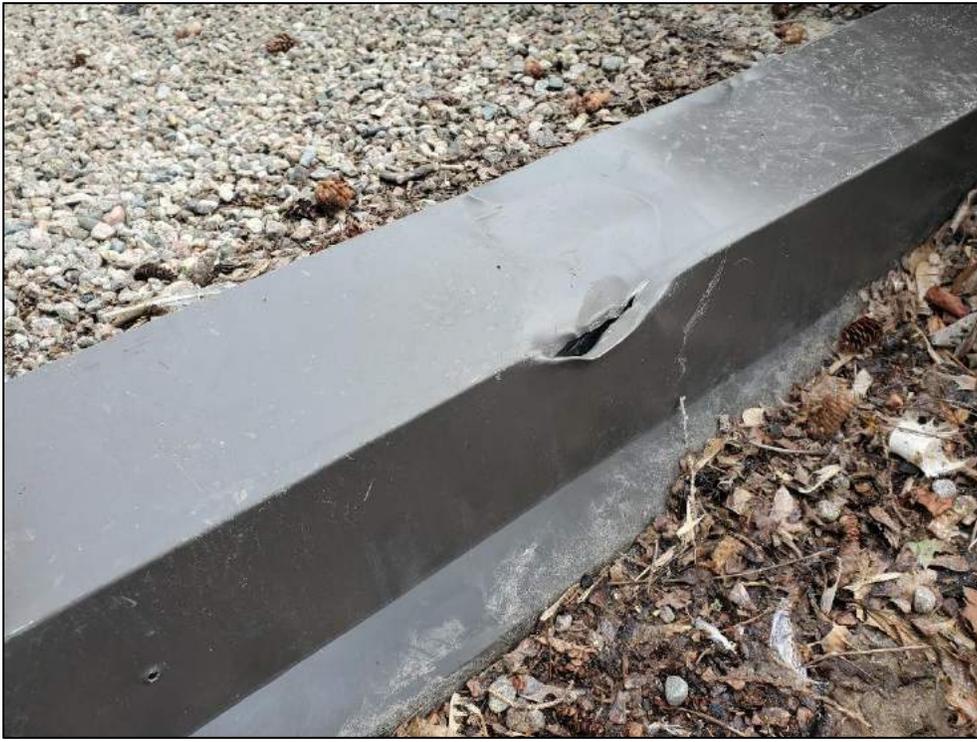
Structure Number: BLDG3

Overgrown tree at south.
