**The Corporation of the City of Temiskaming Shores**  
**Special Meeting of Council**  
**Friday, October 27, 2023 – 12:00 noon**  
**City Hall – Council Chambers – 325 Farr Drive**

a) **Administrative Report No. RS-024-2023 – Lawrence “Bun” Eckensviller Community Hall**

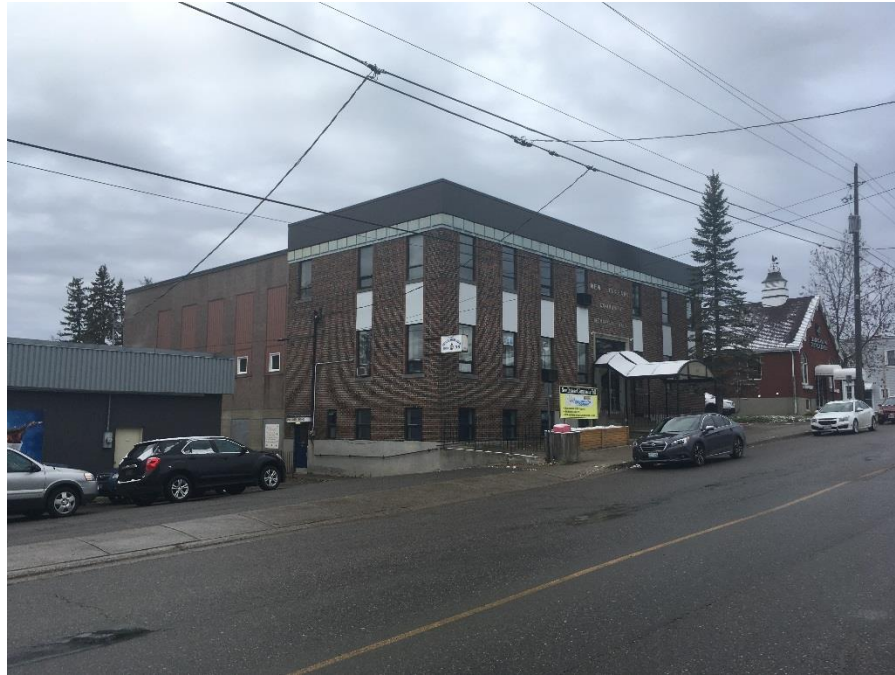
**Photograph 1:** View from Whitewood Avenue looking south-west. Note slope of site and elevation difference between main entrance/exit (north elevation) and Legion Hall entrance/exit (east elevation).

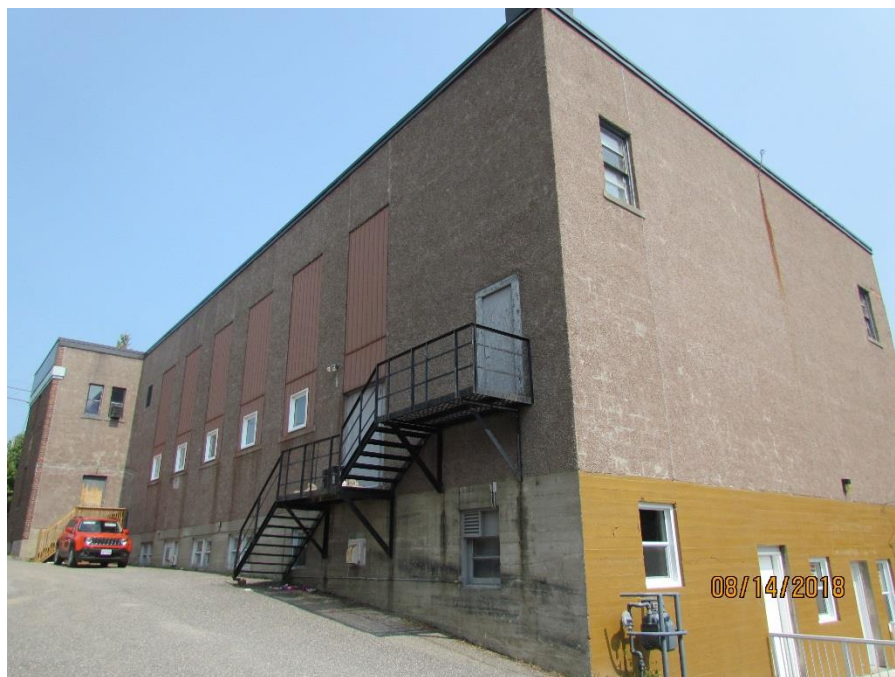
**Photograph 2:** View from back alley looking north-east. Note kitchen, east auditorium, stage and south basement entrance/exit locations.

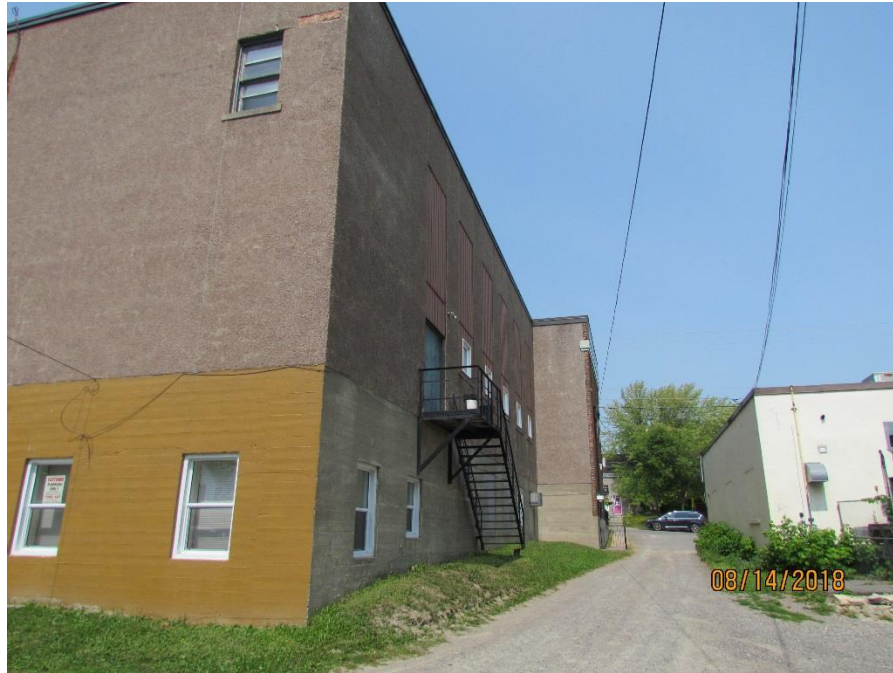
**Photograph 3:** View from back alley looking north. Note east auditorium and Legion Hall entrance/exit locations.

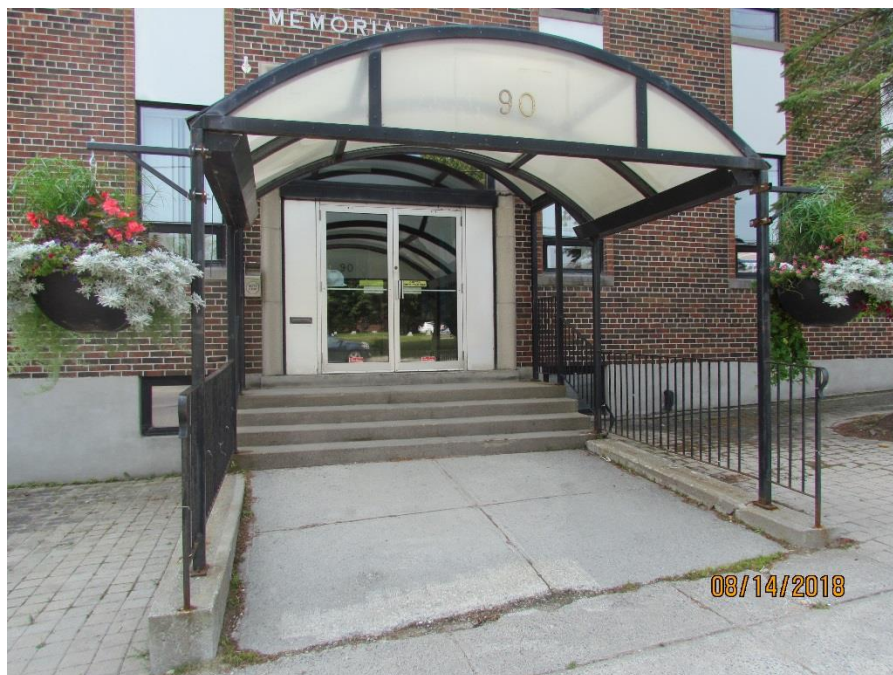
**Photograph 4:** Main building entrance/exit. Note level change to main floor is five (5) exterior steps and three (3) interior steps (refer to photograph 7).

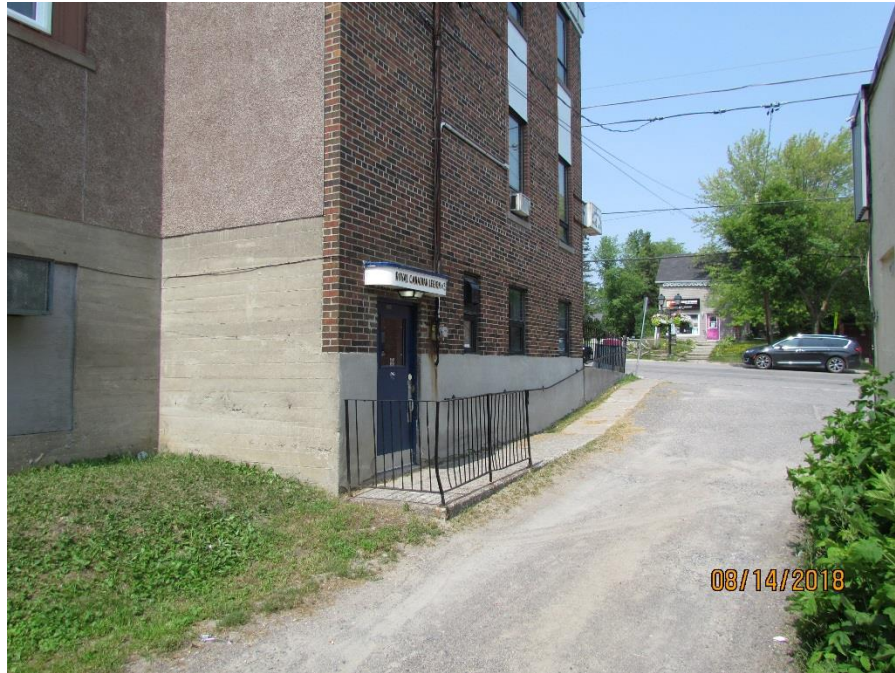
**Photograph 5:** Legion Hall entrance/exit (view from side alley). Note entrance is three (3) steps above the floor level of the hall. Note ramp concrete sidewalk (ramp) are not within the property limits.

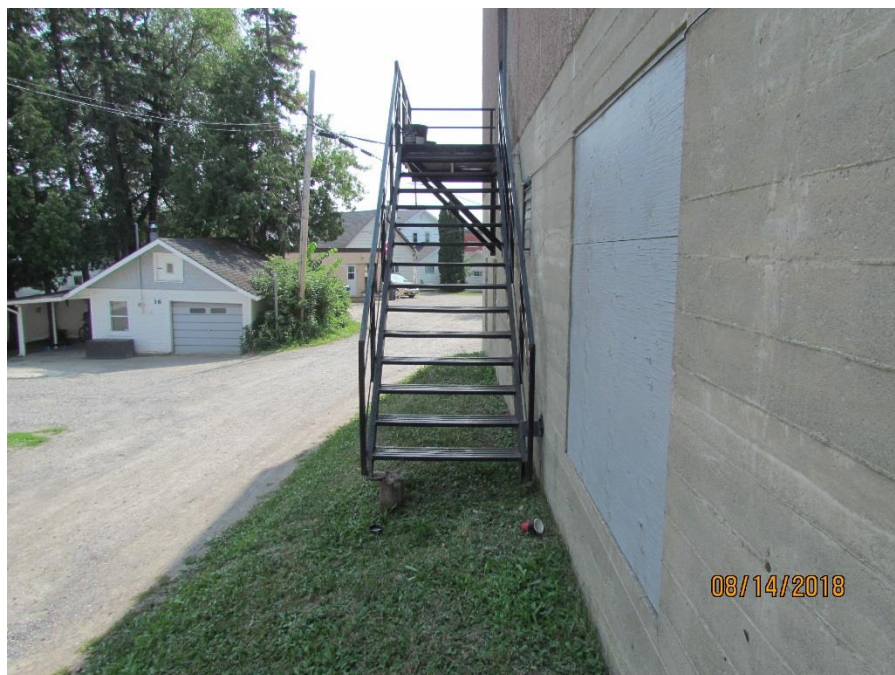
All assemblies could not be fully accessed or determined. No issues were noted with respect to the observable principal structural systems. The exterior foundations for the steel stage exit stairs (east and west) were noted to be out of alignment with the base of the stairs.

- 4.2.1.7. The noted foundation issue (Section 3.2 above) with respect to the east and west exterior exit stairs would mean that these stairs would likely be deficient under full emergency egress loading.

**Photograph 6:** East auditorium exit stair. Note left concrete foundation.

Greenview notes that the south exterior exit stairs should be repaired as soon as possible with respect to noted foundation issues (as indicated in Section 3.2 above). Exterior brick, stucco, and other cladding repairs should be considered.

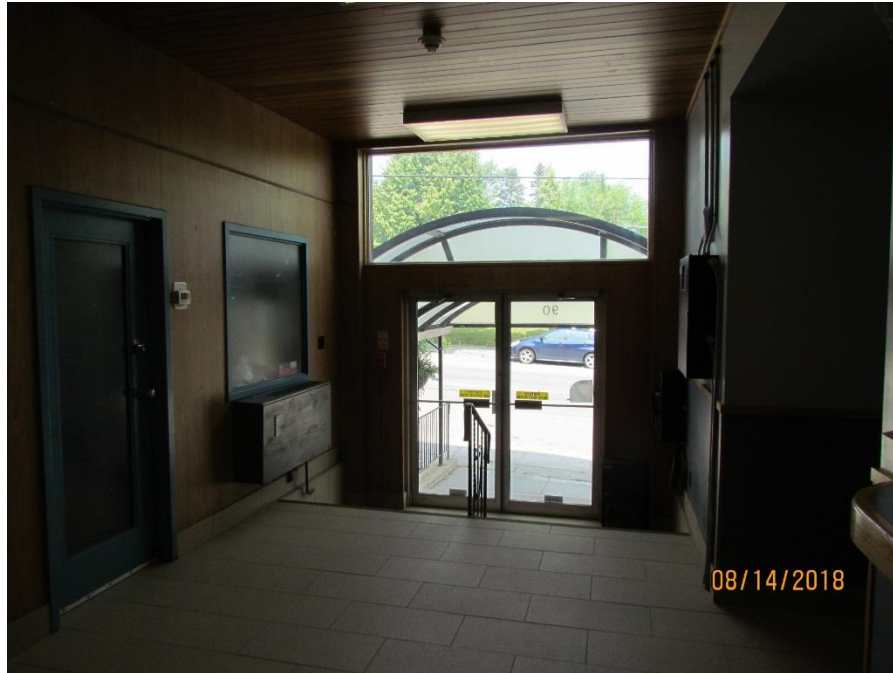
**Photograph 7:** Main entrance/exit (view looking north from lobby). Note step down to doors.

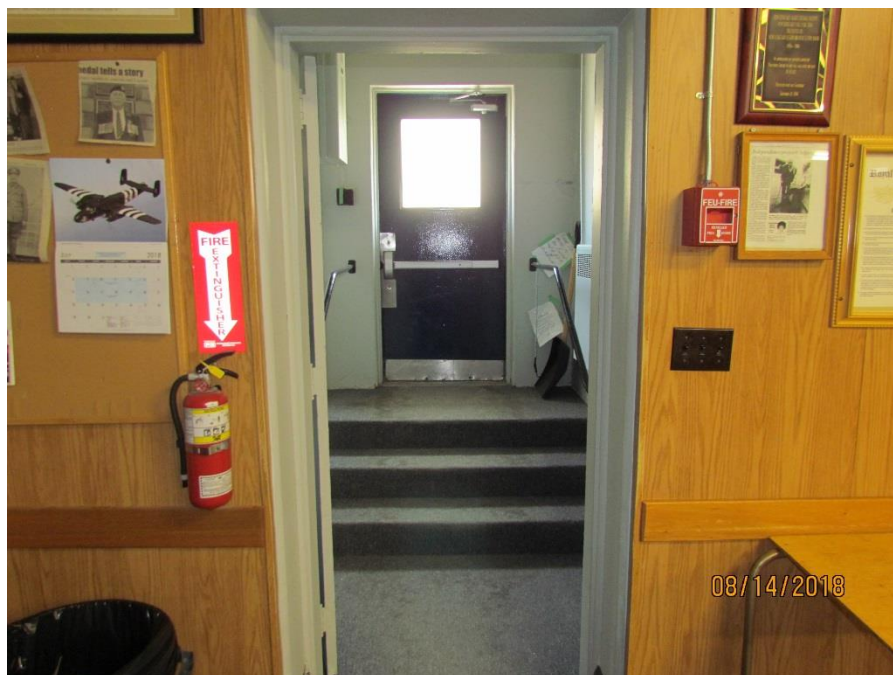
**Photograph 8:** Legion Hall entrance/exit vestibule (view looking east from Legion Hall). Note step up to exit.

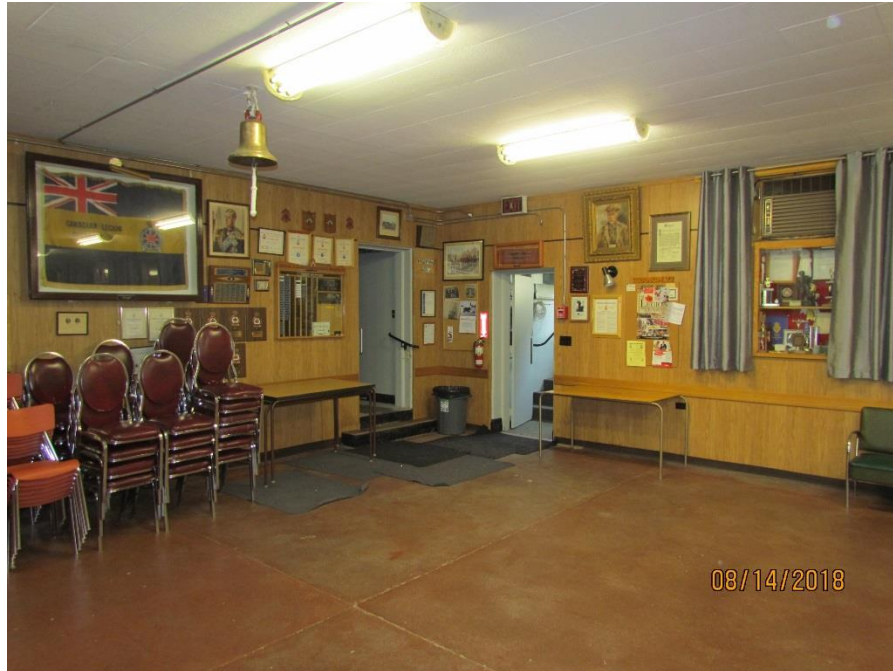
**Photograph 9:** Legion Hall view looking north east. Note two steps up to north basement.

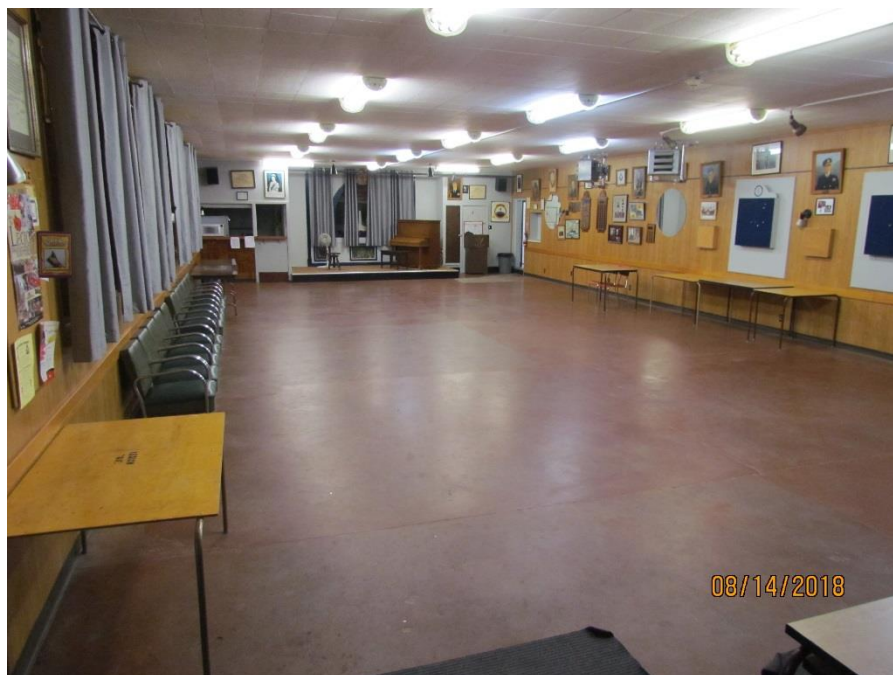
**Photograph 10:** Legion Hall view looking south. Note step up to west basement (door at south west corner).

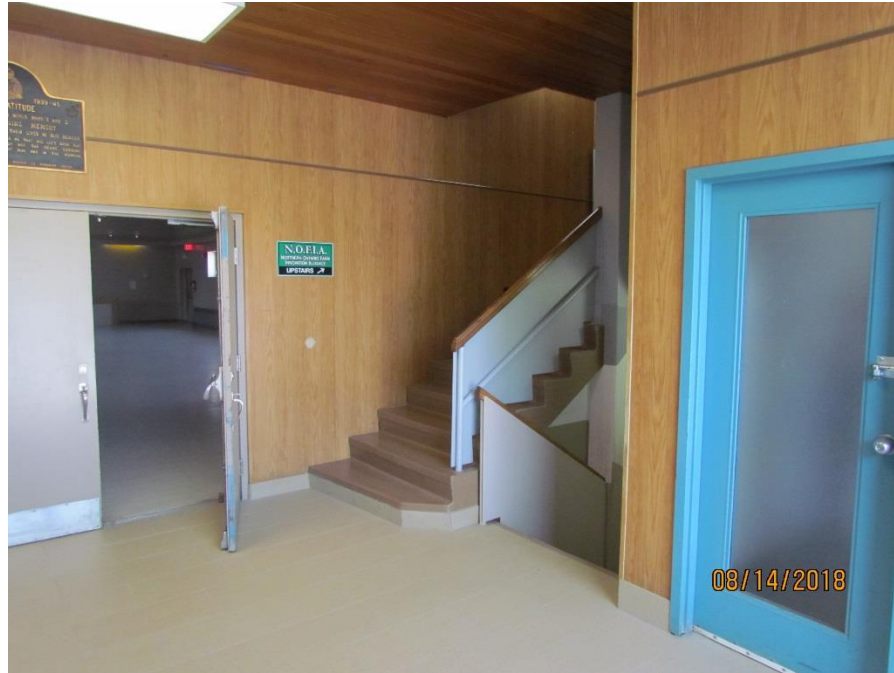
**Photograph 11:** Lobby view looking south west to stairwell. Note fire separation required between exit stair and lobby.

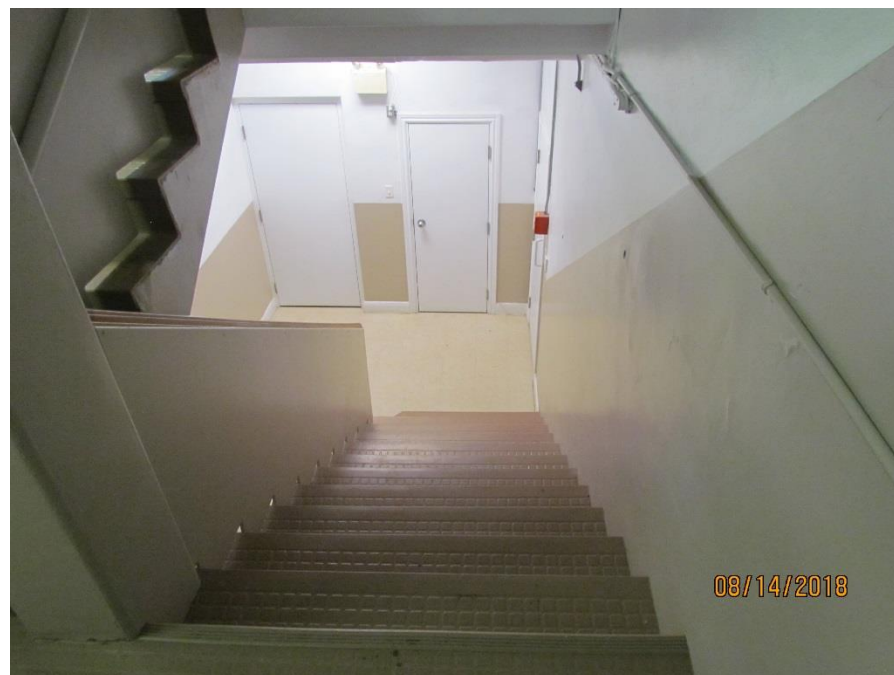
**Photograph 12:** Main stairwell view to basement (view looking east). Note fire separation required between exit stair and other parts of basement.

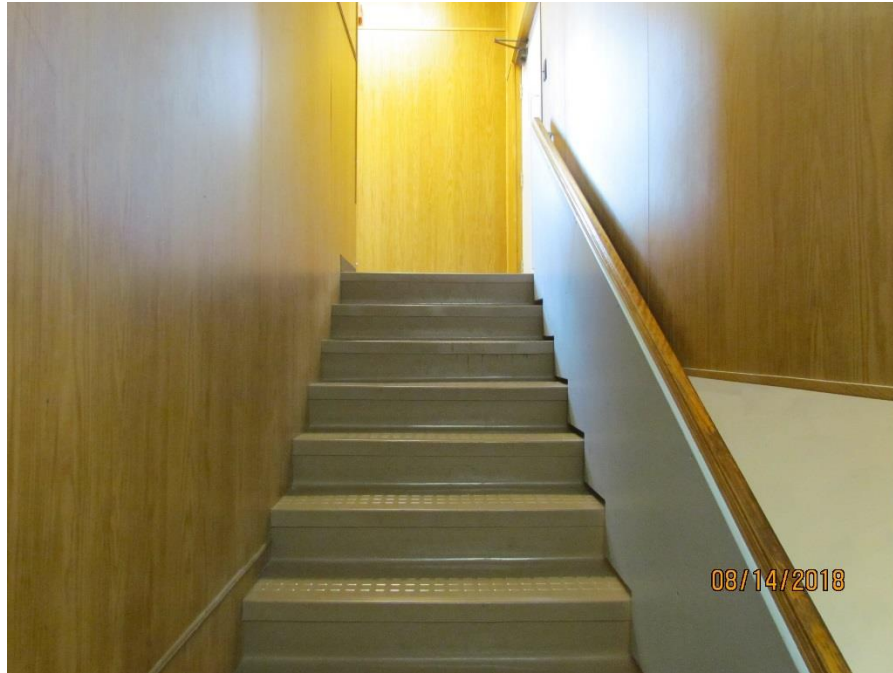
**Photograph 13:** Main stairwell view to second storey. Note fire separation required between exit stair and other parts of second storey.
