**The Corporation of the City of Temiskaming Shores
Regular Meeting of Council
Tuesday, December 20, 2022 – 6:00 p.m.
City Hall – Council Chambers – 325 Farr Drive**

Table 1 - Additional investigation required.....	Error! Bookmark not defined.
Table 2 - Recommended 10-Year Capital Bridge and Culvert Program.....	3

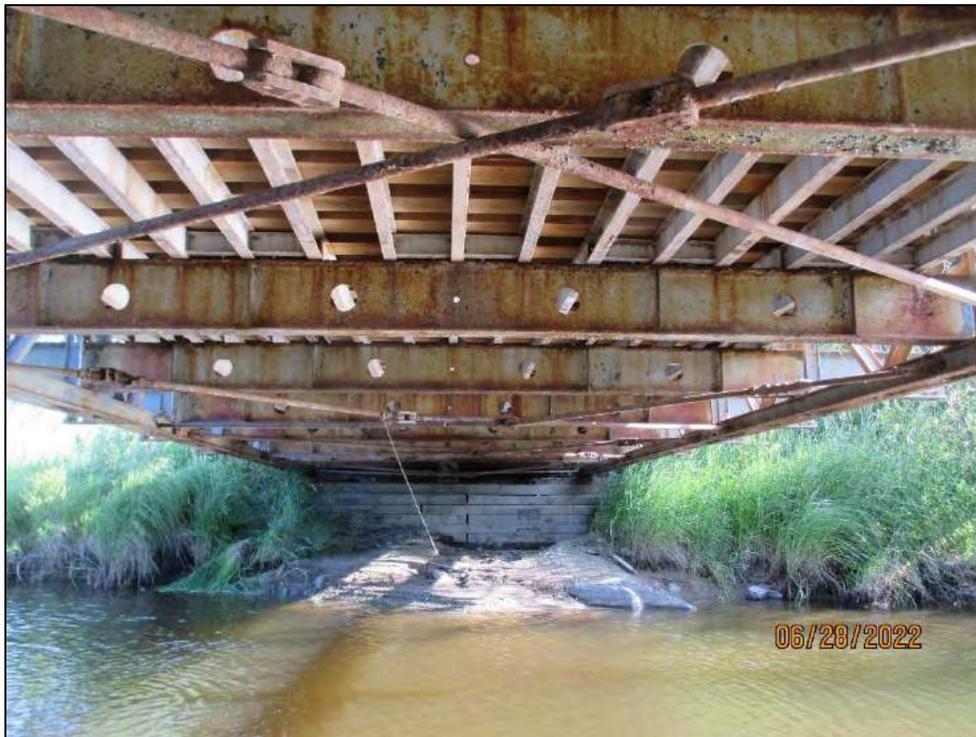
Structure Number: 01

Transom / Floor Beam – Top Flange Corrosion (Typ.)

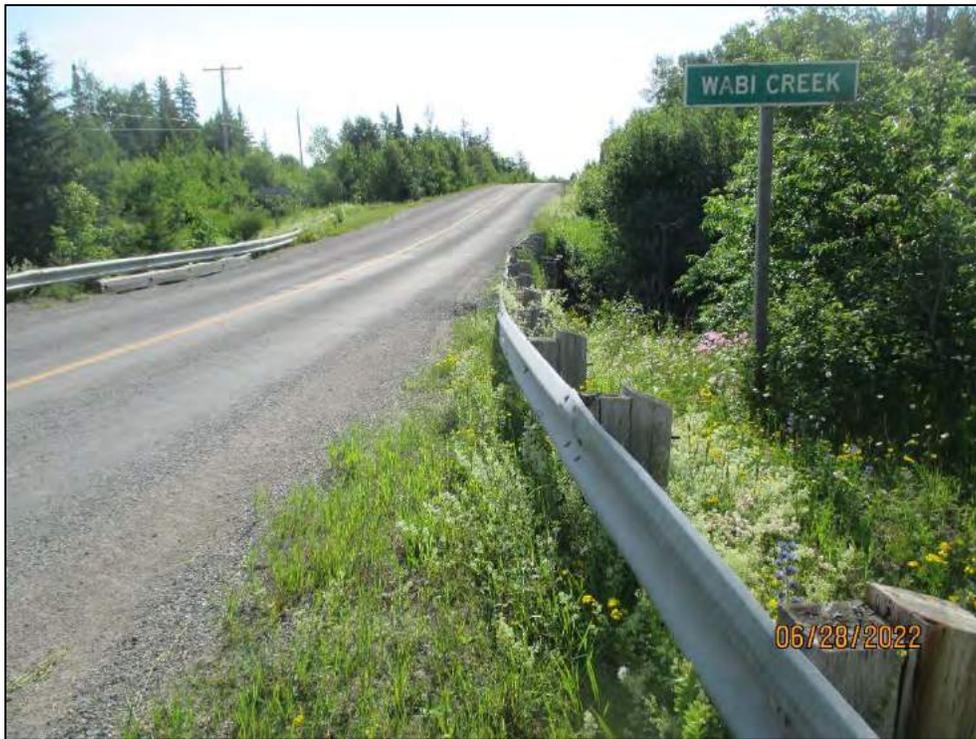
Structure Number: 02

Collision damage and poor SBGR at S/W

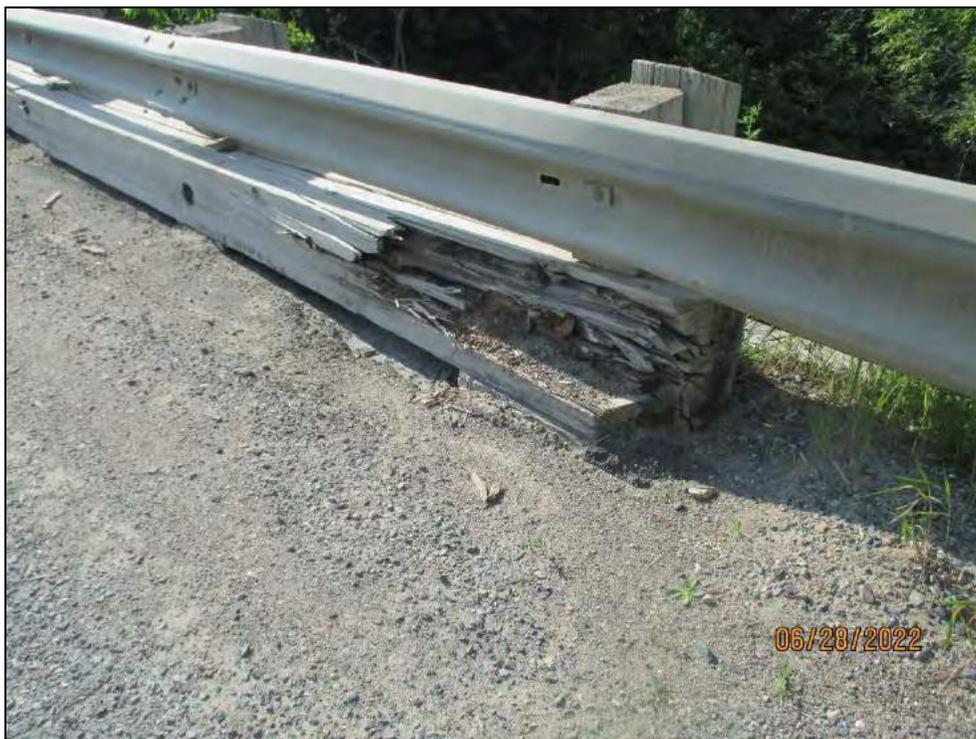
Curb damage at S/W

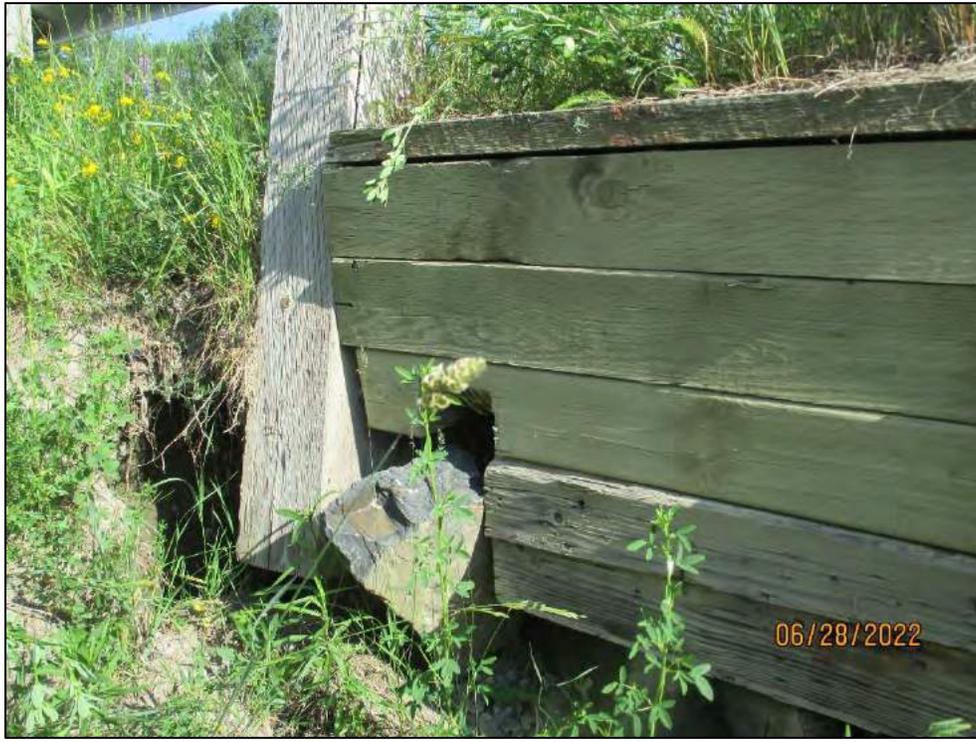
Displaced SBGR Port and rotating Retaining Wall section

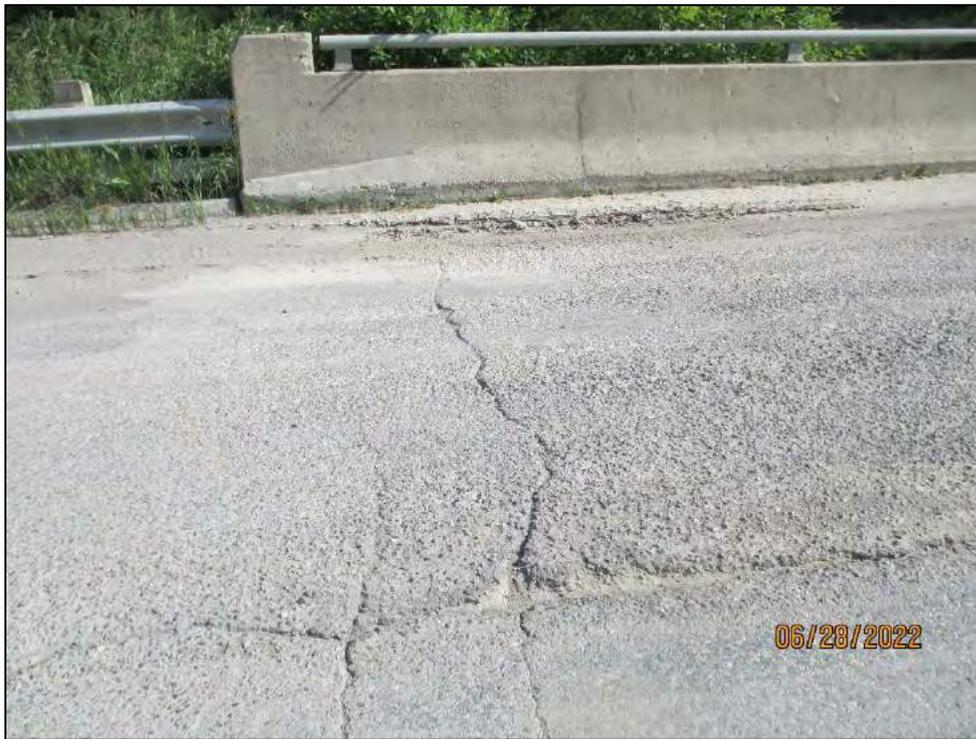
Approach Slab (West) – Potential Settlement

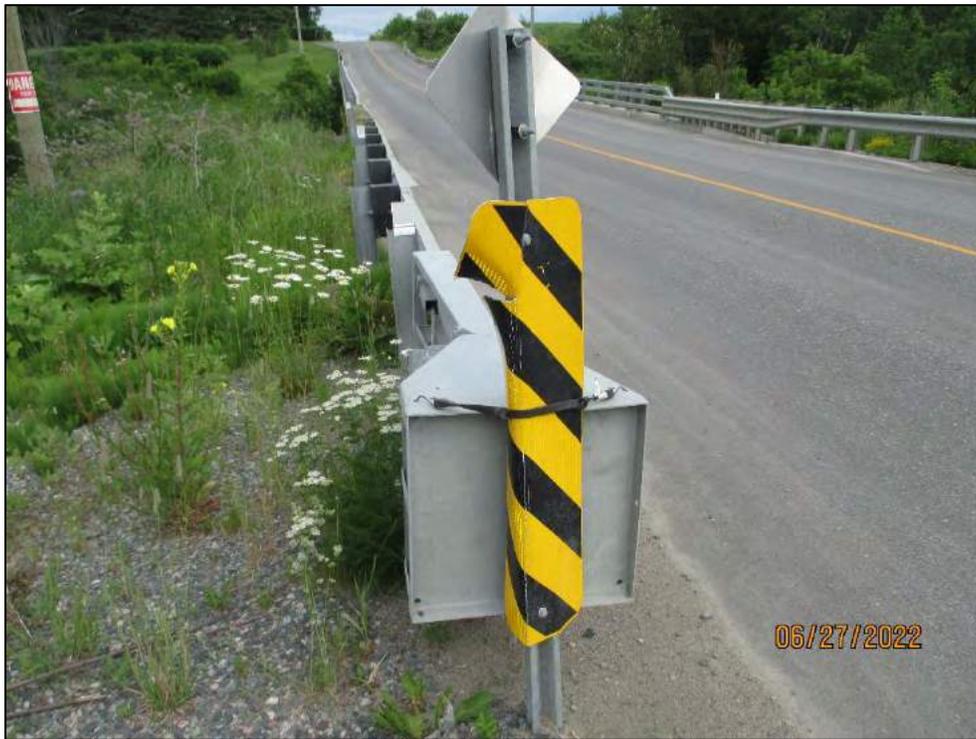
SBGR End Treatment (Torn Hazard Marker)

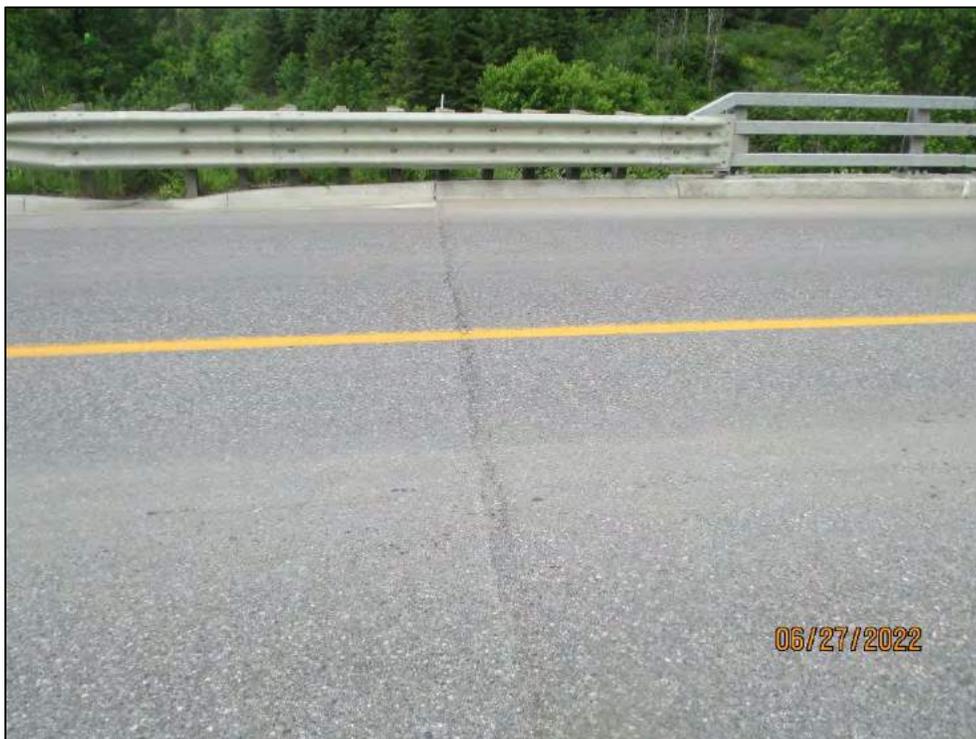
End of Approach Slab (Cracking in Asphalt) – Typ.

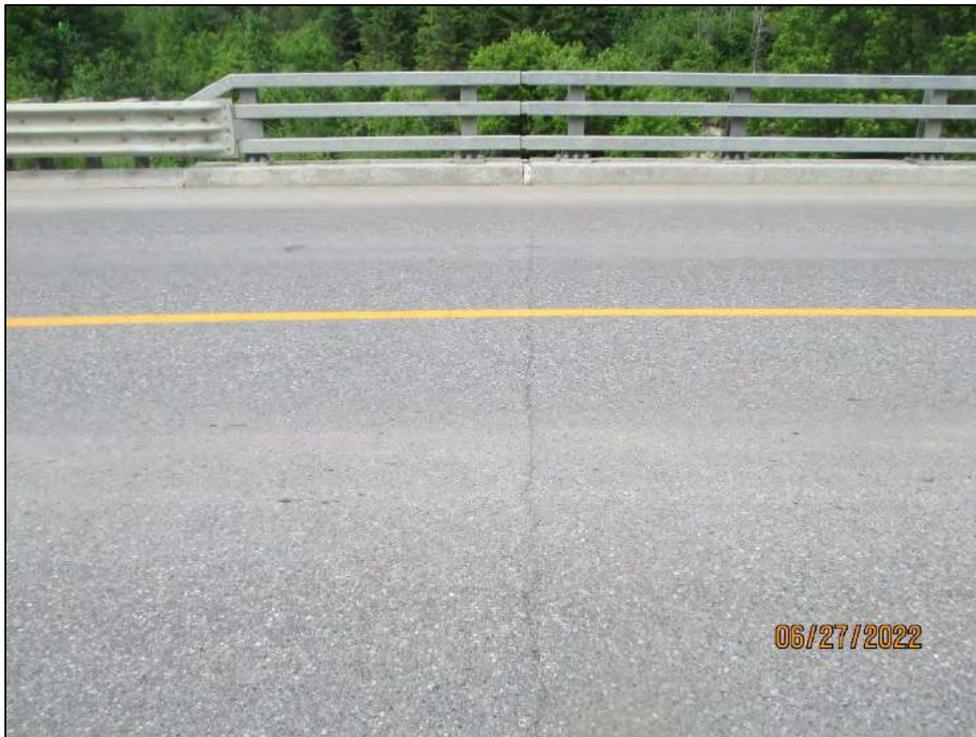
Deck End / Approach Slab (Cracking in Asphalt) – Typ.

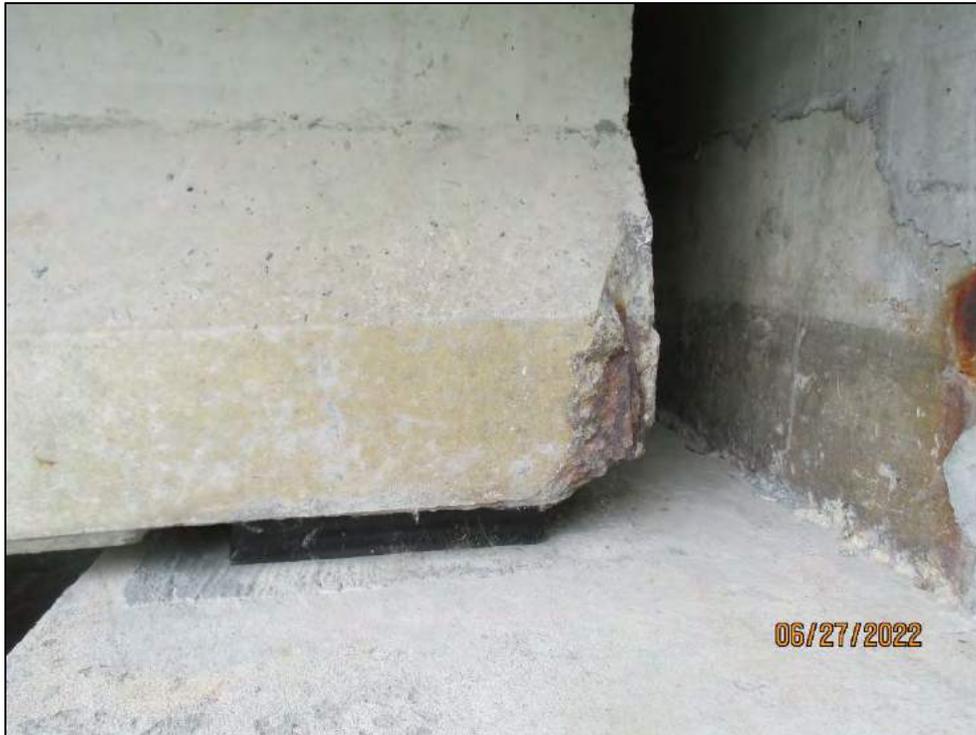
Girder End Spall – S/E

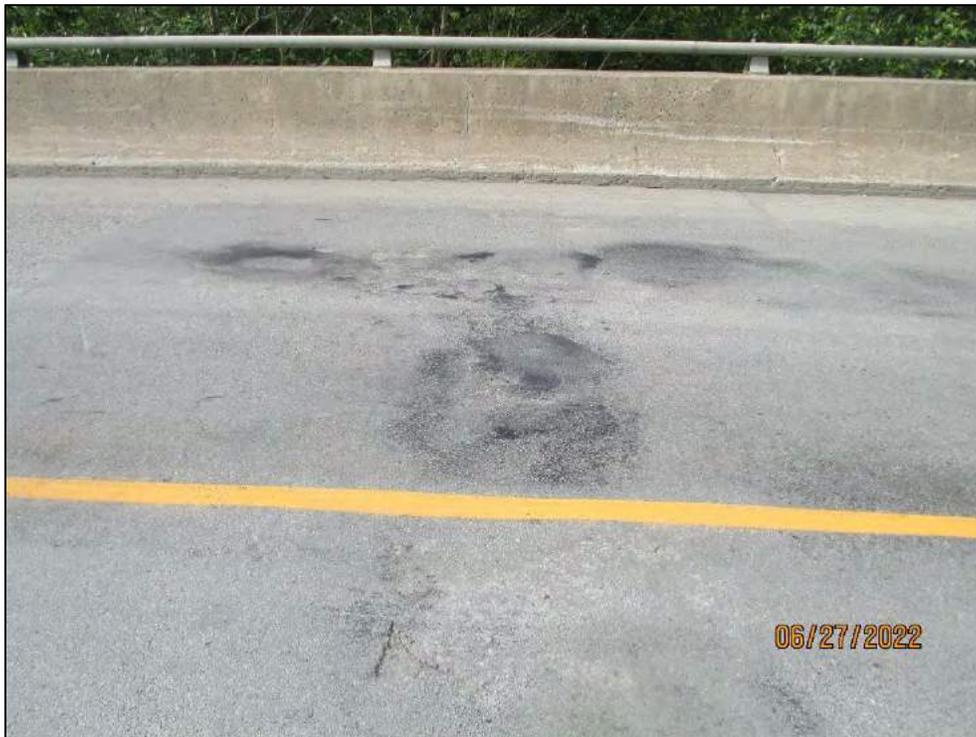
Deck Top- Wearing Surface Defects

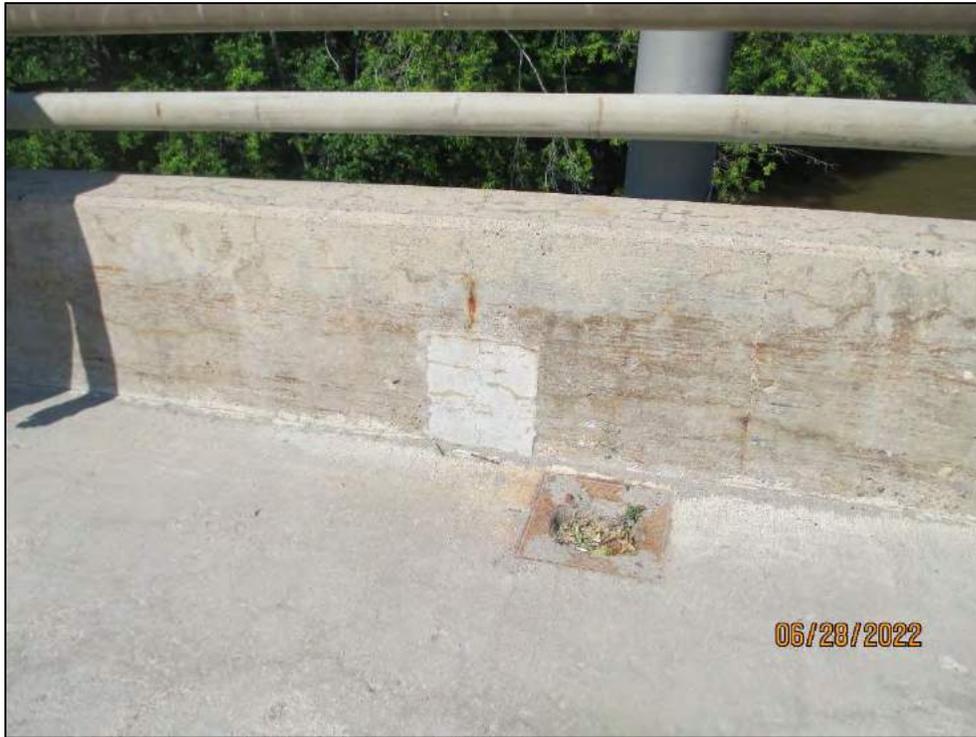
West Sidewalk / Parapet – Note: Deteriorated Junction Box Cover Plate

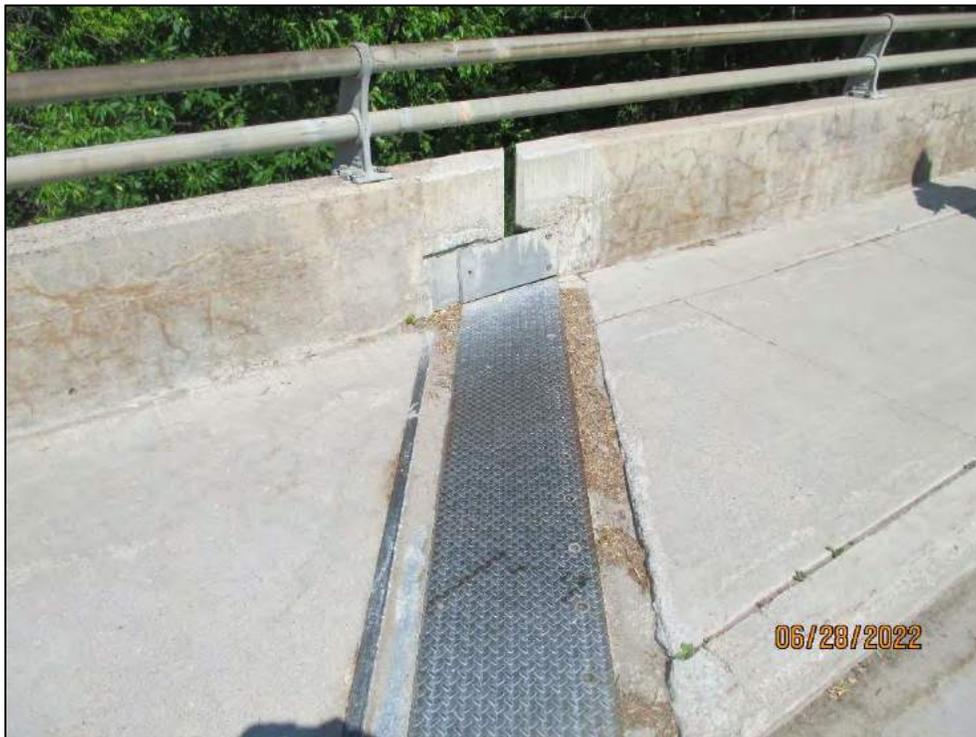
Expansion Joint (Cover Plate) – N/W (Missing Grout)

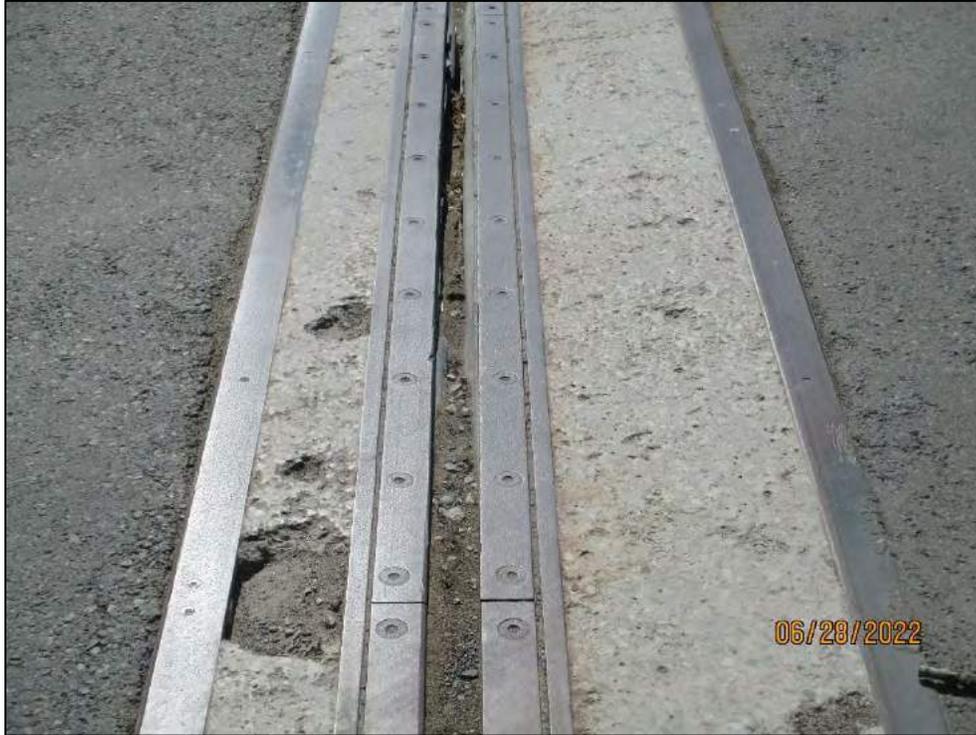
Expansion Joint (North) - Torn Seal and End Dam Deterioration

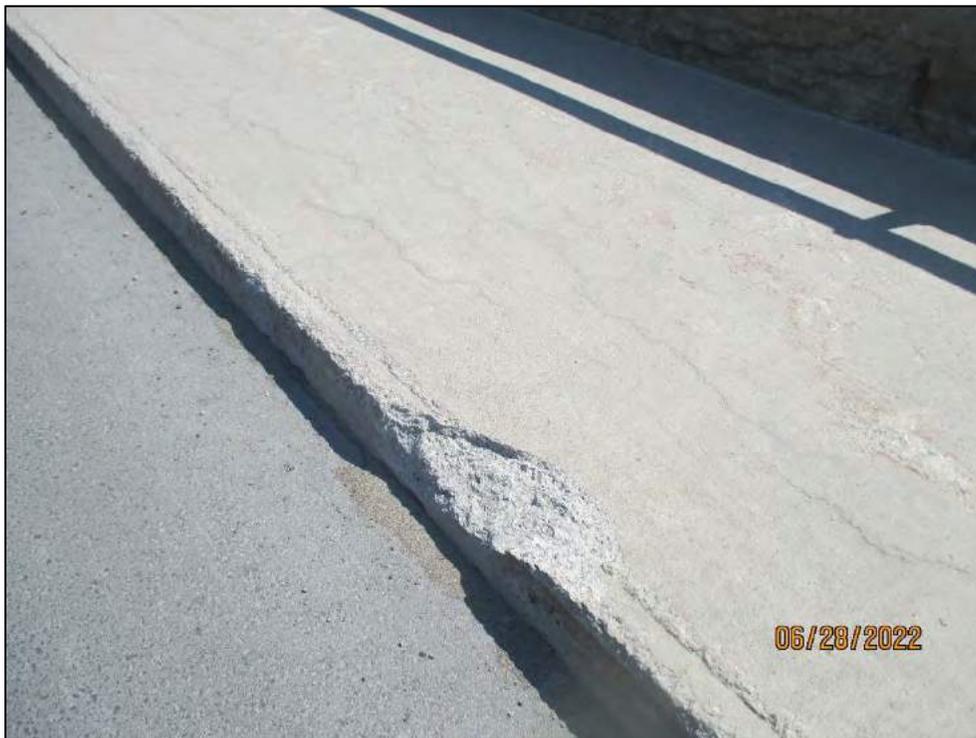
Scaling and Spall – East Sidewalk/Curb

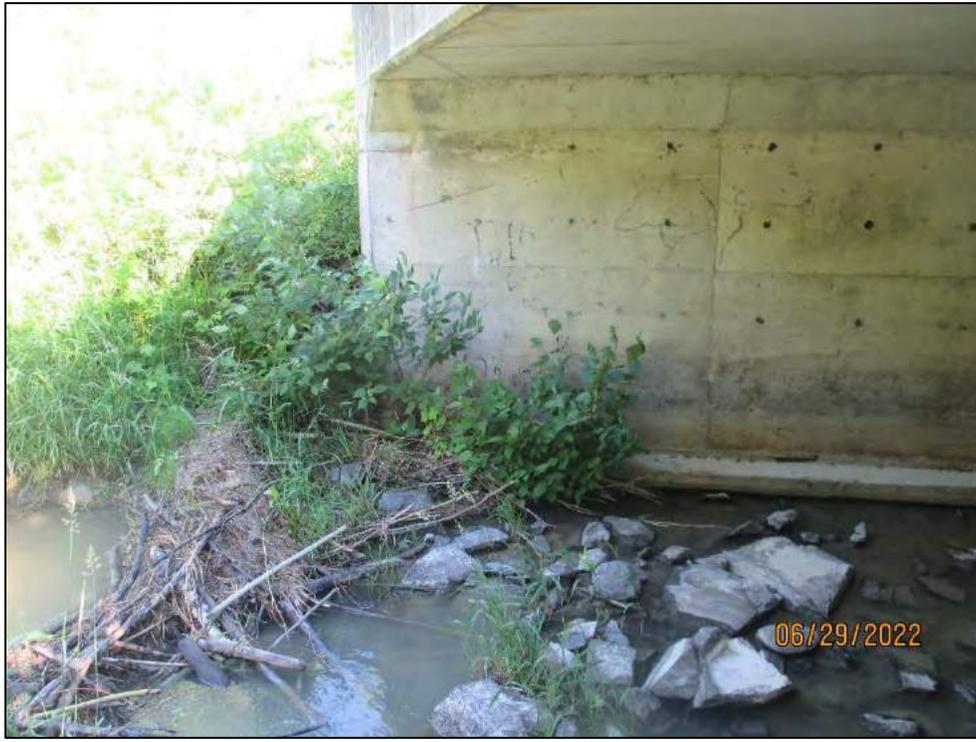
Debris / Blockage at Inlet

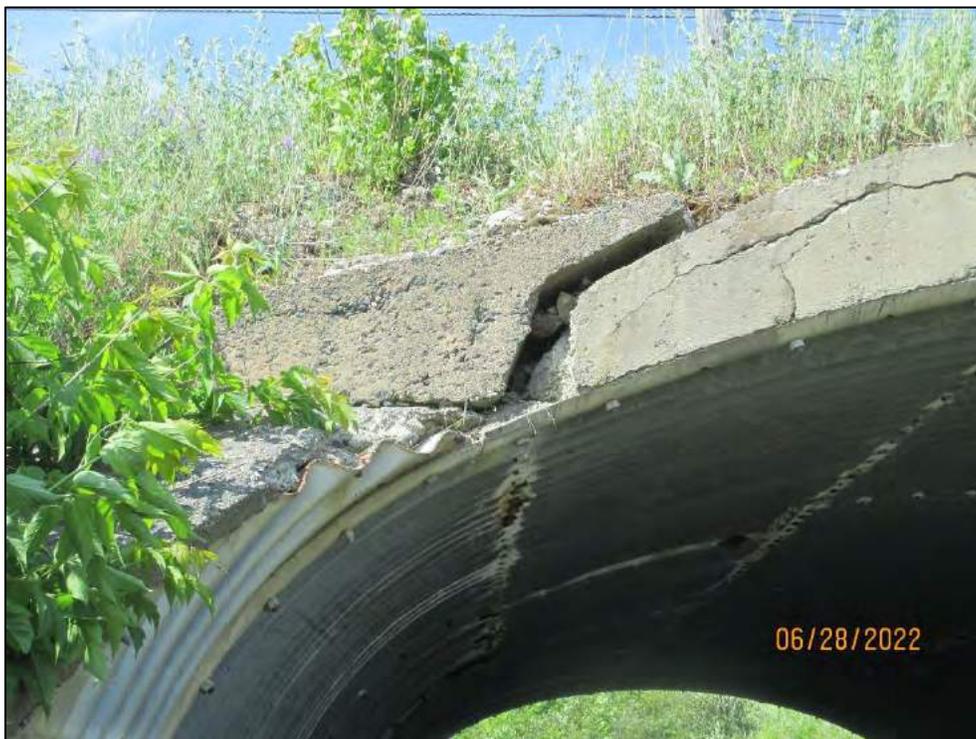
Concrete Damage (Typ.)

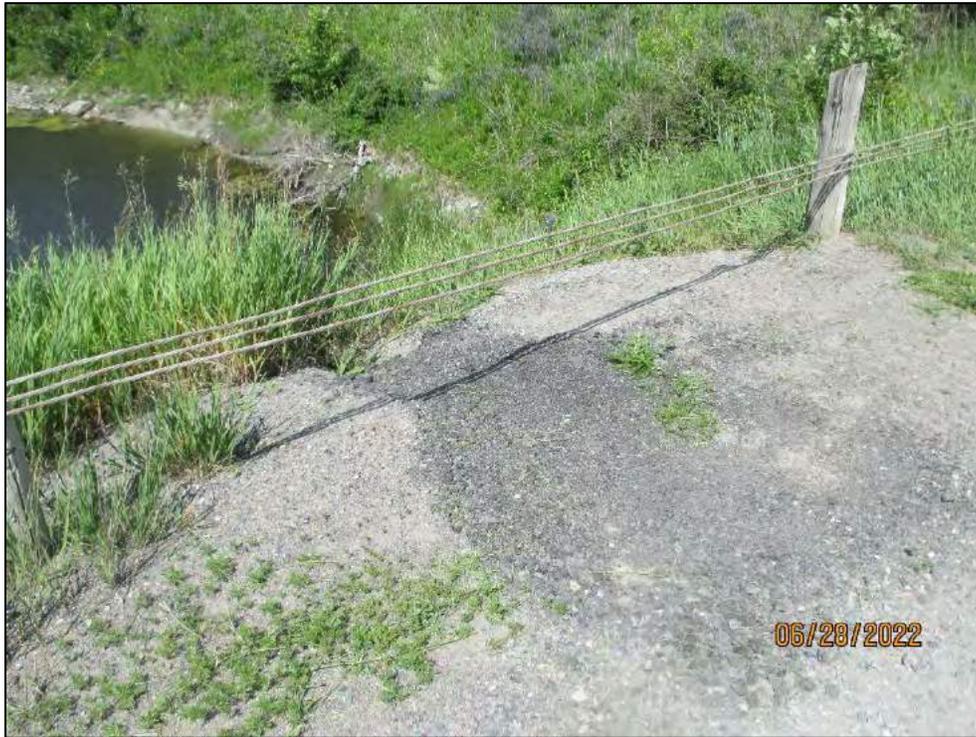
Shoulder Washout over Barrel (North)

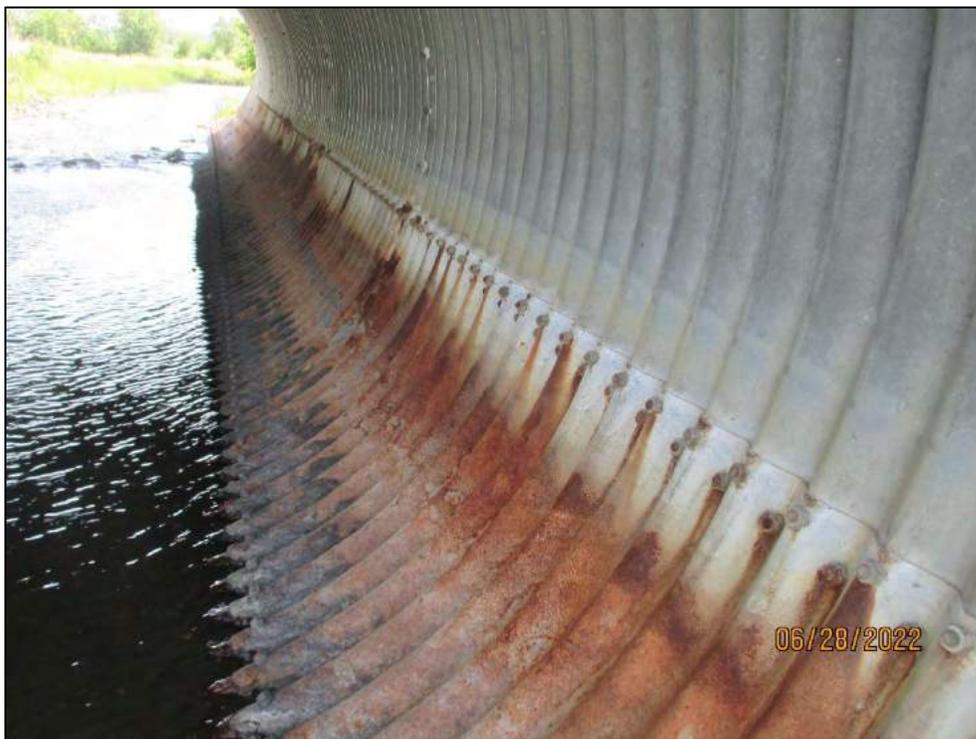
Barrel Corrosion (Typ.)

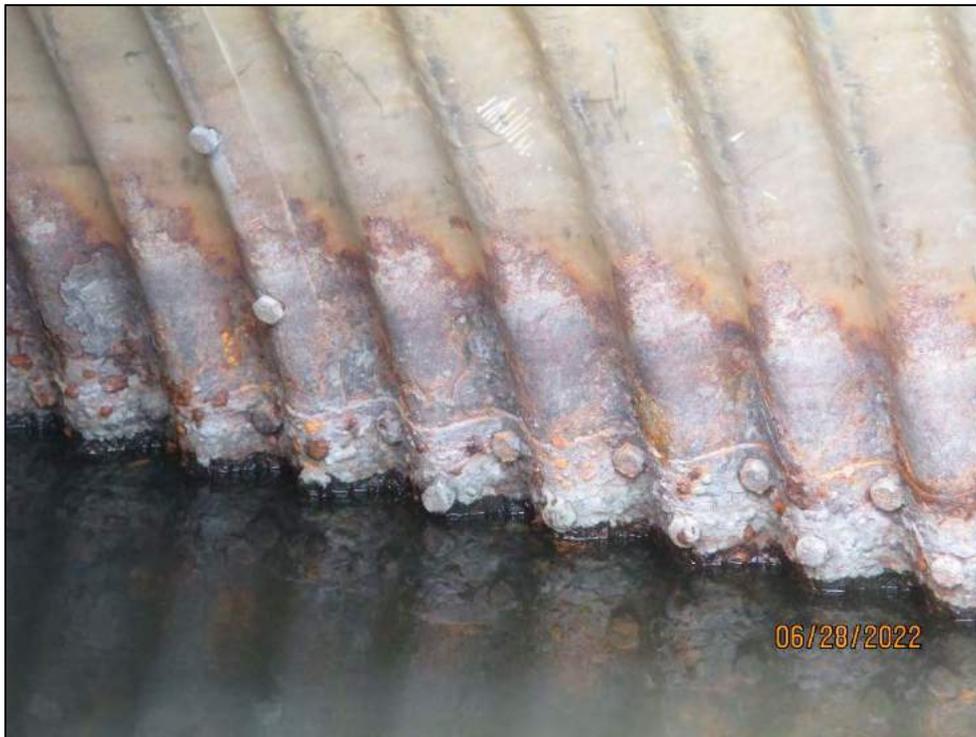
Culvert Barrel (corrosion at waterline) – Typ.

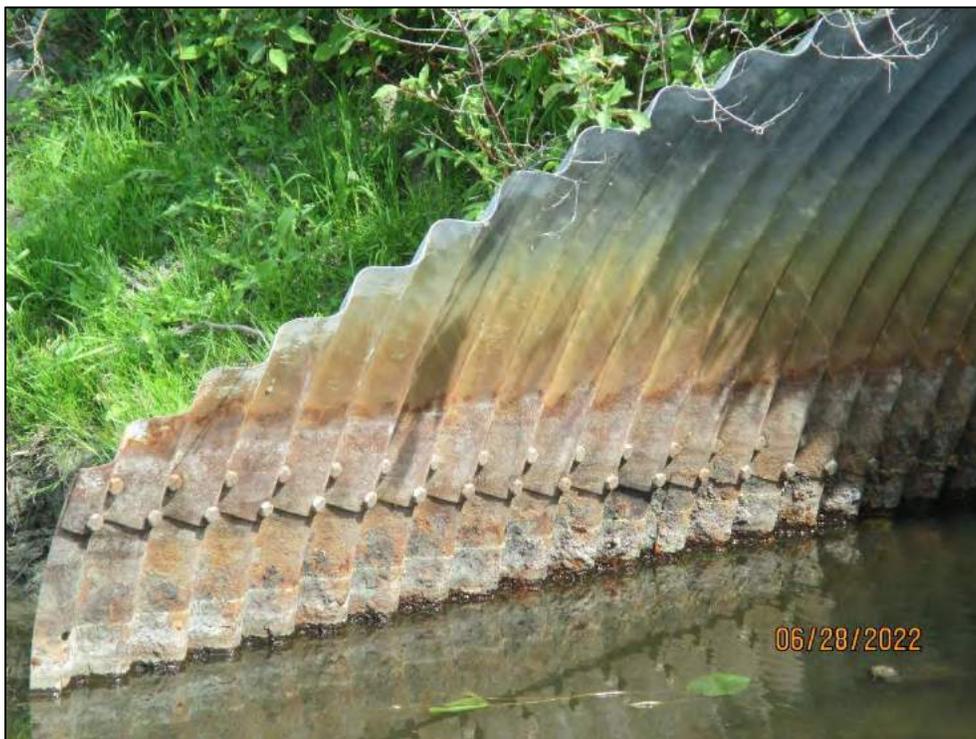
Culvert Barrel (corrosion and uplift at outlet) – Typ.

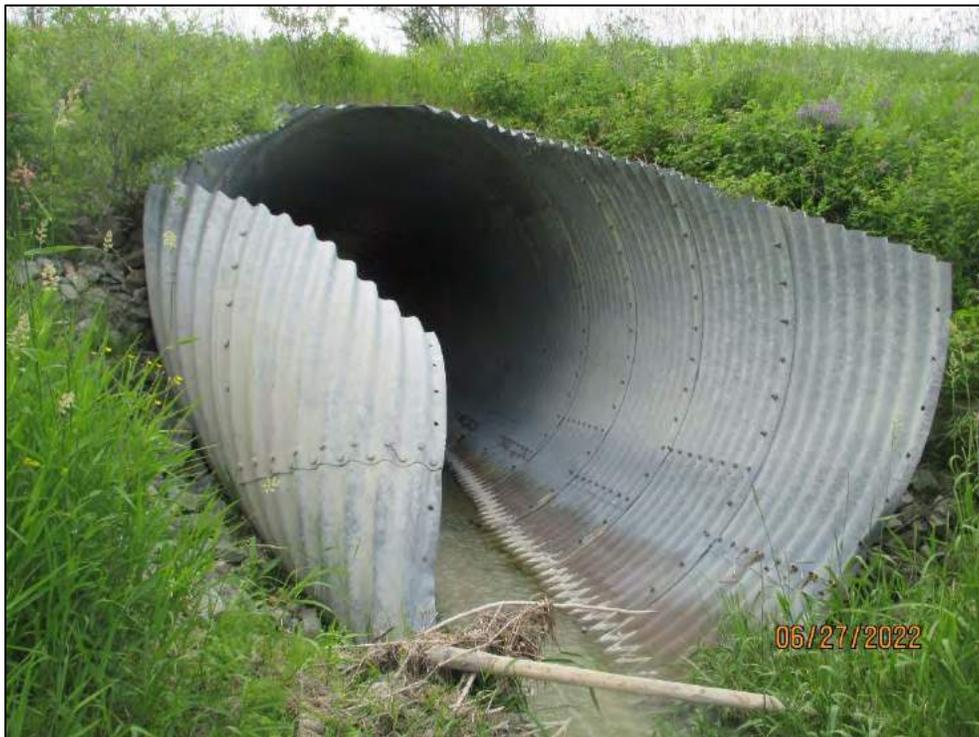
East (Inlet) Culvert Barrel Damage

Please note Urgent repairs required to Culvert No. 11 in 2022.

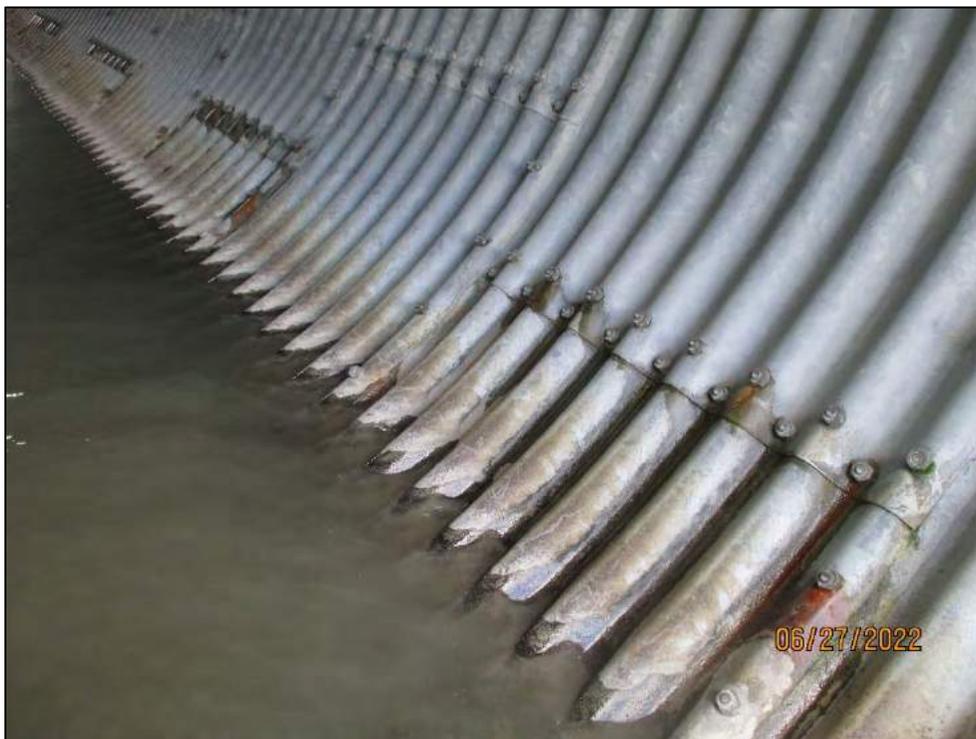
Culvert Barrel (minor corrosion at bolt seams)

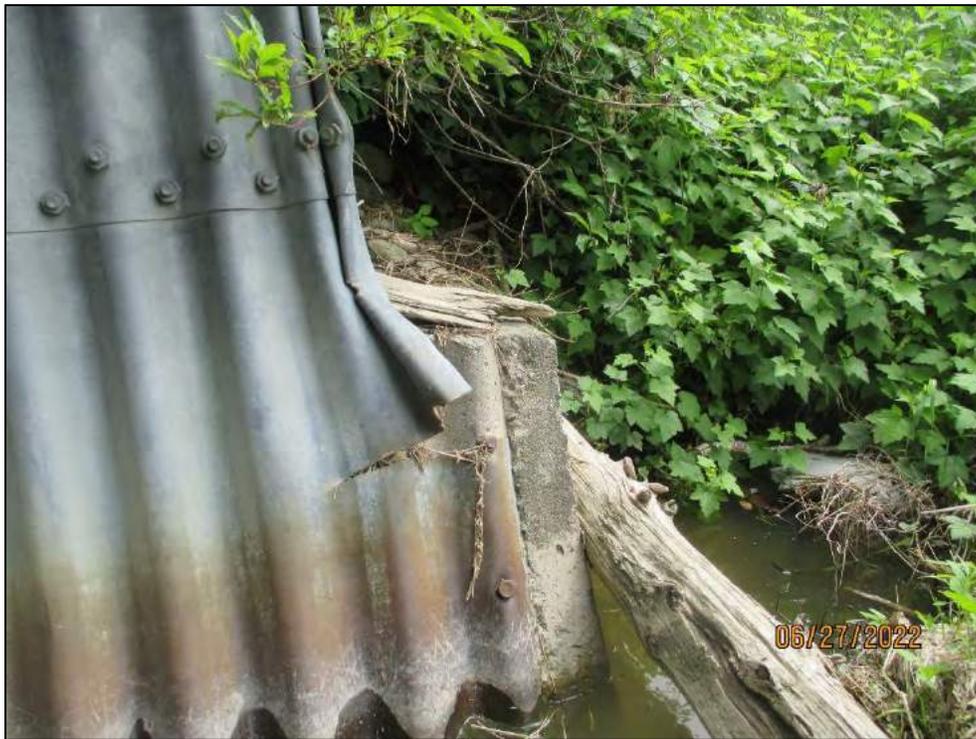
West (Inlet) Cut-Off Wall and Impact Damage to Culvert Barrel

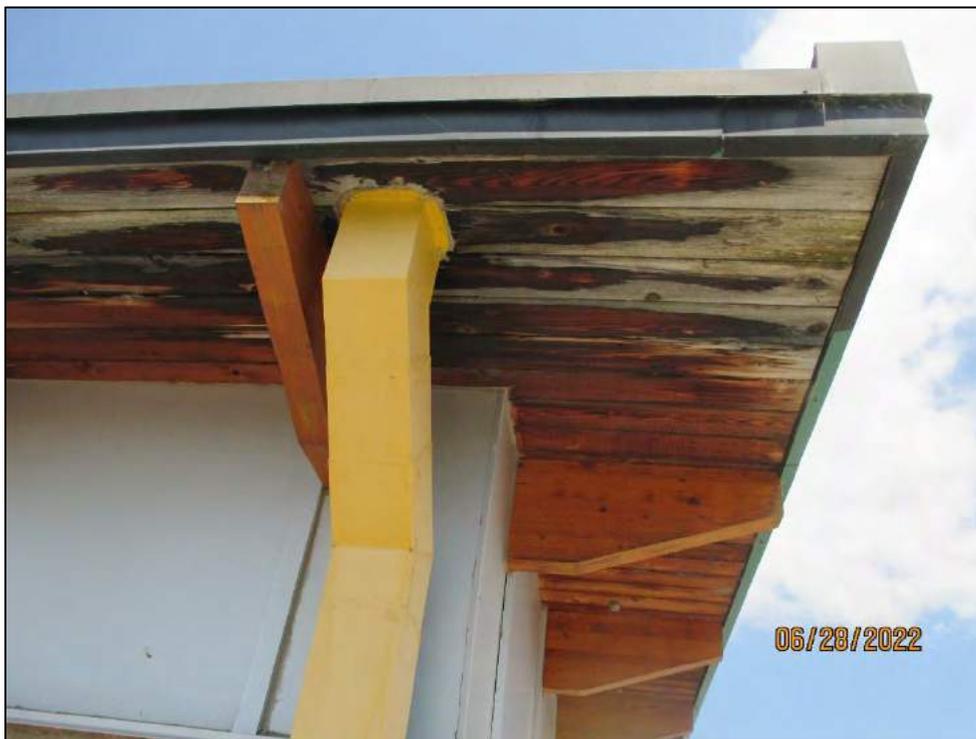
Dry Rot in Soffit Timbers (Typ. (South Roof Edge))

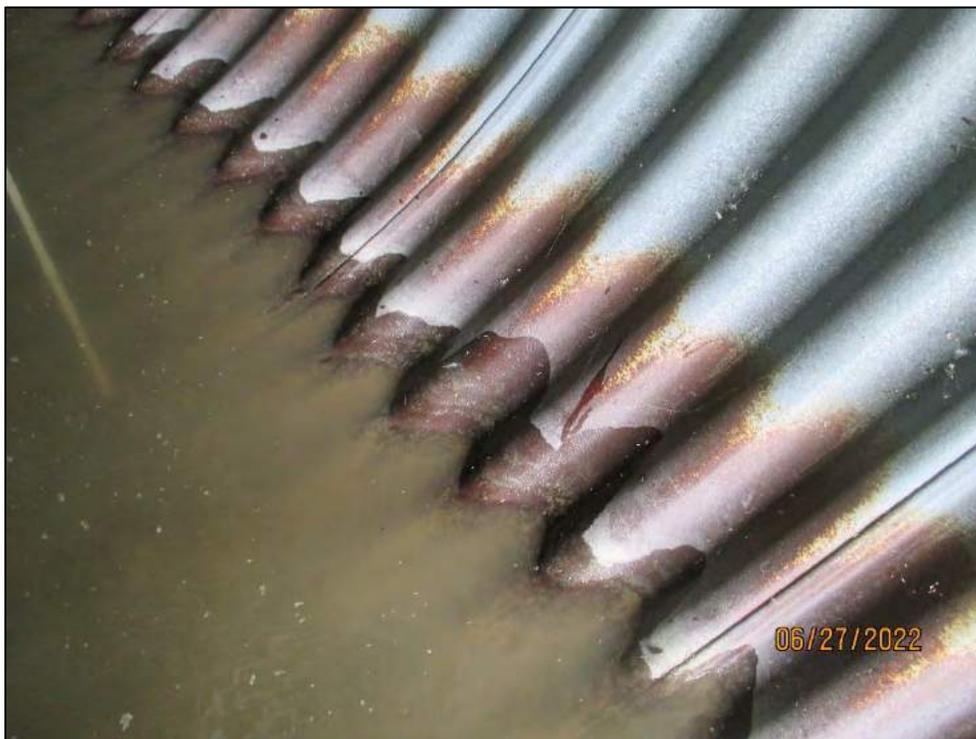
Minor Corrosion at Waterline

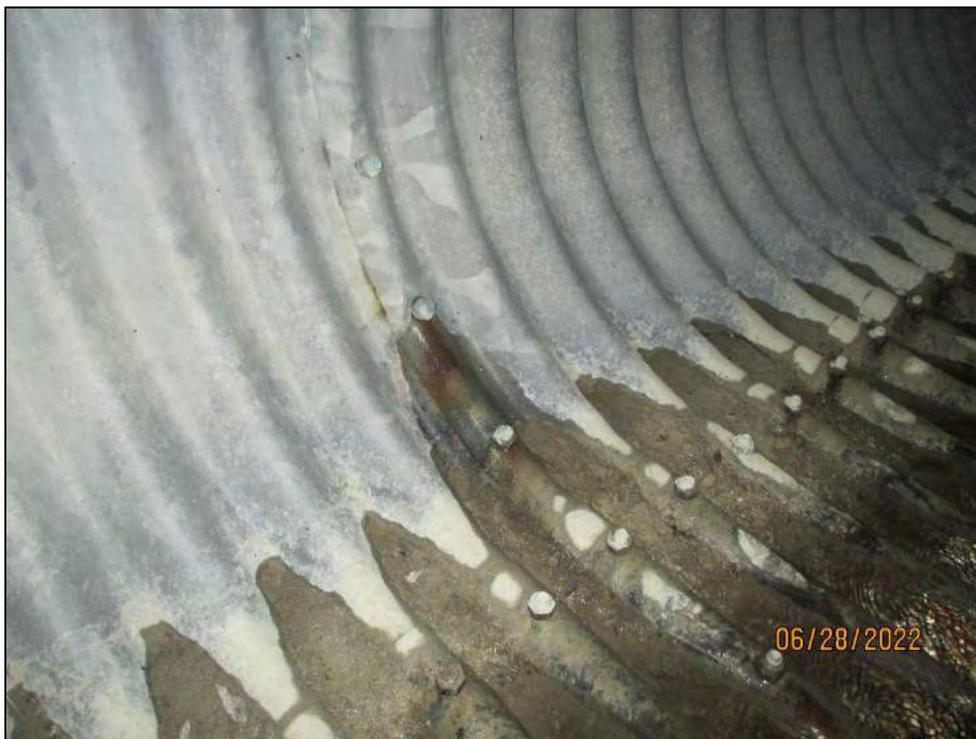
West Barrel (leakage at bolt seam)

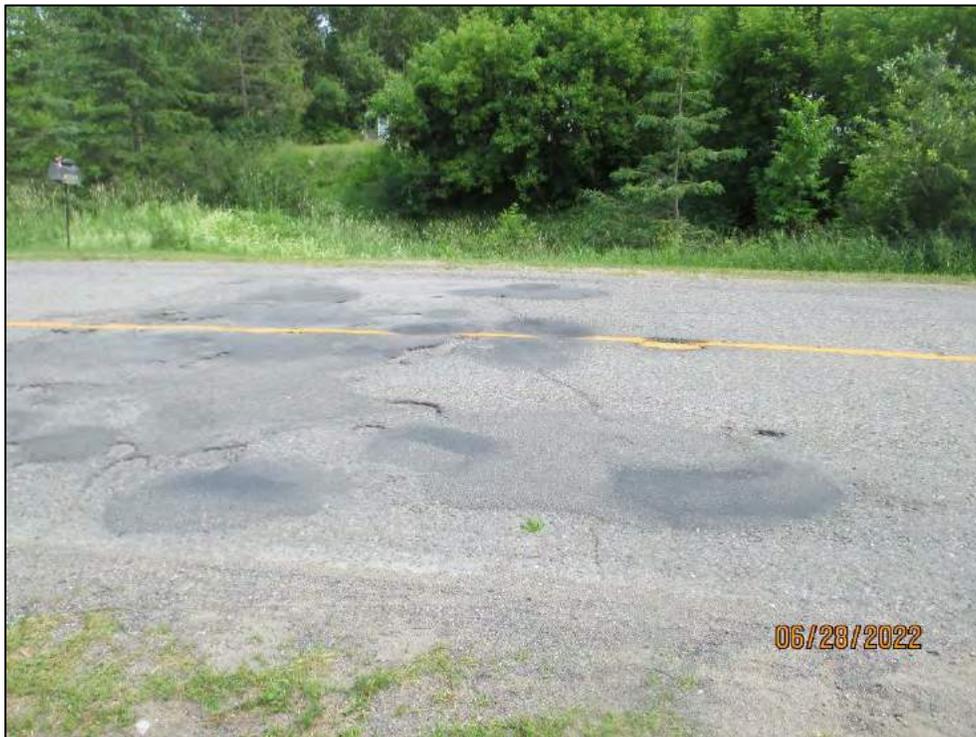
Approach Wearing Surface (Poor)

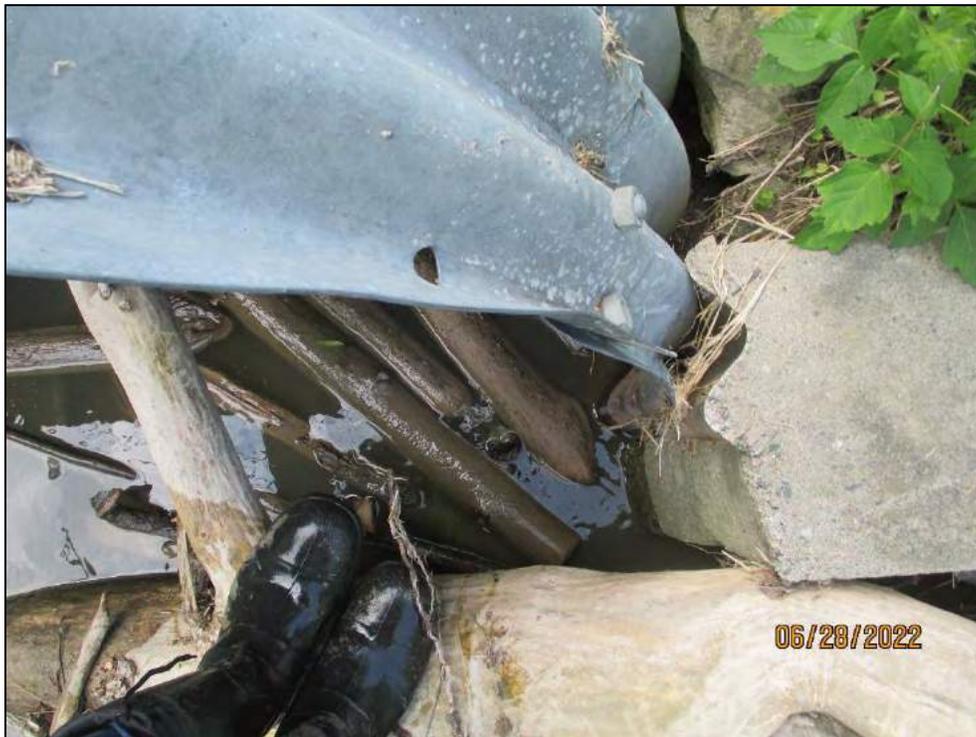
Culvert Damage (pulled from cut-off wall at inlet)
