**The Corporation of the City of Temiskaming Shores**  
**Special Meeting of Council**  
**Friday, October 27, 2023 – 12:00 noon**  
**City Hall – Council Chambers – 325 Farr Drive**

a) **Administrative Report No. RS-024-2023 – Lawrence “Bun” Eckensviller Community Hall**

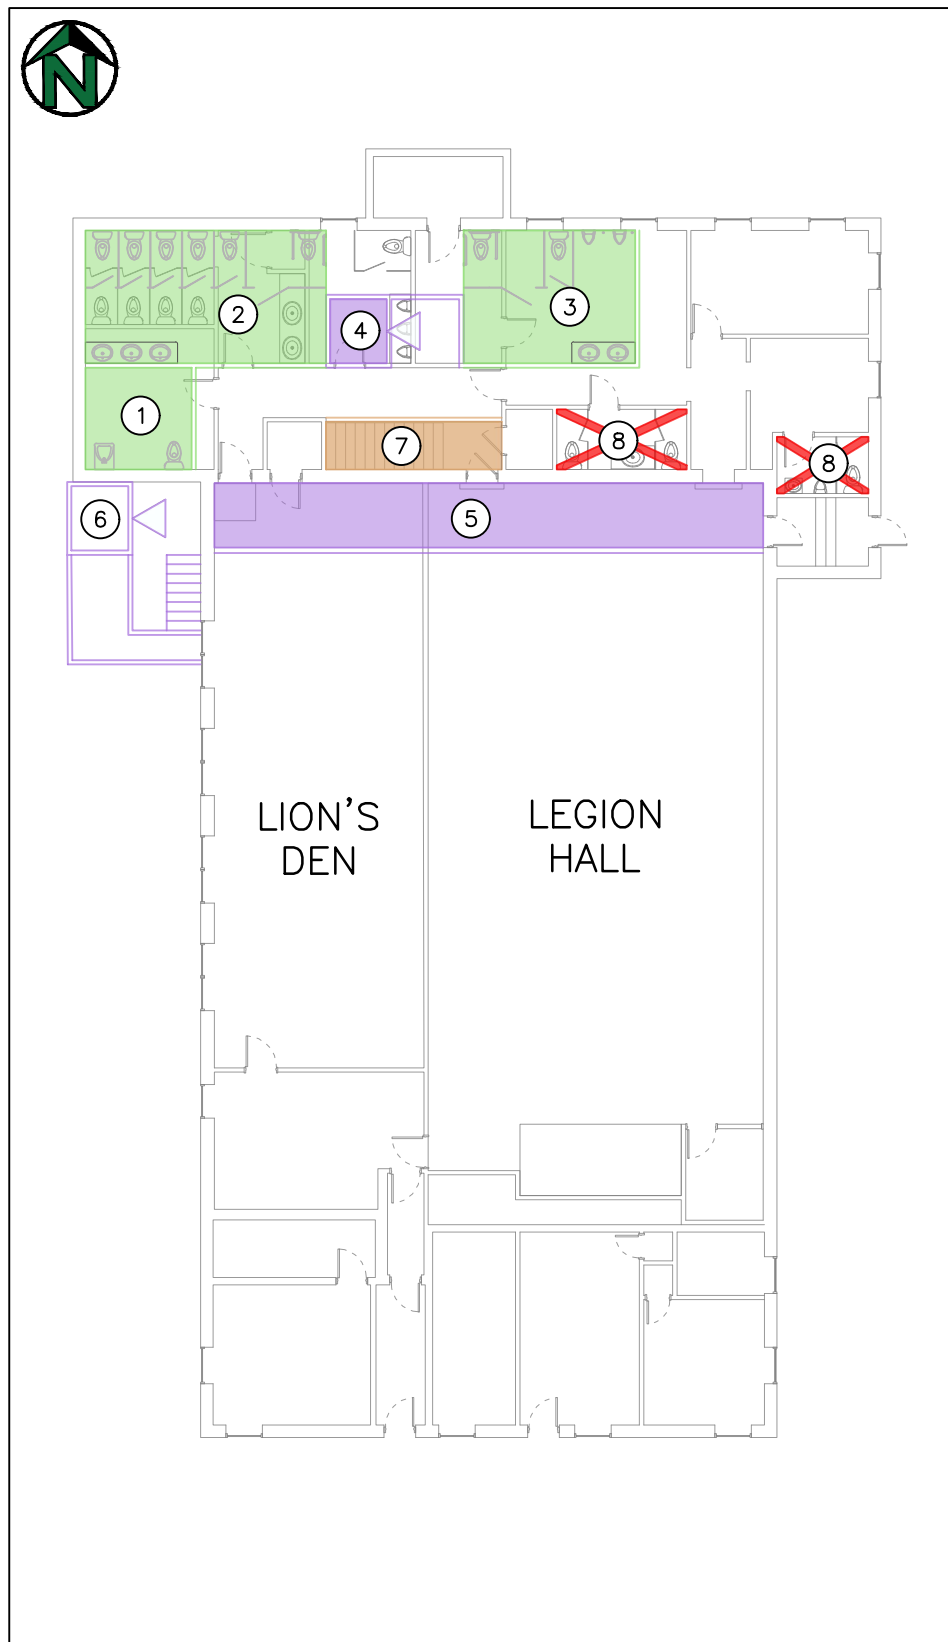
**BASEMENT**  
1:200

- 4.2.1.5. Basement access to the main stairwell from the Legion Hall space and Lion's Den space is deficient with respect to stair riser (two riser) configuration (OBC 3.4.6.2.).
