The Corporation of the City of Temiskaming Shores
Regular Meeting of Council
Tuesday, November 17, 2020 – 6:00 p.m.
City Hall – Council Chambers – 325 Farr Drive

City Staff have reviewed the report which included 13 roadway structures, as well as 3 roof inspections and below is a list of maintenance work required as well as additional Engineering investigations required. Not shown in the table below, is a recommendation to remove and replace the roofing membrane on both the New Liskeard Arena, as well as the Pool Fitness Centre within the next 1-5 years. The City was provided a budget cost in 2019 for the New Liskeard Arena (\$1,000,000.00) however we do not have a cost estimate at this time for the Pool Fitness Centre.

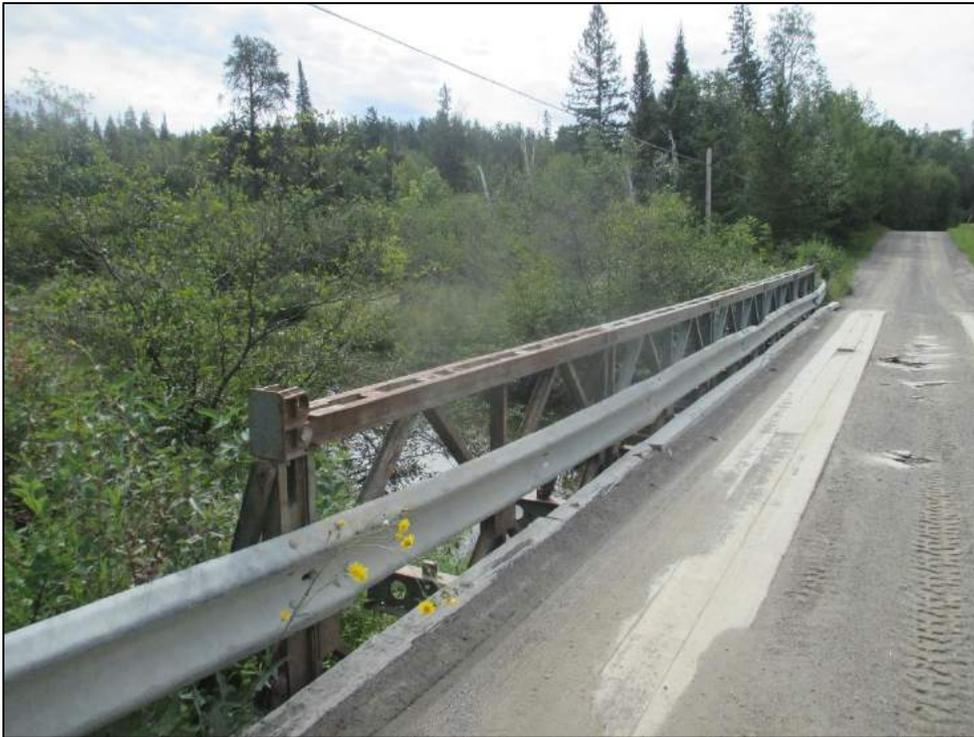
Collision damage at west rail, note no offset blocks present.

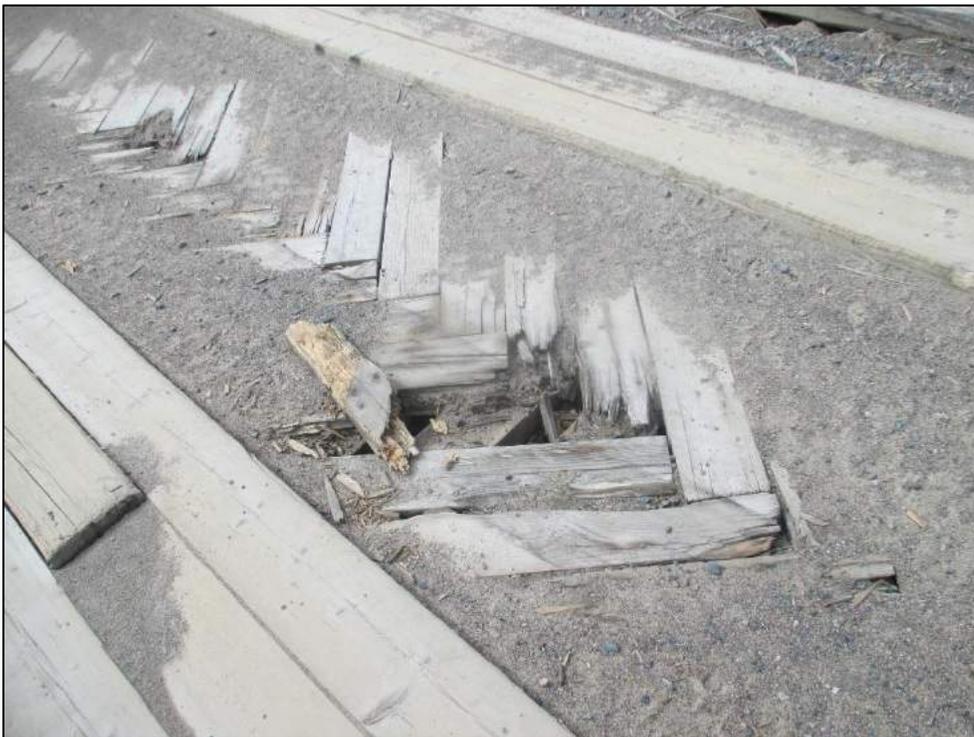
Severely damaged deck top.

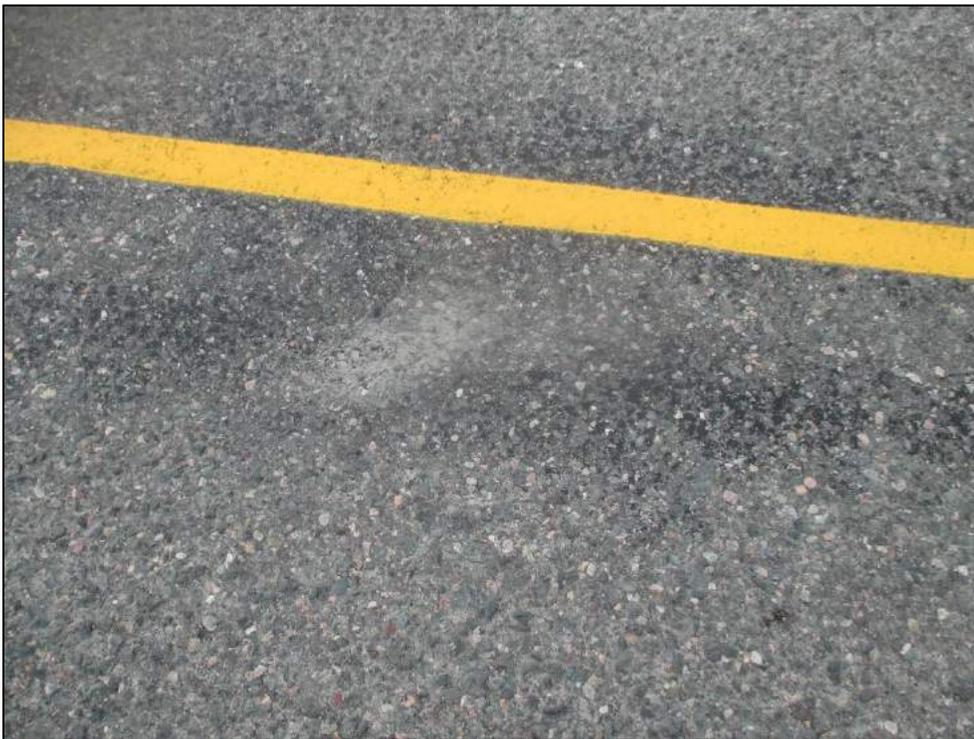
Pothole on deck wearing surface.

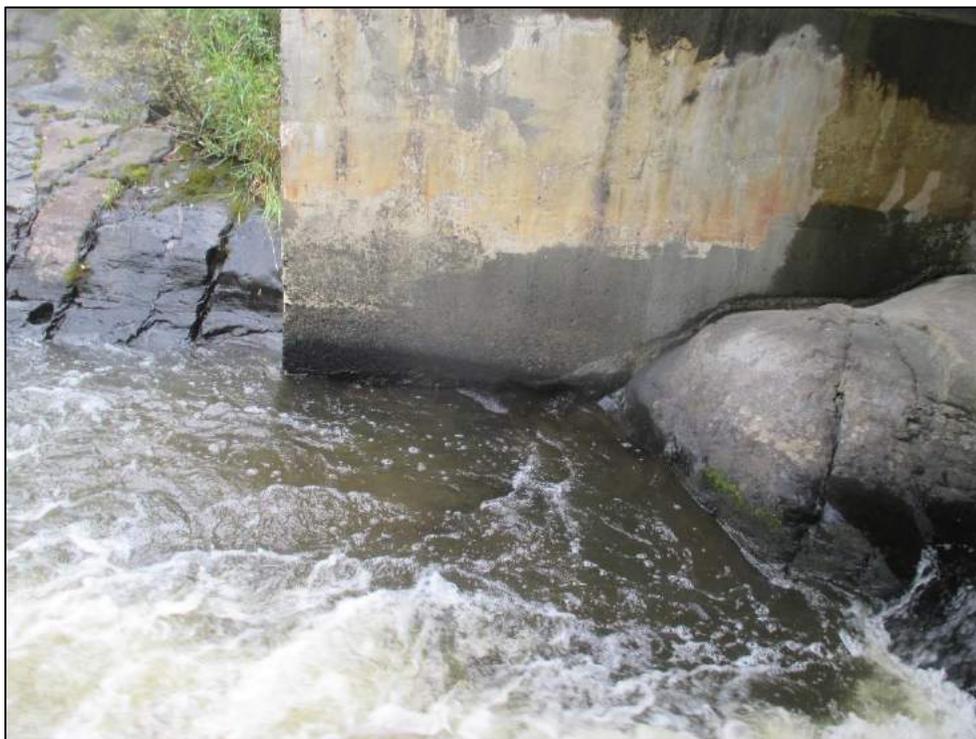
Undermining of abutment wall footing at northeast due to scour effect.

The structural evaluation on Bridge No. 2 – Mowat Landing Road Bridge is required to determine if load postings should be implemented until structural repairs can be completed.

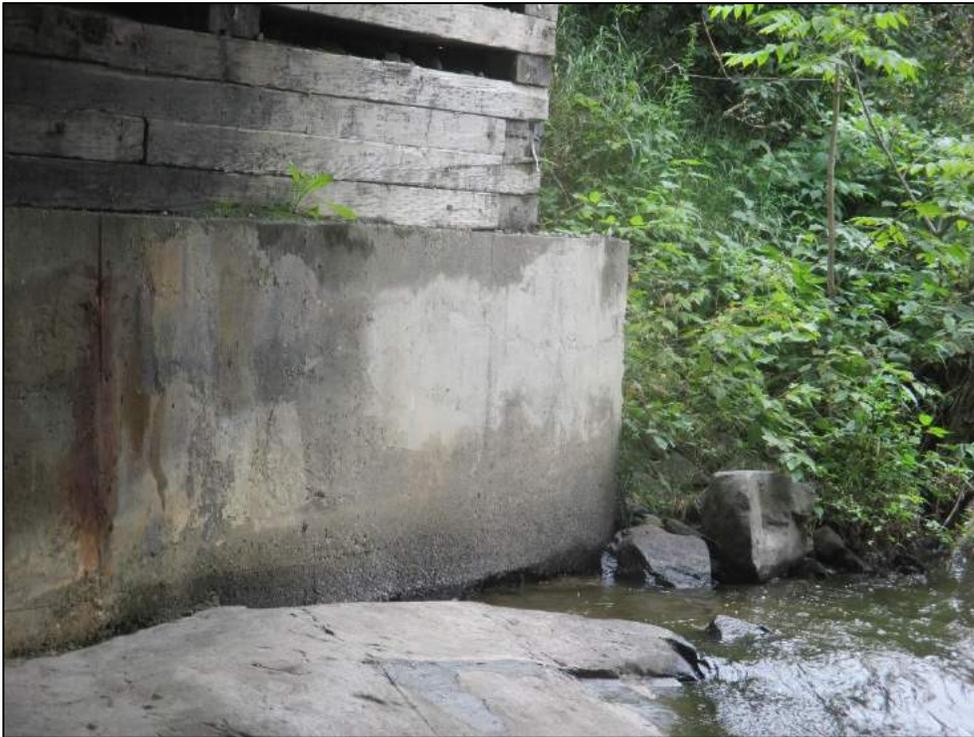
Undermining of abutment wall footing at southeast due to scour effect.

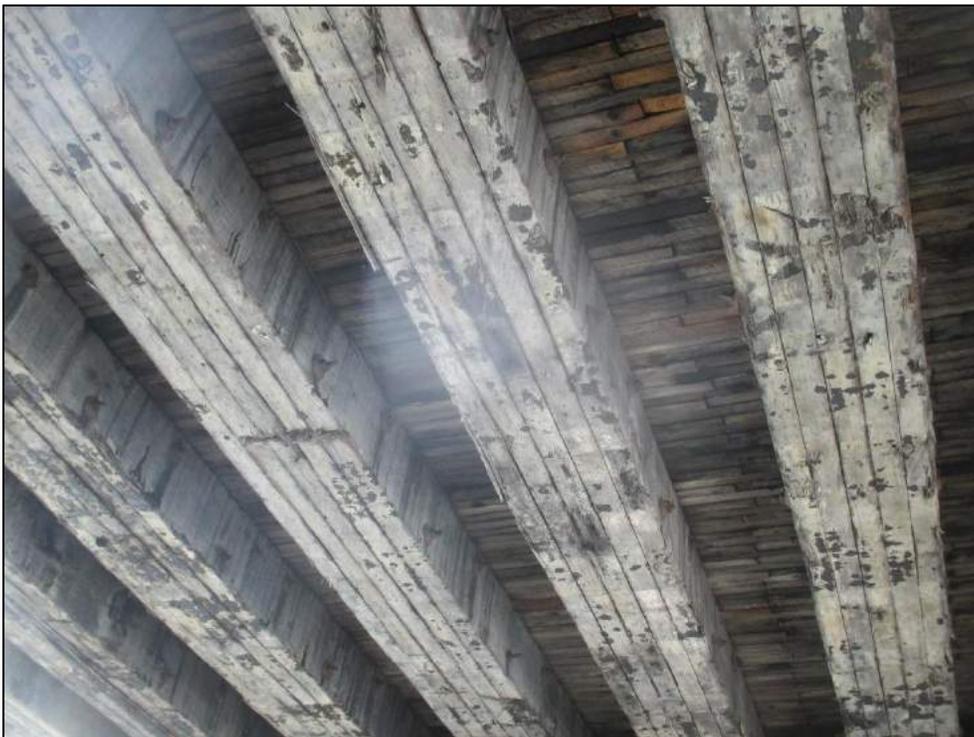
Severe checks, light rot of timber beams.

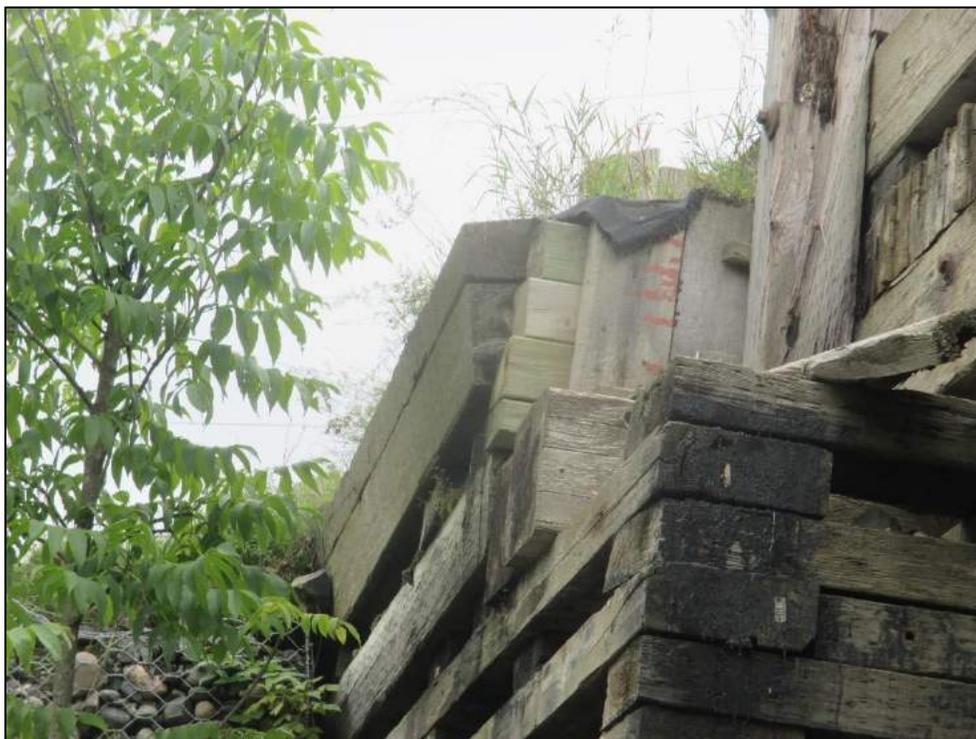
Rotated wingwall at northeast.

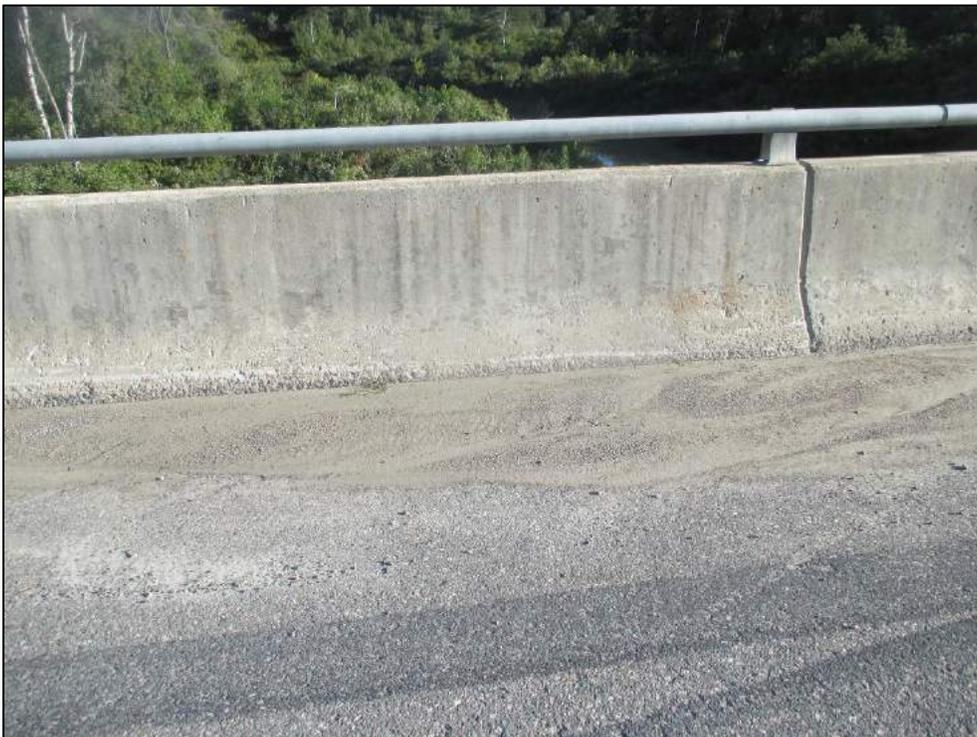
Medium to severe scaling at north wall.

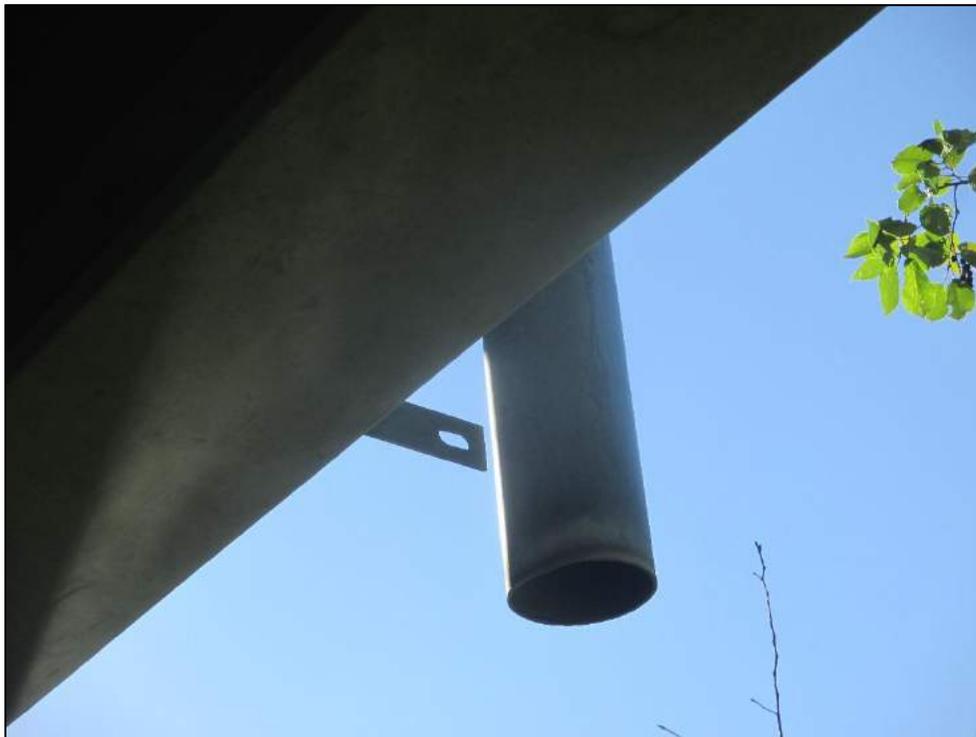
Drain pipe not connected to girders.

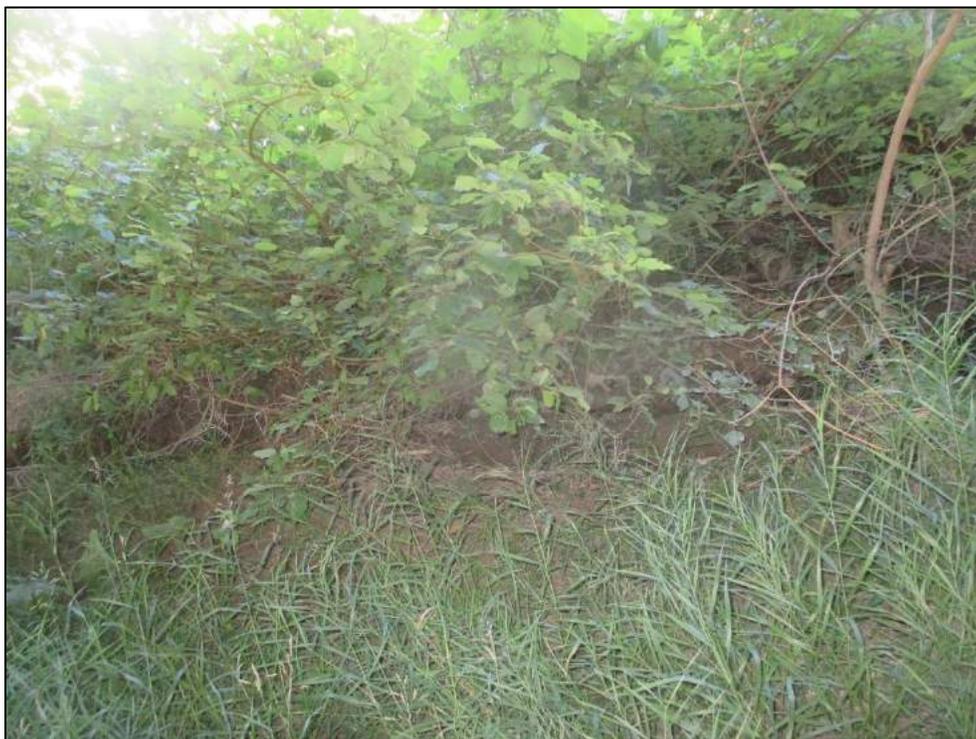
Erosion in embankment due to deck drain.

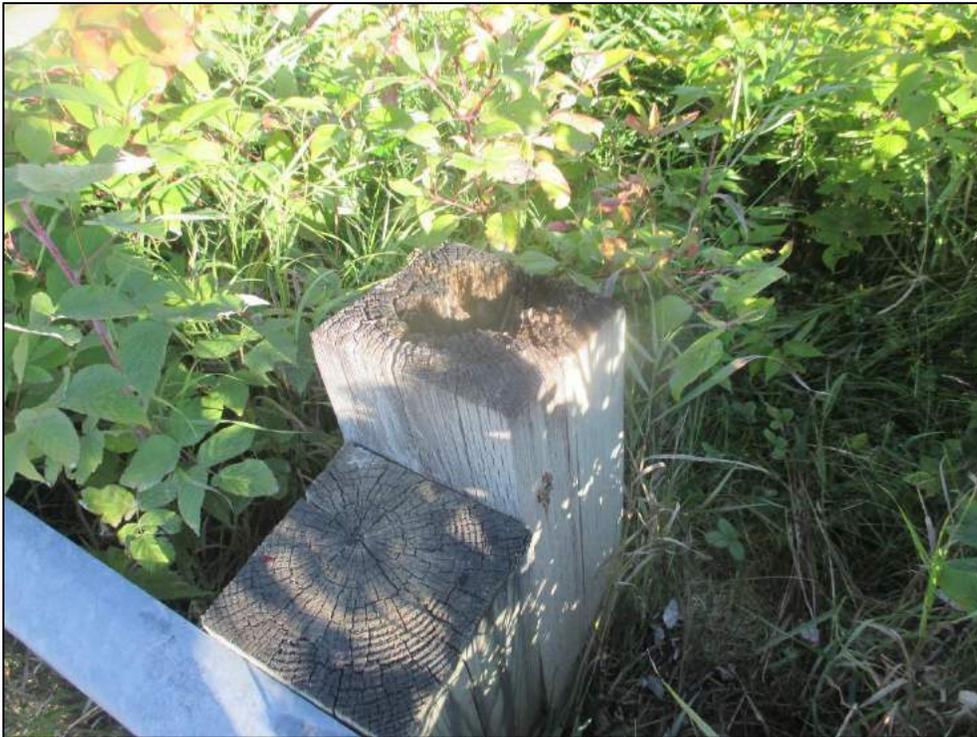
Rotted guiderail post.

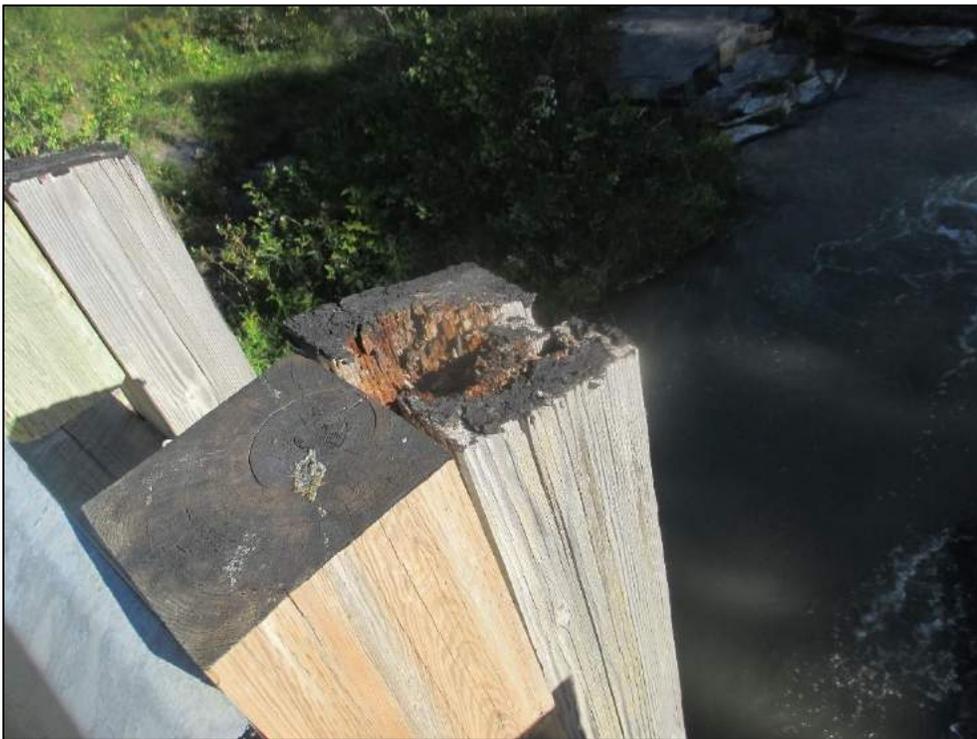
Rotted guiderail post.

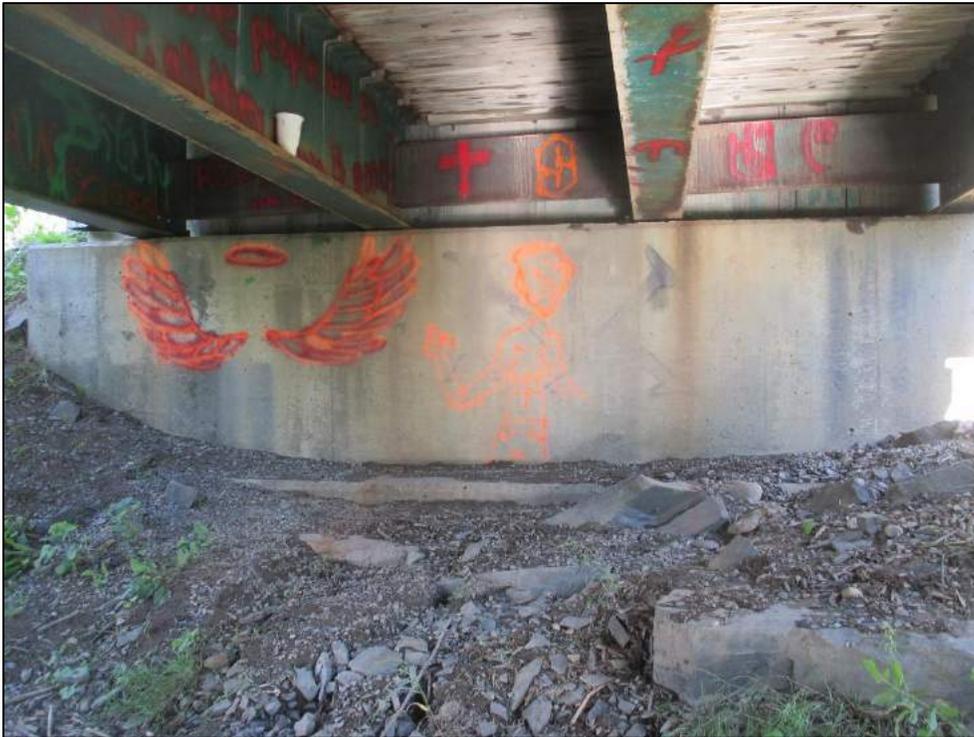
East abutment wall, narrow vertical crack visible at south.

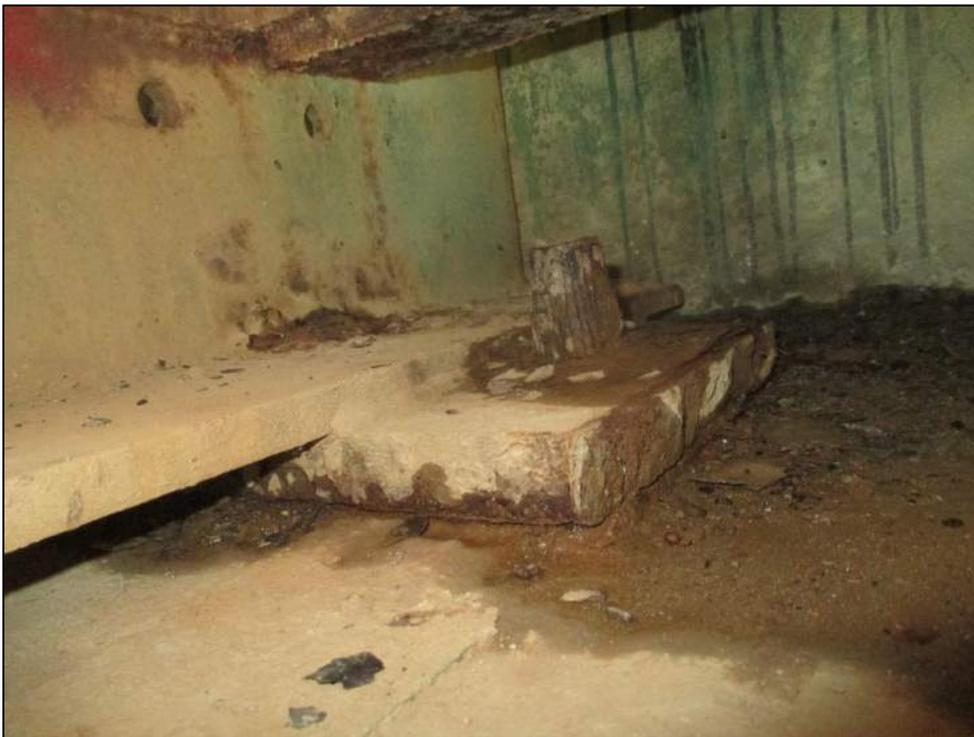
Medium corrosion of bearing.

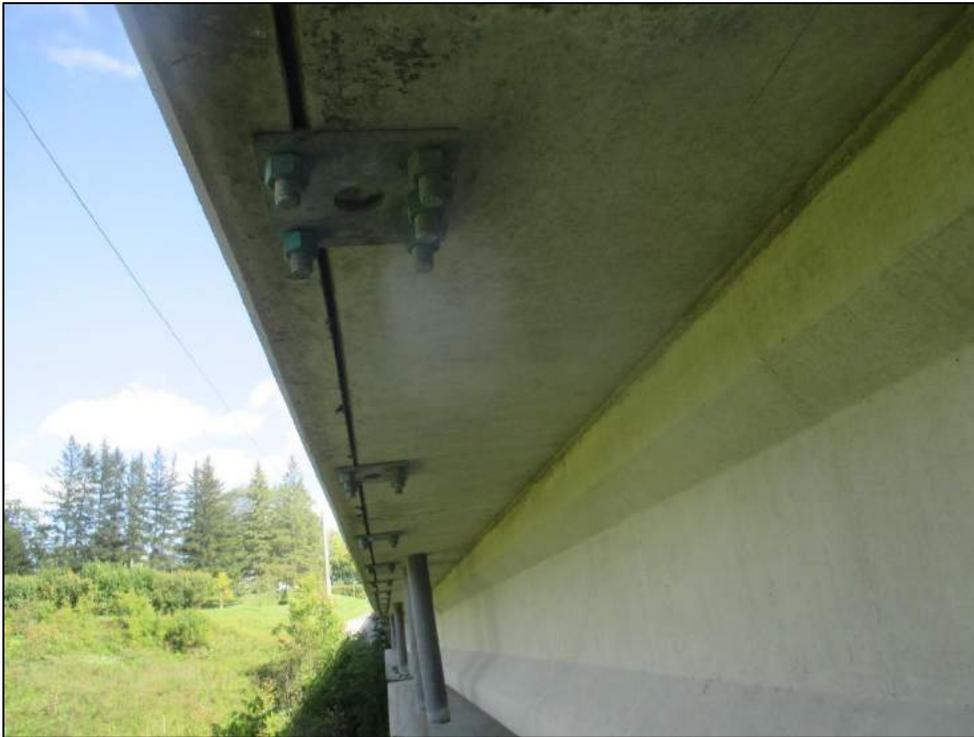
Exterior soffit and deck drains, hairline crack visible.

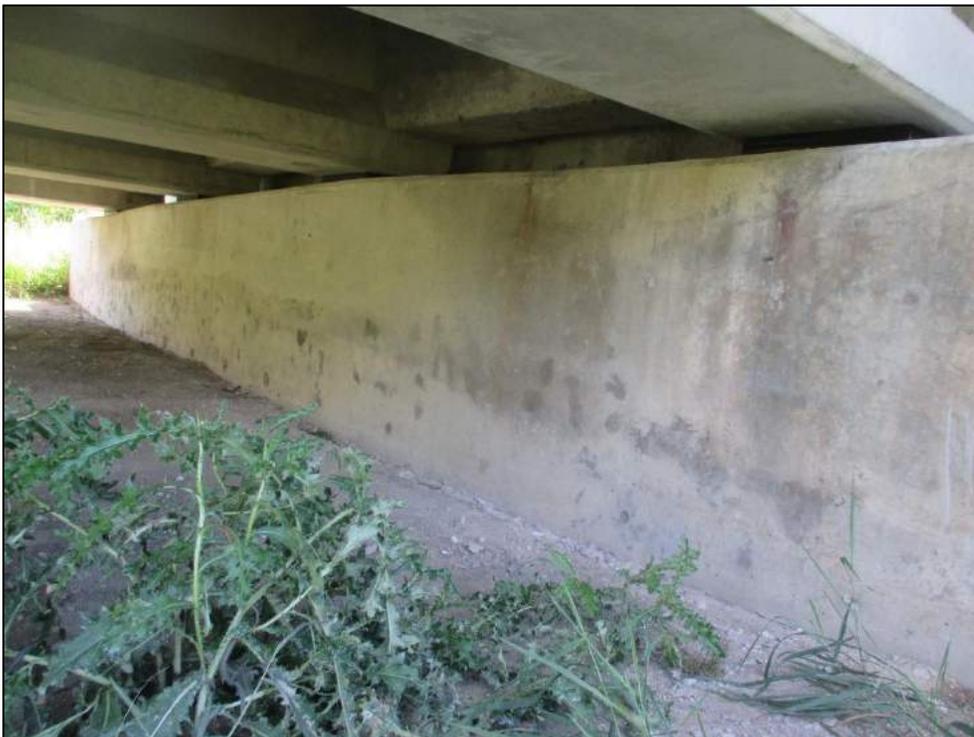
West abutment, pattern cracking with rust staining shown.

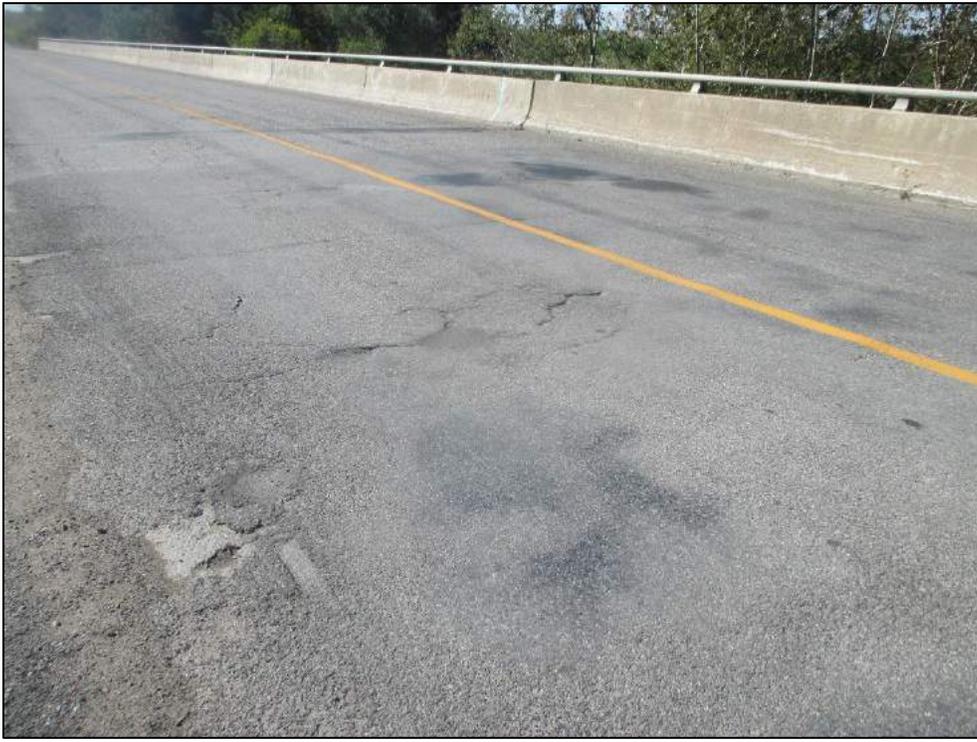
Potholes on east approach.

The detailed bridge condition survey of Bridge No. 06 – Golf Course Road Bridge (East) is required to determine the condition of the bridge and the extent of structural rehabilitation that is necessary.

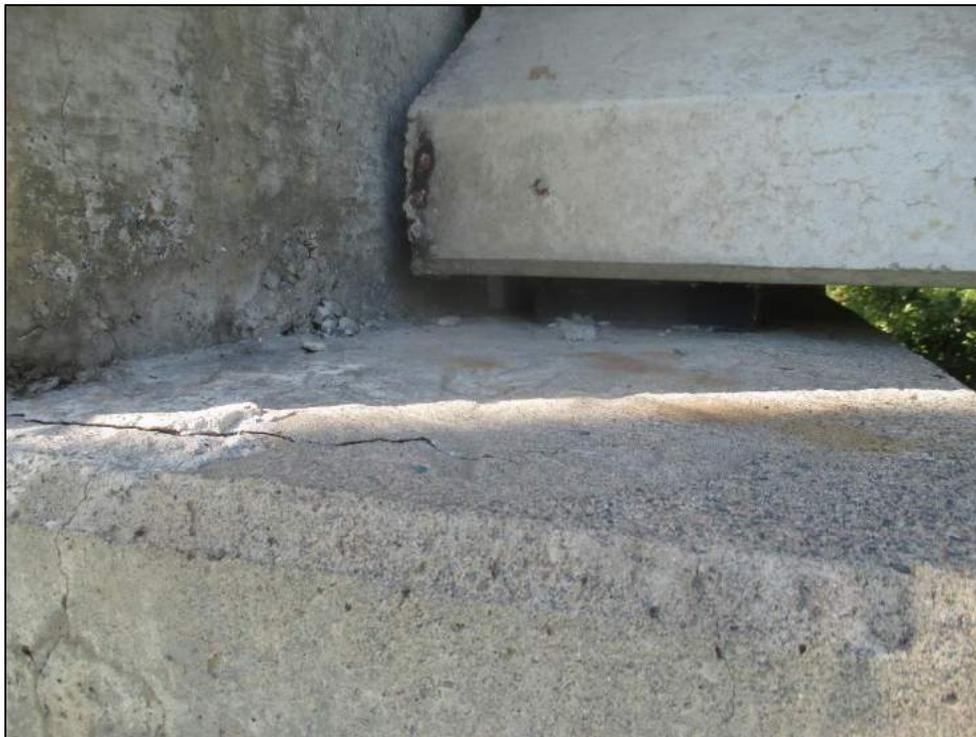
Crack, delamination at bearing seat and honeycombing of ballast wall.

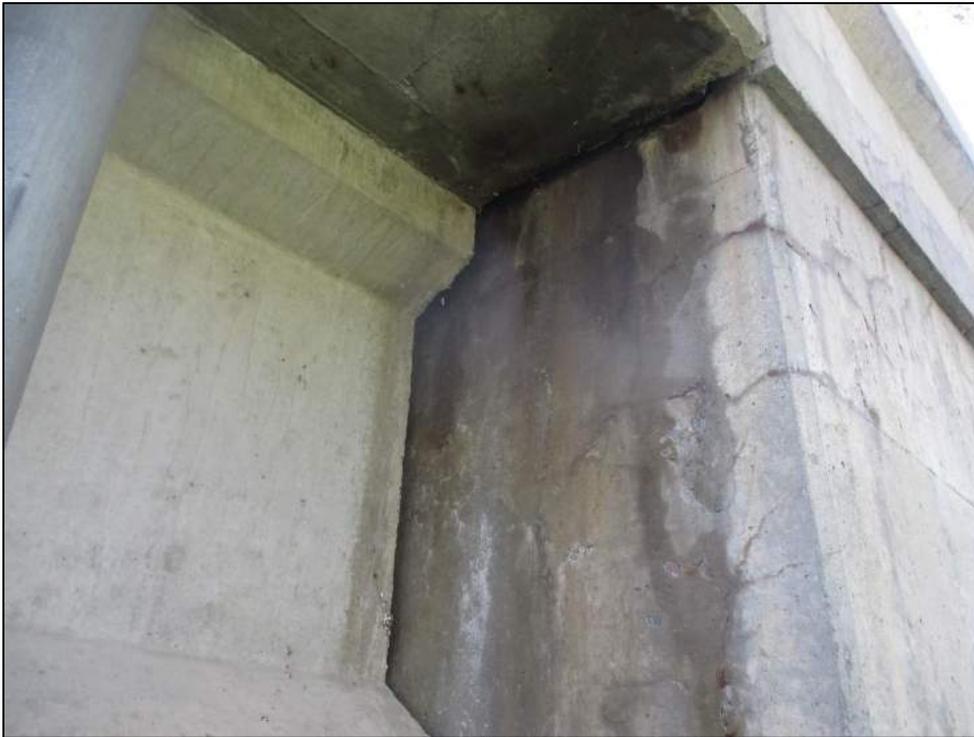
Wet stains on ballast wall due to joint leakage, spall and cracking in ballast wall.

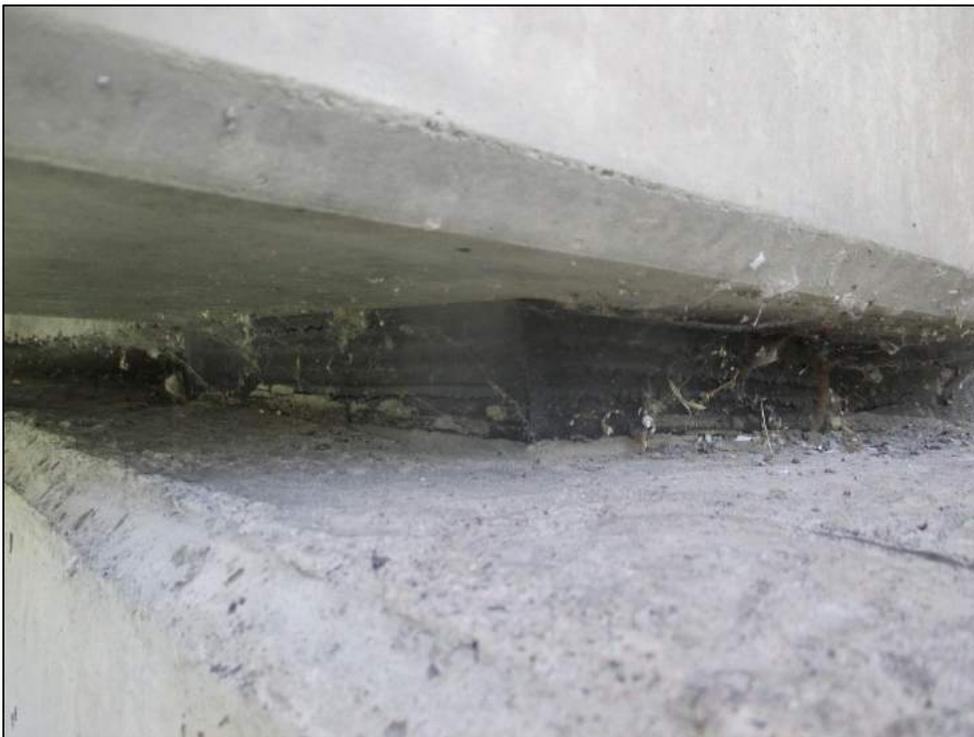
Wide crack in northwest bearing.

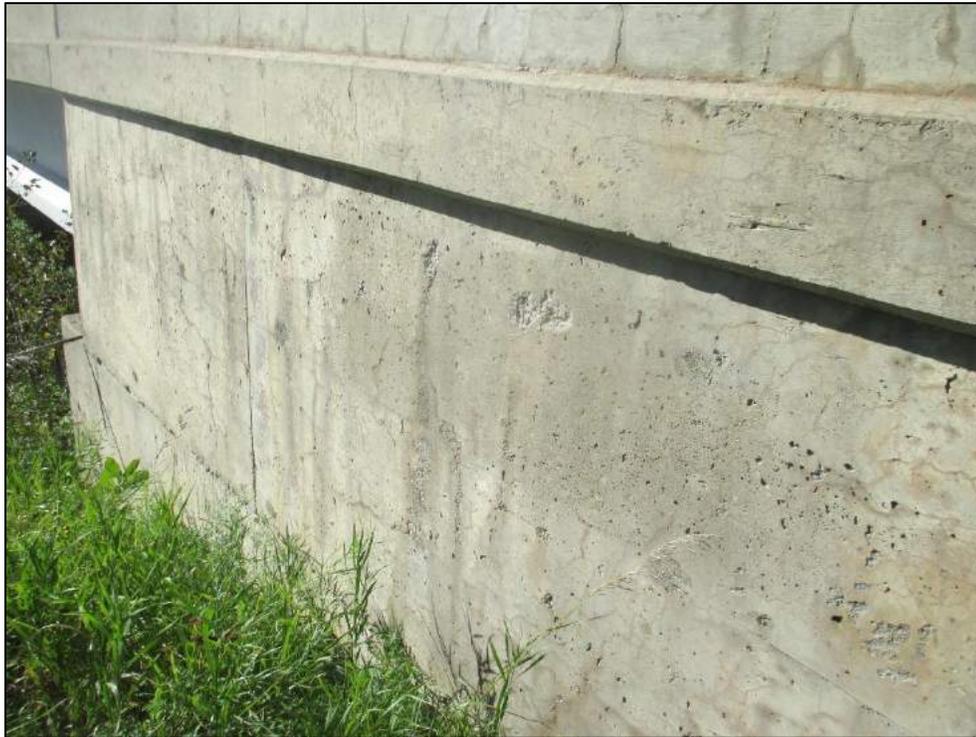
Map cracking, bugholes in southeast wingwall.

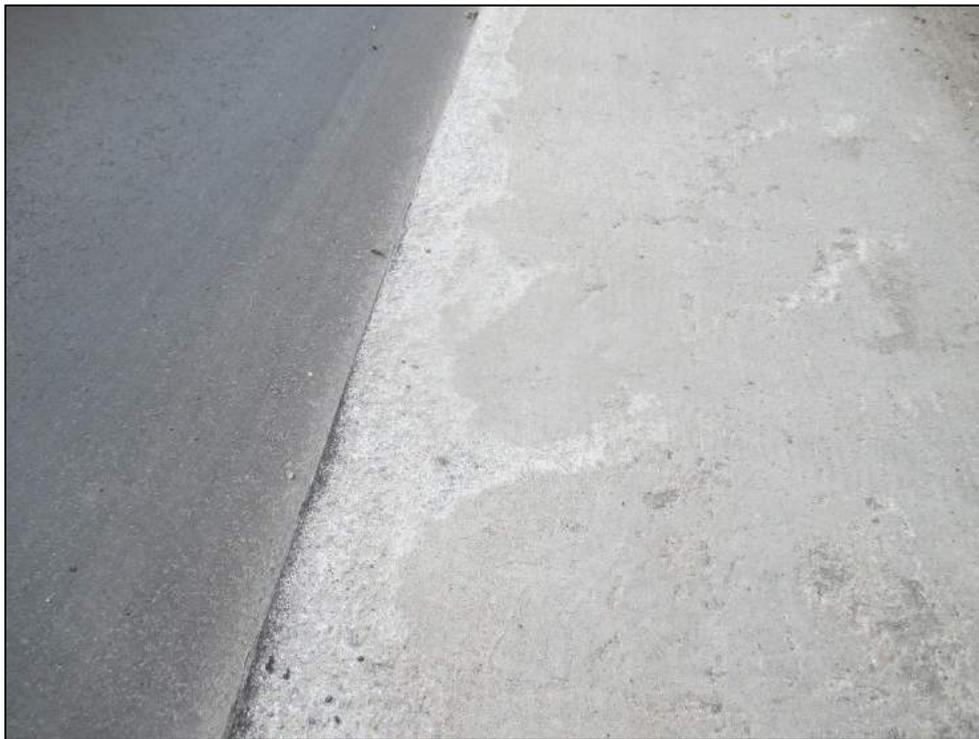
Scaling of sidewalk at northwest.

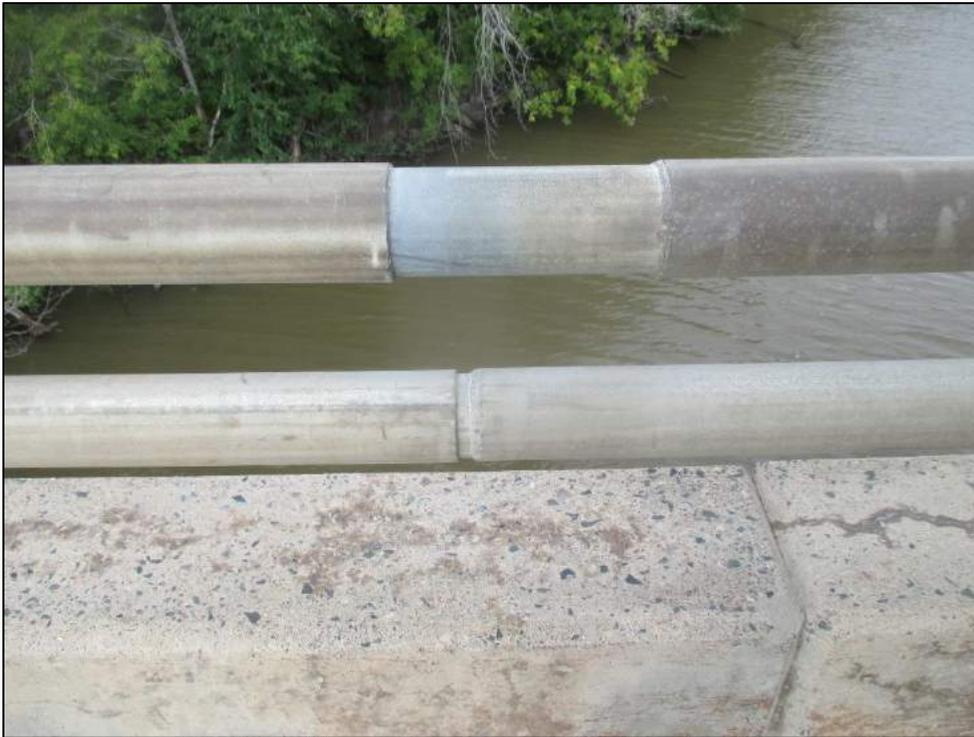
Excessive gap due to short handrail section at southwest.

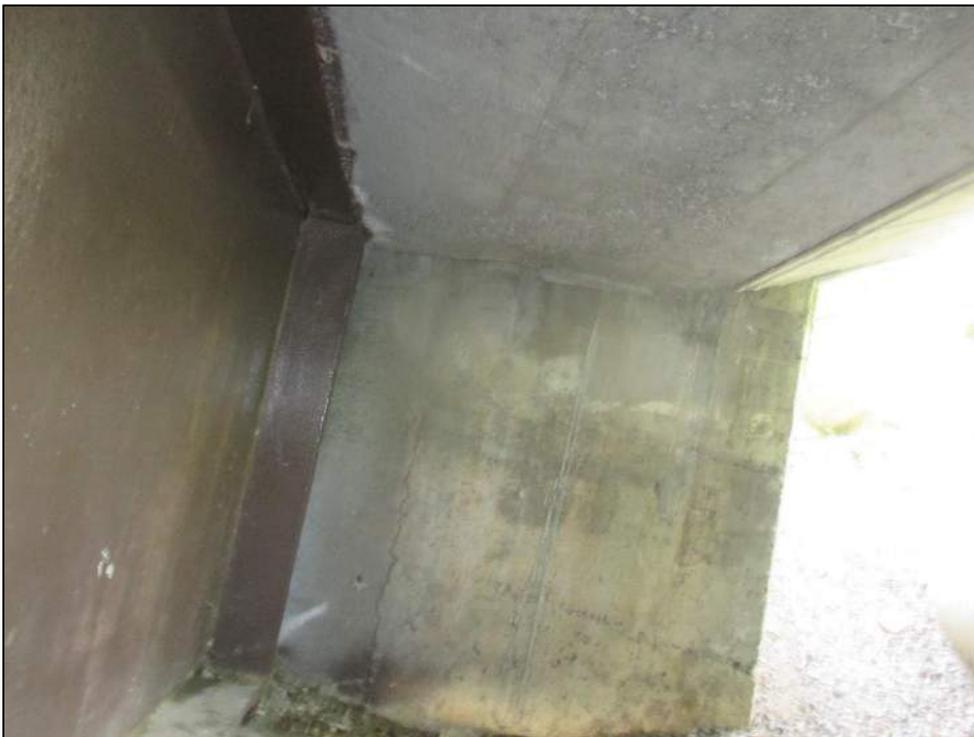
Crack in southwest ballast wall.

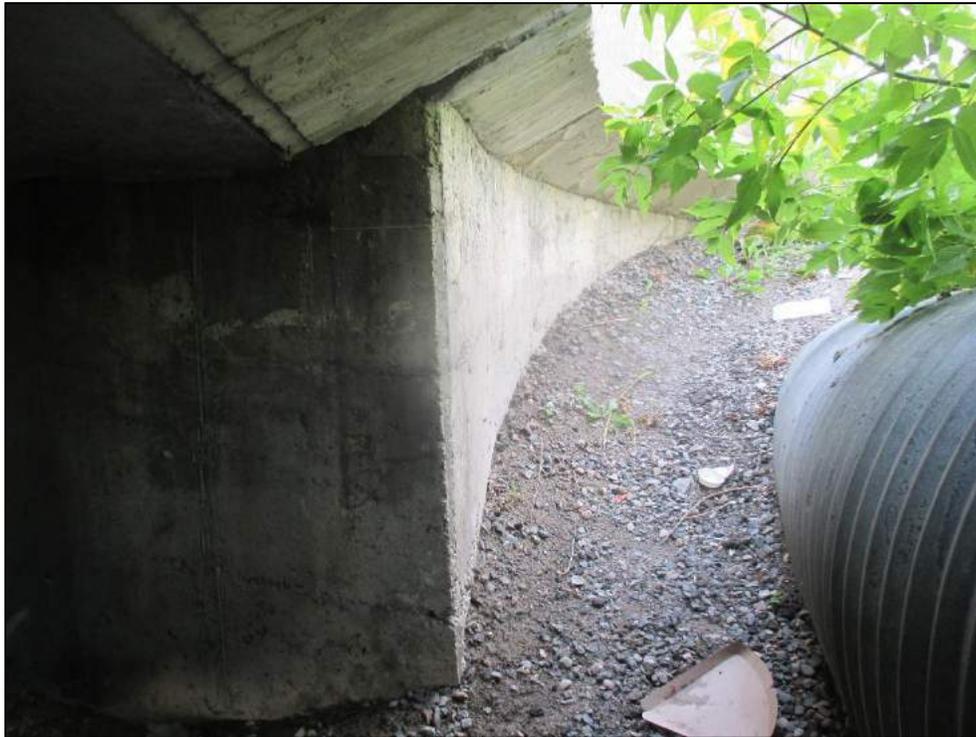
Honeycombing at southwest wingwall and ballast wall.

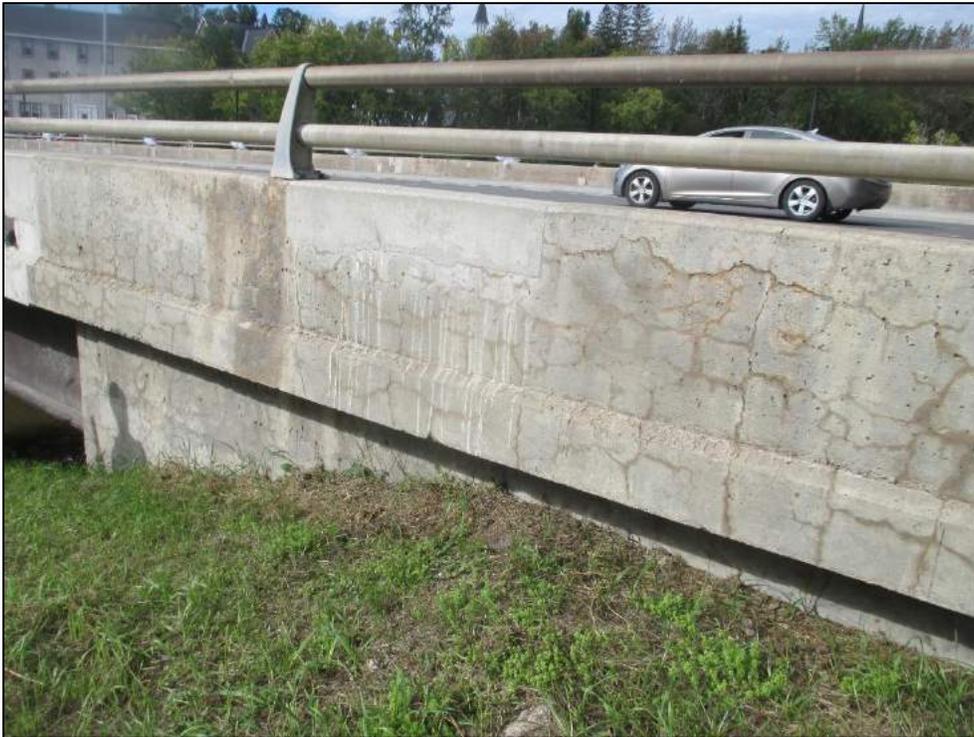
Extensive map cracking, possible AAR, at northeastern parapet wall and wingwall.

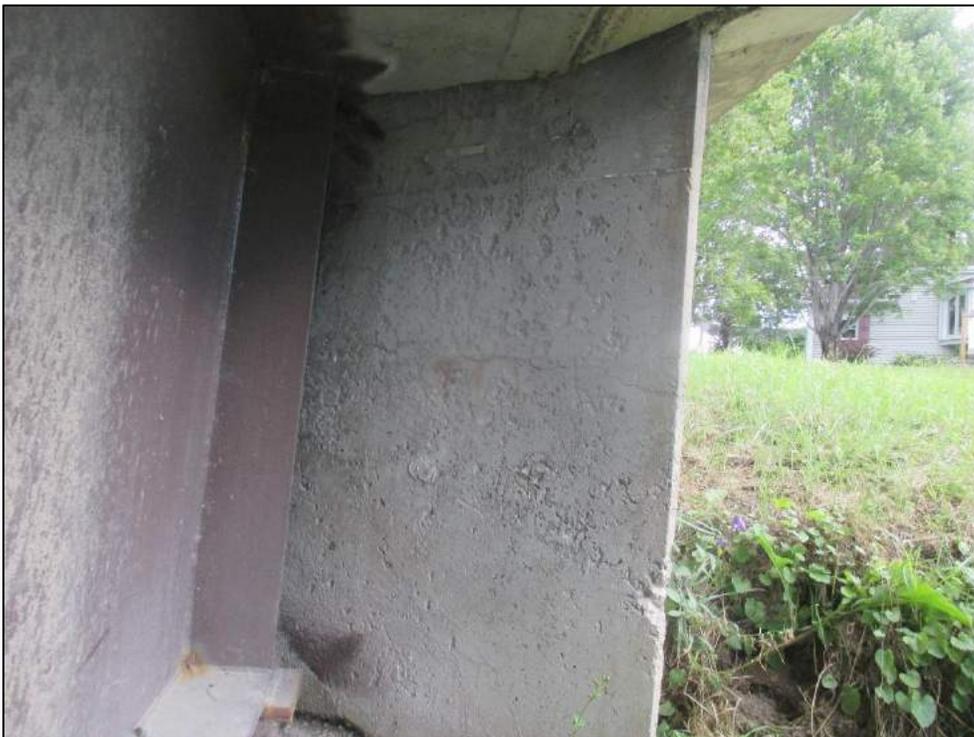
Cracking and honeycombing at northeast ballast wall.

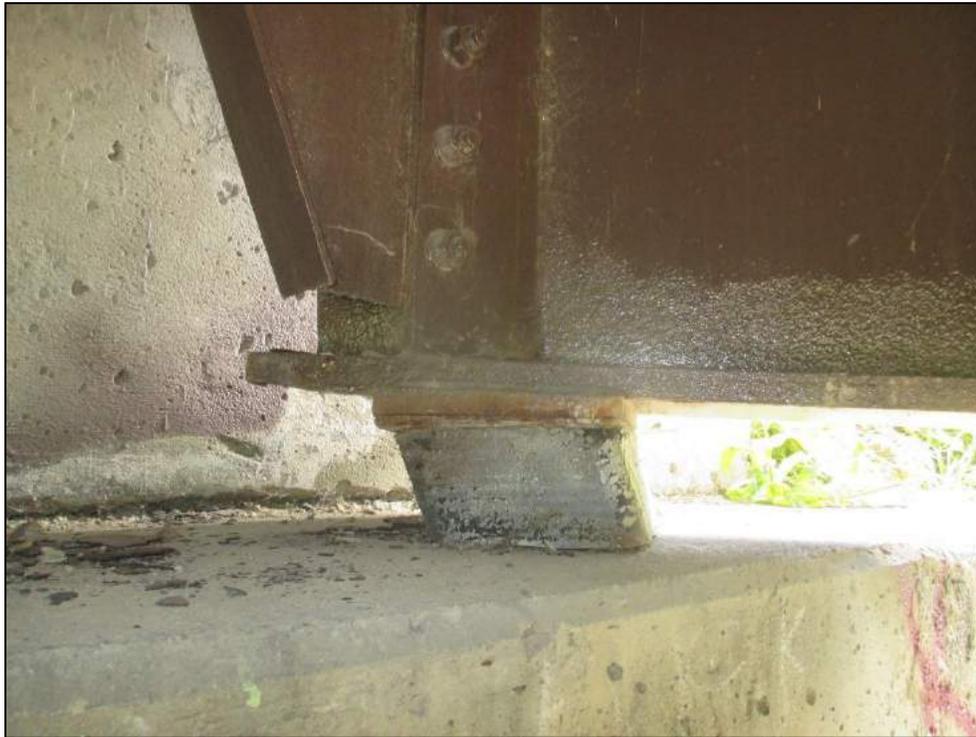
Excessive deformation of north bearings.

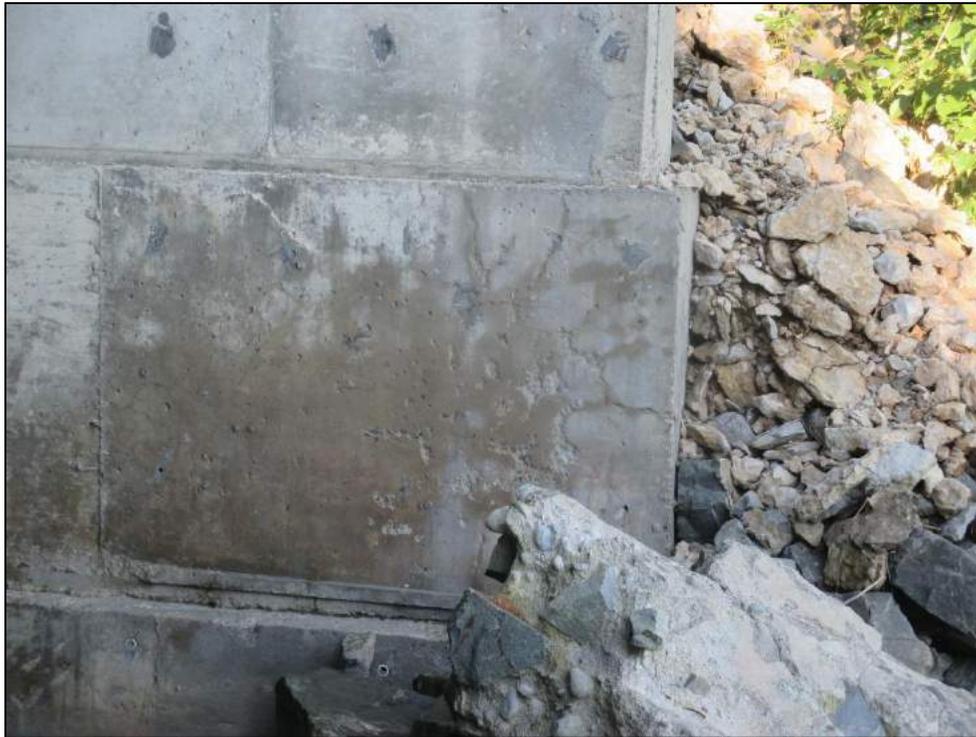
Scaling and map cracking at northwest wall.

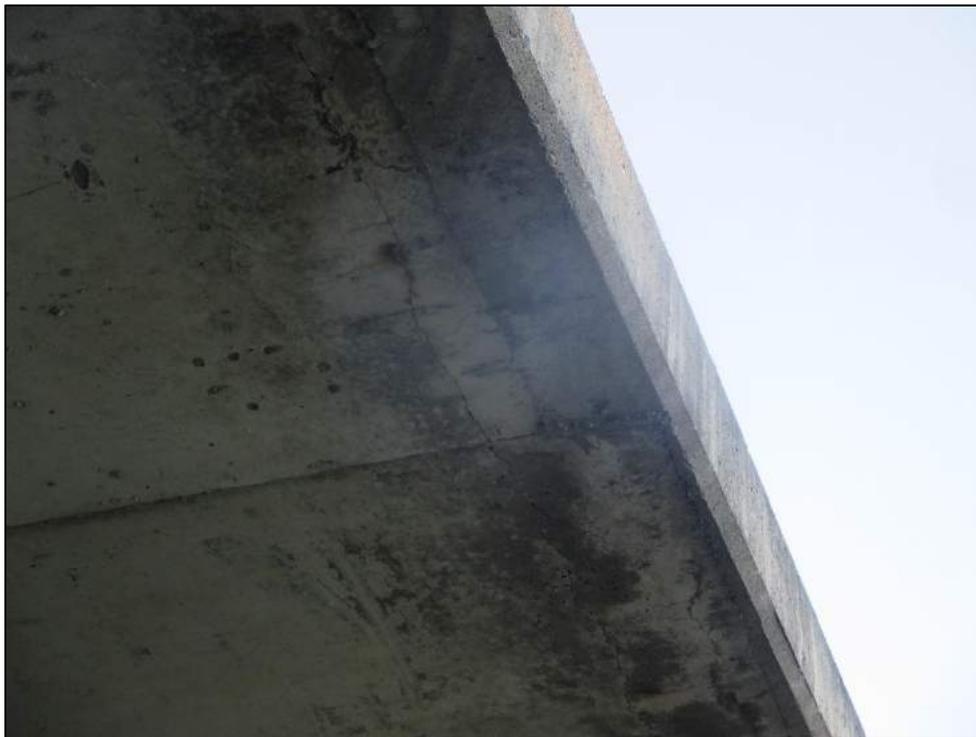
Crack, delamination, wet stains at north end soffit.

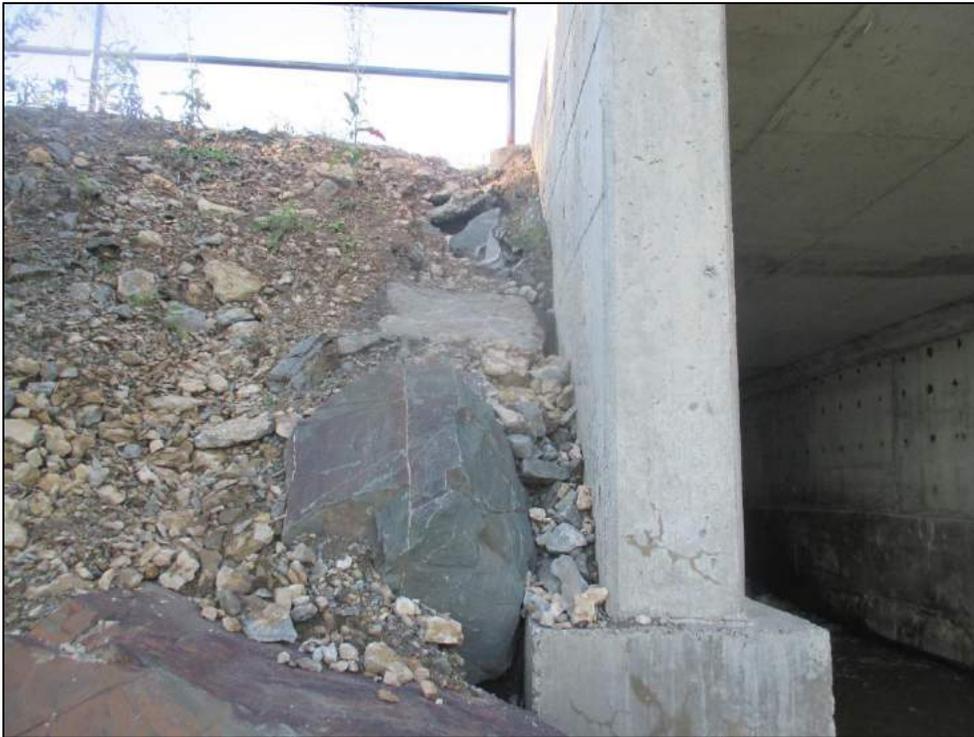
Washout at northeast, rail post losing soil support.
