The Corporation of the City of Temiskaming Shores
Regular Meeting of Council
Tuesday, November 17, 2020 – 6:00 p.m.
City Hall – Council Chambers – 325 Farr Drive

City Staff have reviewed the report which included 13 roadway structures, as well as 3 roof inspections and below is a list of maintenance work required as well as additional Engineering investigations required. Not shown in the table below, is a recommendation to remove and replace the roofing membrane on both the New Liskeard Arena, as well as the Pool Fitness Centre within the next 1-5 years. The City was provided a budget cost in 2019 for the New Liskeard Arena (\$1,000,000.00) however we do not have a cost estimate at this time for the Pool Fitness Centre.

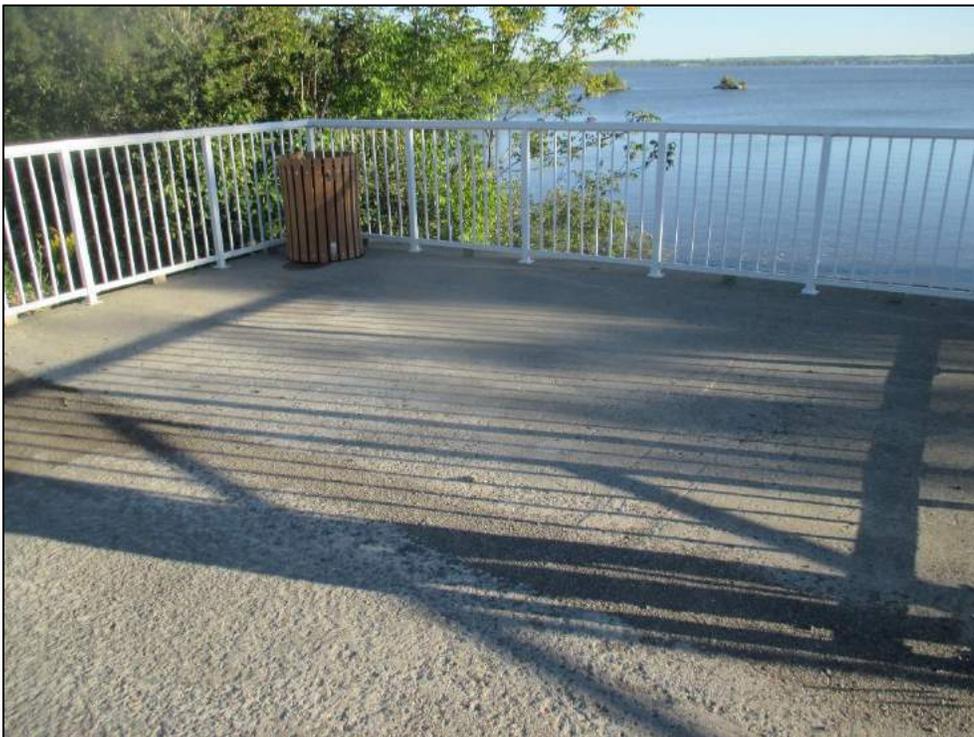
Severe scaling of north end deck top.

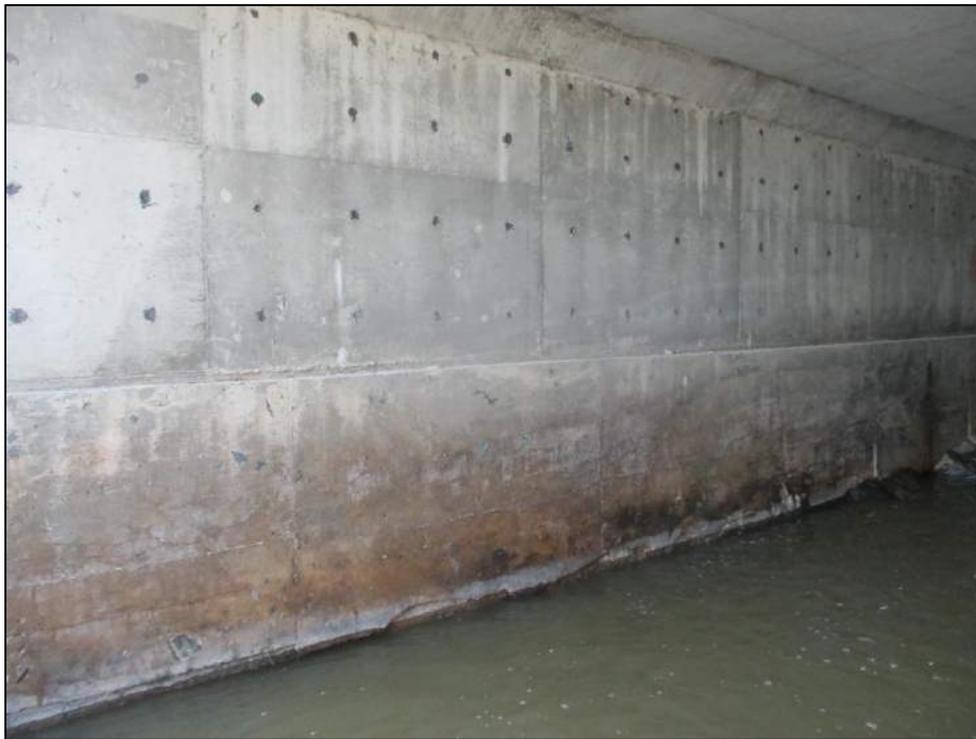
Severe scaling, undermining due to scouring action at northeast.

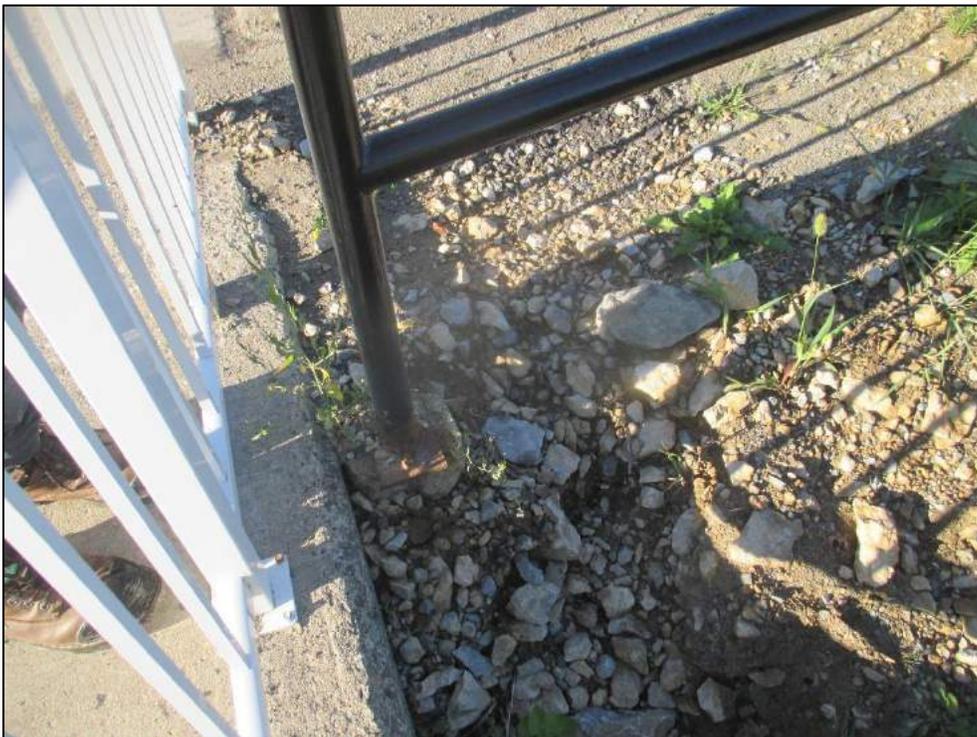
Rail post losing soil support at northwest, and deteriorate concrete.

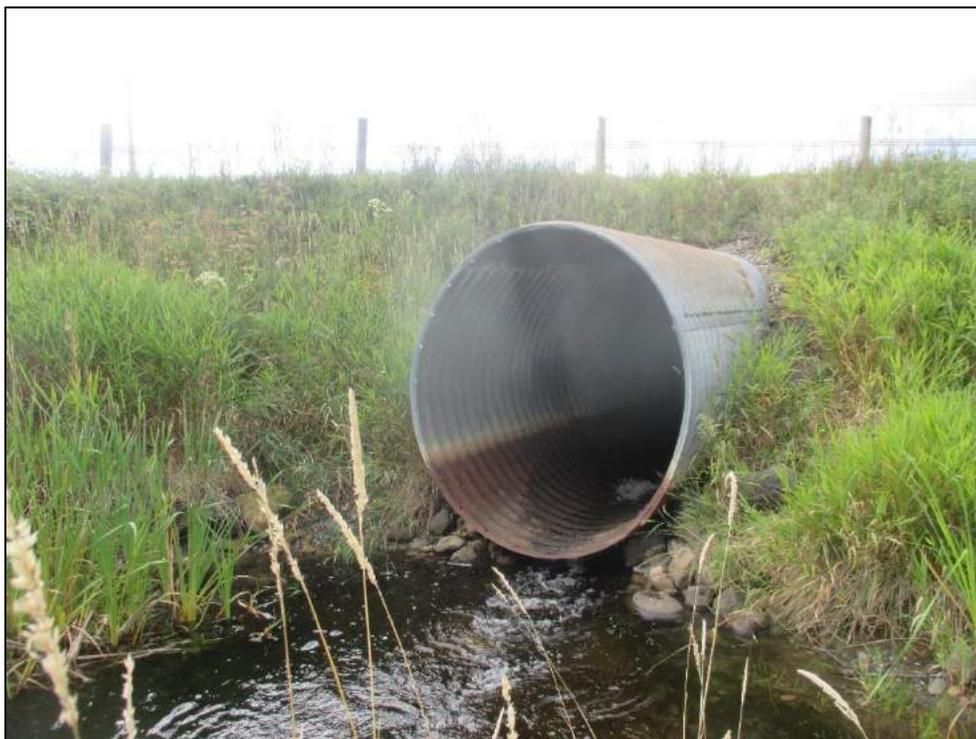
Severe undermining of north barrel end due to perforated bottom.

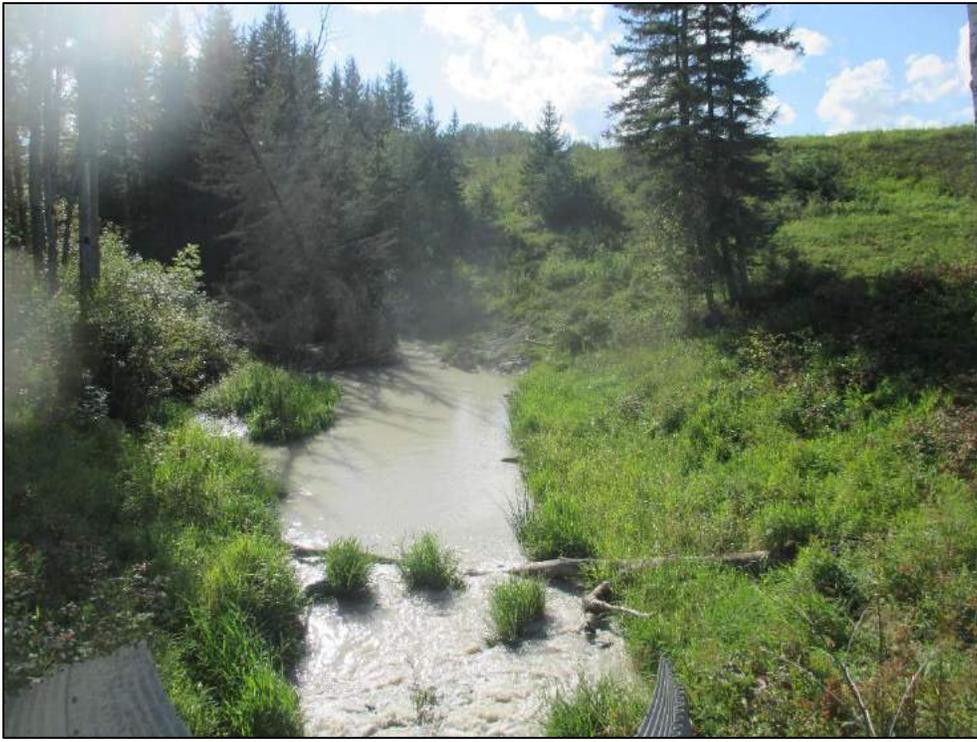
Erosion of downstream.

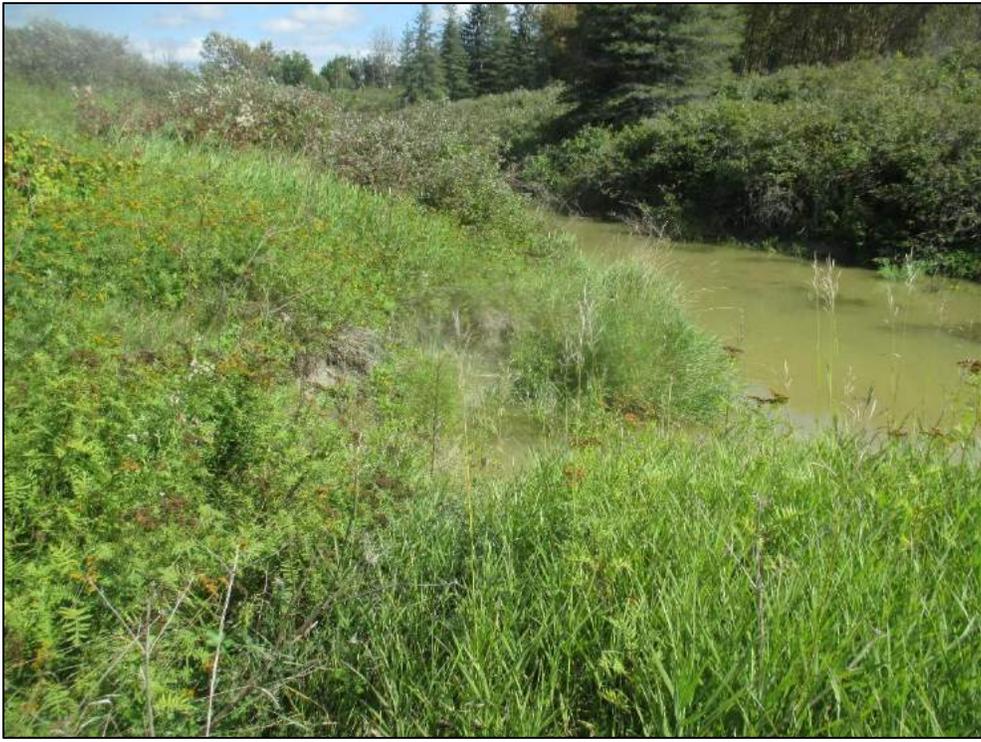
Severe washout of embankment at northeast.

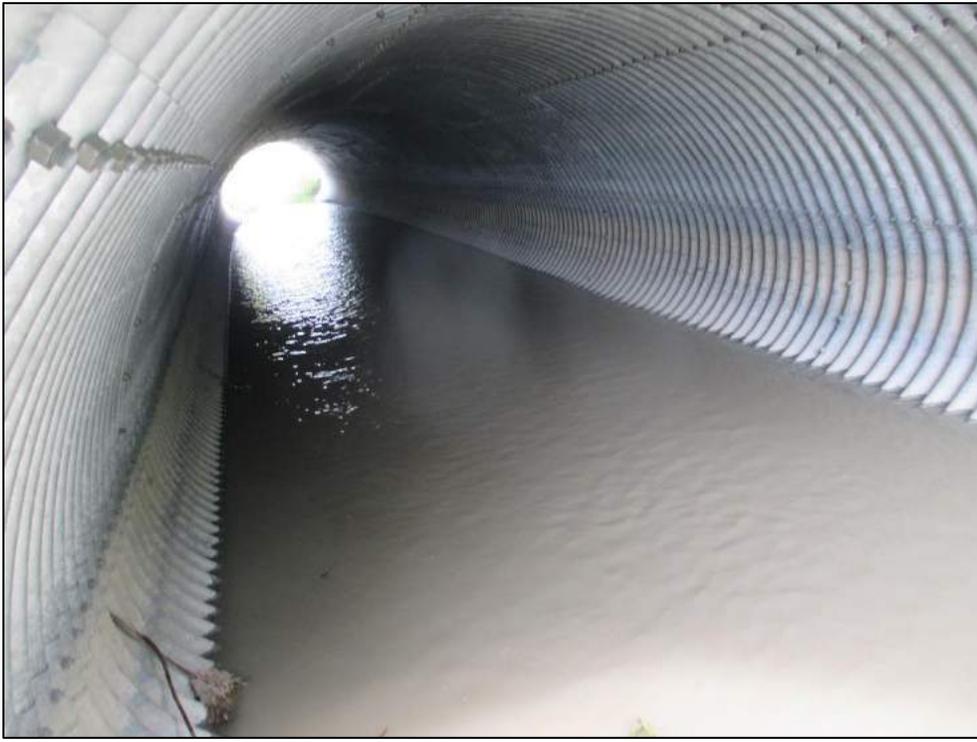
Barrel looking north.

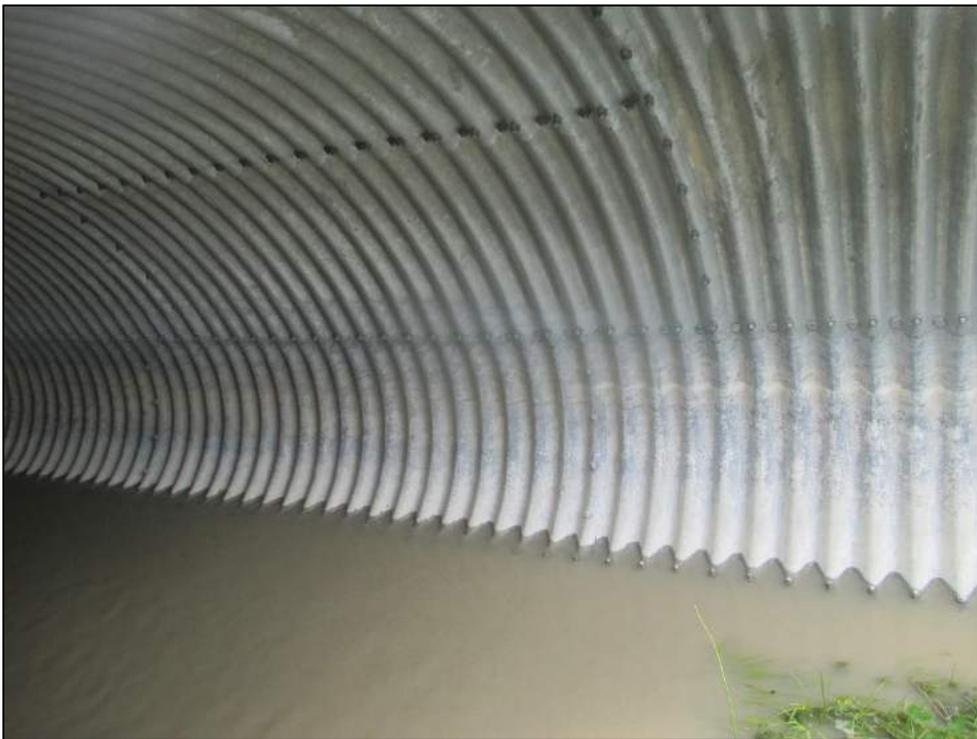
Barrel wall (typ.)

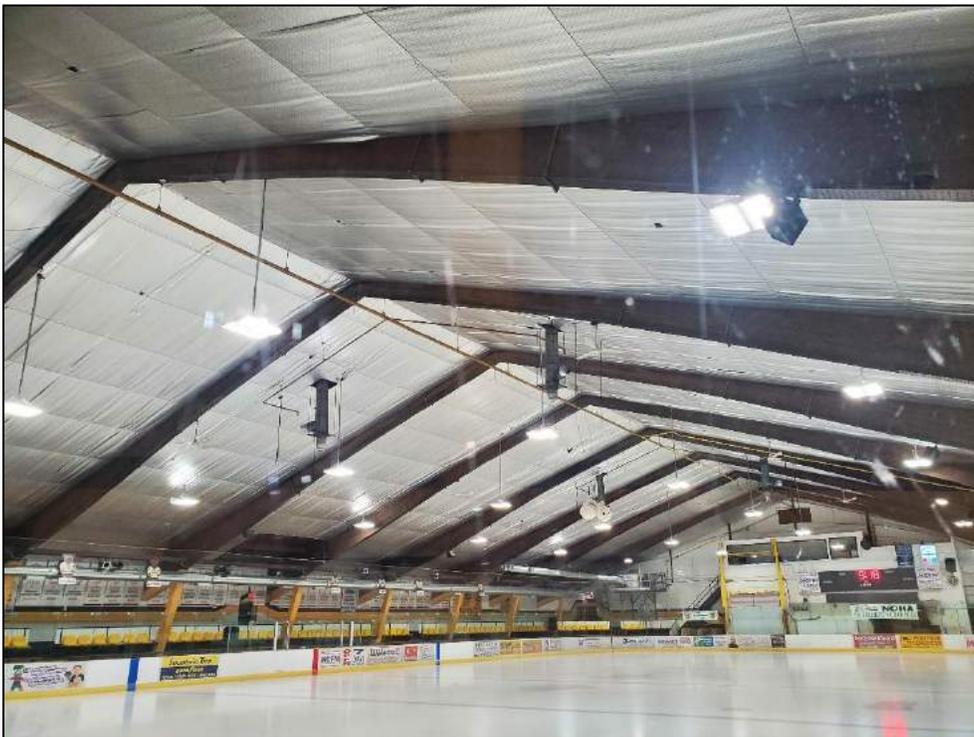
Glulam beams and insulation on interior of roof.

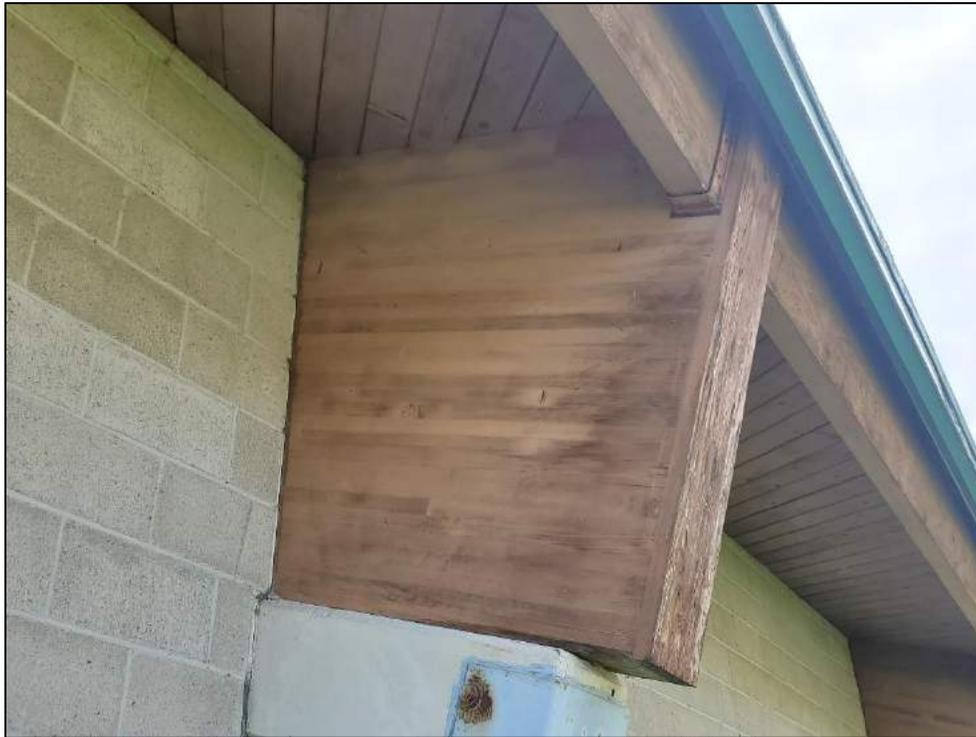
Condition Data:	Units	Exc	Good	Fair	Poor																						
	Sq. m		555.19	10	10																						
Maint. Needs																											
Perform. Deficiencies	None																										
Estimated Construction Cost:	\$5,000.00																										
Priority	None 6-10 yrs 1-5 yrs Within 1 yr Urgent																										
<p>Comments</p> <p>The depth of the glulam beams varies along their length. An average depth is used to calculate quantity. Beams exhibit dry rot at exposed ends on outside of arena.</p>																											
<p>Recommended Work</p> <p>Recoat and provide moisture protection to exposed ends of beams.</p>

Dry rot on glulam beam ends.

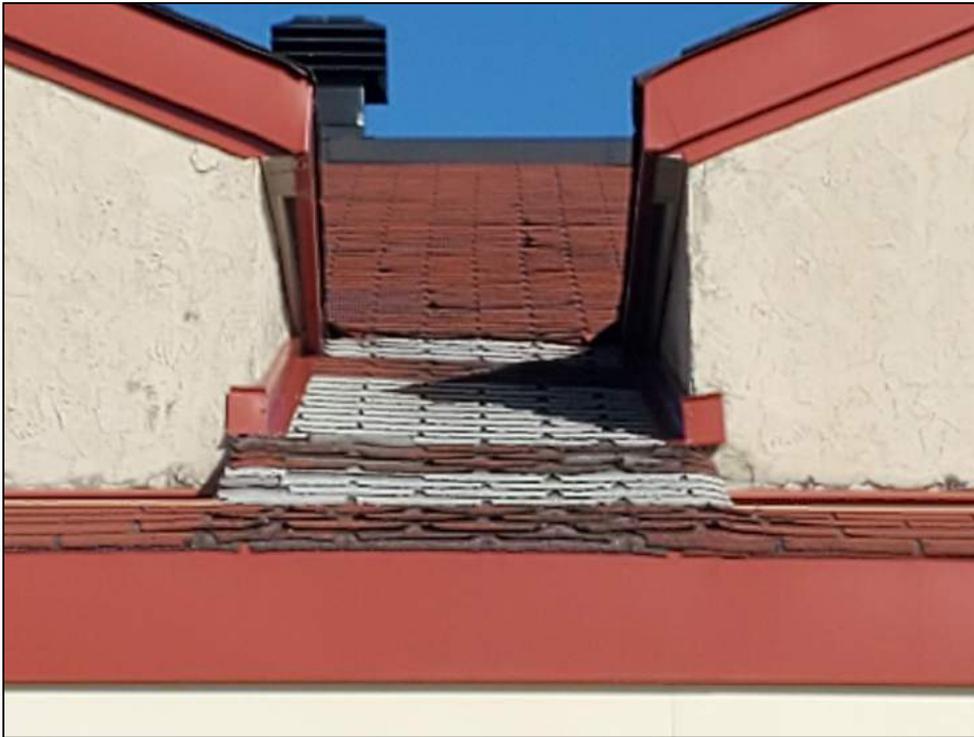
Deteriorated shingles at southeast.

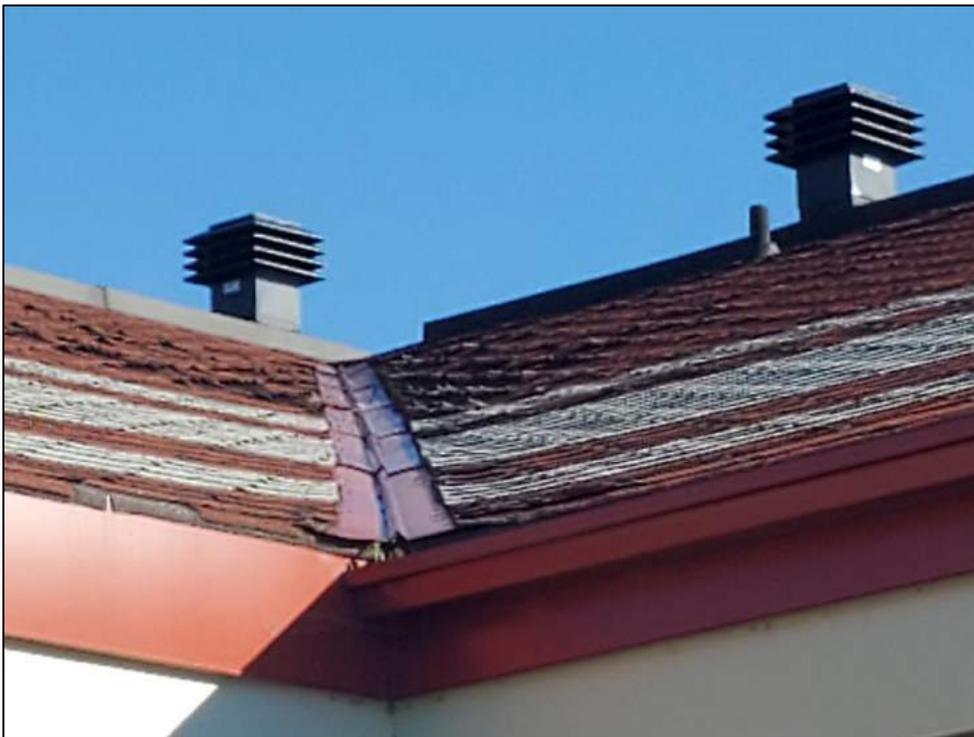
<table border="1" style="width:100%; border-collapse: collapse;"> <tr><td>Element Group:</td><td>Roofs</td></tr> <tr><td>Element Name:</td><td>Shingles</td></tr> <tr><td>Location:</td><td>External</td></tr> <tr><td>Material:</td><td>Asphalt</td></tr> <tr><td>Element Type:</td><td>Asphalt shingles</td></tr> <tr><td>Environment:</td><td>Severe</td></tr> <tr><td>Protection System:</td><td></td></tr> </table> <p>Condition Data: Units Exc Good Fair Poor</p> <p> Sq. m <input type="text"/> <input type="text" value="155.59"/> <input type="text" value="50"/> <input type="text"/></p> <p>Comments</p> <p>Shingles curling and deteriorated at multiple locations.</p> <p>Recommended Work</p> <p>Replace roofing.</p>	Element Group:	Roofs	Element Name:	Shingles	Location:	External	Material:	Asphalt	Element Type:	Asphalt shingles	Environment:	Severe	Protection System:		<table border="1" style="width:100%; border-collapse: collapse;"> <tr><td>Length:</td><td><input type="text" value="79.79"/></td></tr> <tr><td>Width:</td><td><input type="text" value="37.38"/></td></tr> <tr><td>Height:</td><td><input type="text"/></td></tr> <tr><td>Count:</td><td><input type="text"/></td></tr> <tr><td>Total Quantity:</td><td><input type="text" value="2056"/></td></tr> <tr><td>Limited Inspection</td><td><input type="checkbox"/></td></tr> </table> <p>Maint. Needs</p> <p>Perform. Deficiencies</p> <table border="1" style="width:100%; border-collapse: collapse;"> <tr><td>Estimated Construction Cost:</td><td><input type="text" value="\$250,000.00"/></td></tr> <tr><td>Priority</td><td> <input type="text"/> None <input type="text"/> 6-10 yrs <input checked="" type="text"/> 1-5 yrs <input type="text"/> Within 1 yr <input type="text"/> Urgent </td></tr> </table>	Length:	<input type="text" value="79.79"/>	Width:	<input type="text" value="37.38"/>	Height:	<input type="text"/>	Count:	<input type="text"/>	Total Quantity:	<input type="text" value="2056"/>	Limited Inspection	<input type="checkbox"/>	Estimated Construction Cost:	<input type="text" value="\$250,000.00"/>	Priority	<input type="text"/> None <input type="text"/> 6-10 yrs <input checked="" type="text"/> 1-5 yrs <input type="text"/> Within 1 yr <input type="text"/> Urgent

Extensive curling and damage to shingles.

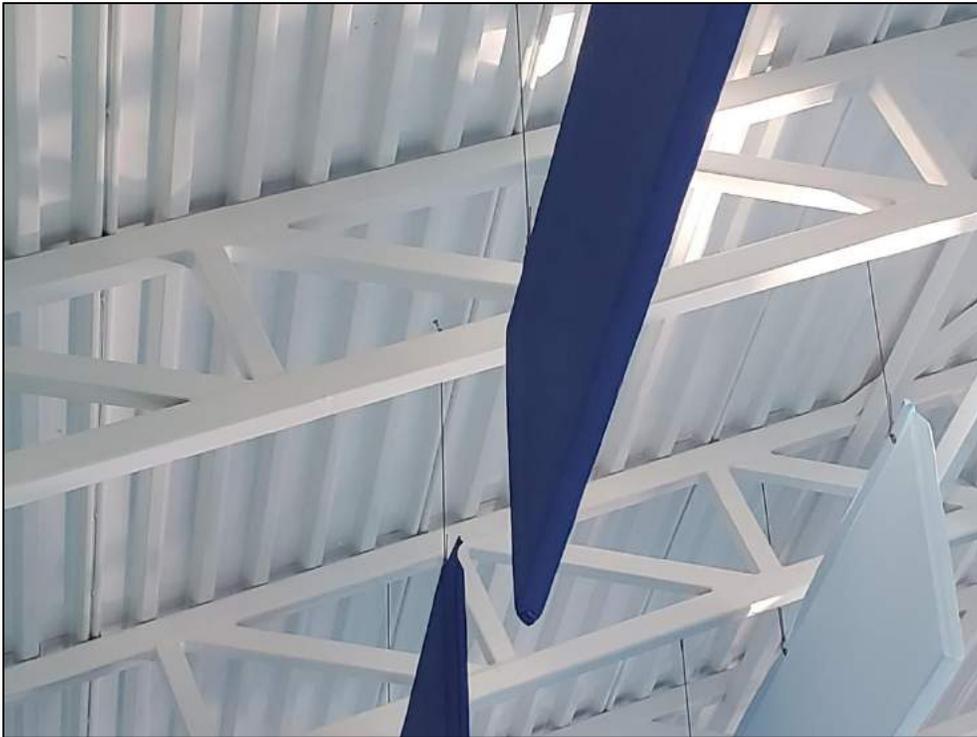
Painted decking and steel joists on roof of pool area (typ.).

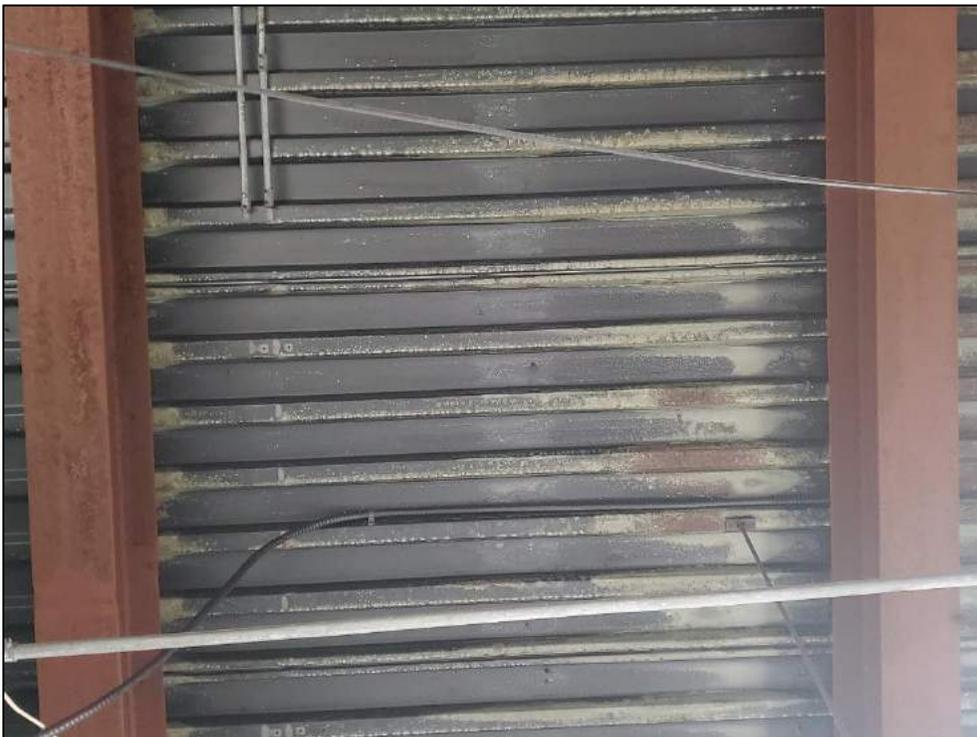
Condition Data:	Units	Exc	Good	Fair	Poor																								
	Sq. m			43.69	6																								
Maint. Needs																													
Perform. Deficiencies																													
Estimated Construction Cost:	\$10,000.00																												
Priority	None																												
	6-10 yrs																												
	1-5 yrs																												
	Within 1 yr																												
	Urgent																												
<p>Comments</p> <p>Galvanized coating on corrugated steel damaged due to high humidity levels in fan room. Corrosion at some locations.</p>																													
<p>Recommended Work</p> <p>Recoat corrugated steel.</p>

Damaged galvanized coating of steel decking in filter room.

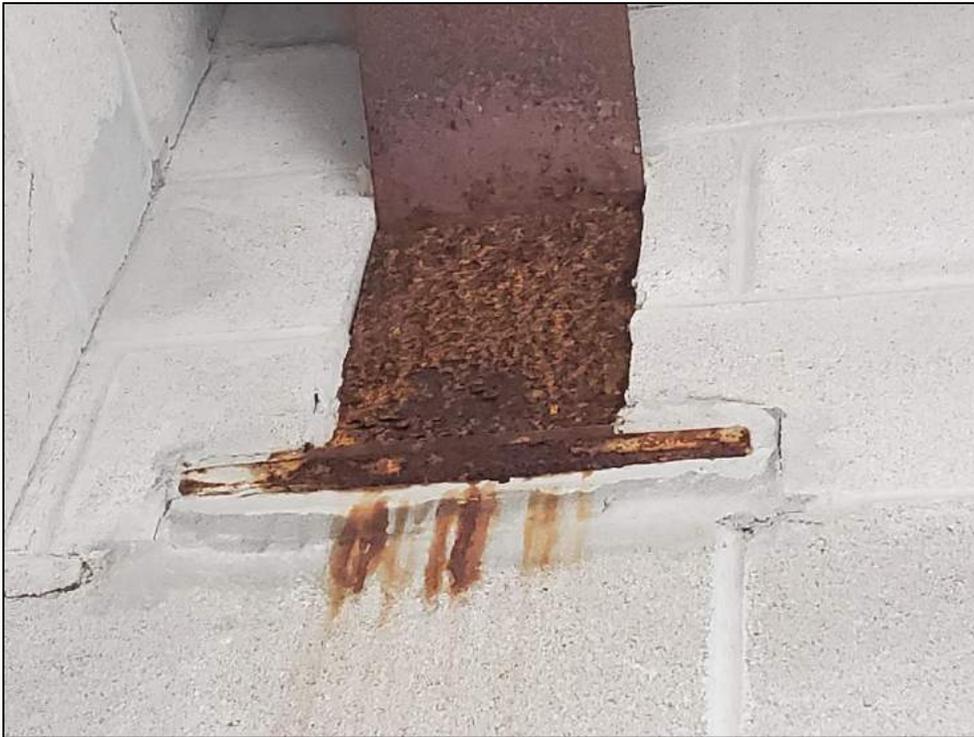
<table border="1" style="width:100%; border-collapse: collapse;"> <tr><td>Element Group:</td><td>Beams/MLE's</td></tr> <tr><td>Element Name:</td><td>Girders</td></tr> <tr><td>Location:</td><td>Fan room</td></tr> <tr><td>Material:</td><td>Steel</td></tr> <tr><td>Element Type:</td><td>I type</td></tr> <tr><td>Environment:</td><td>Severe</td></tr> <tr><td>Protection System:</td><td></td></tr> </table> <p>Condition Data: Units Exc Good Fair Poor</p> <p> Sq. m <input type="text"/> <input type="text"/> <input type="text" value="6"/> <input type="text"/></p> <p>Comments</p> <p>Water condenses on beams, evidenced by moisture stains seen down walls at beam ends. Corrosion on some beam ends.</p> <p>Recommended Work</p> <p>Recoat beam ends.</p>	Element Group:	Beams/MLE's	Element Name:	Girders	Location:	Fan room	Material:	Steel	Element Type:	I type	Environment:	Severe	Protection System:		<table border="1" style="width:100%; border-collapse: collapse;"> <tr><td>Length:</td><td><input type="text"/></td></tr> <tr><td>Width:</td><td><input type="text"/></td></tr> <tr><td>Height:</td><td><input type="text"/></td></tr> <tr><td>Count:</td><td><input type="text" value="6"/></td></tr> <tr><td>Total Quantity:</td><td><input type="text" value="6"/></td></tr> <tr><td>Limited Inspection</td><td><input type="checkbox"/></td></tr> </table> <p>Maint. Needs</p> <p>Perform. Deficiencies</p> <table border="1" style="width:100%; border-collapse: collapse;"> <tr><td>Estimated Construction Cost:</td><td><input type="text" value="\$5,000.00"/></td></tr> <tr><td>Priority</td><td> <input type="text"/> None <input type="text"/> 6-10 yrs <input checked="" type="text"/> 1-5 yrs <input type="text"/> Within 1 yr <input type="text"/> Urgent </td></tr> </table>	Length:	<input type="text"/>	Width:	<input type="text"/>	Height:	<input type="text"/>	Count:	<input type="text" value="6"/>	Total Quantity:	<input type="text" value="6"/>	Limited Inspection	<input type="checkbox"/>	Estimated Construction Cost:	<input type="text" value="\$5,000.00"/>	Priority	<input type="text"/> None <input type="text"/> 6-10 yrs <input checked="" type="text"/> 1-5 yrs <input type="text"/> Within 1 yr <input type="text"/> Urgent

Moisture staining due to condensation and severe corrosion at girder ends in filter room.

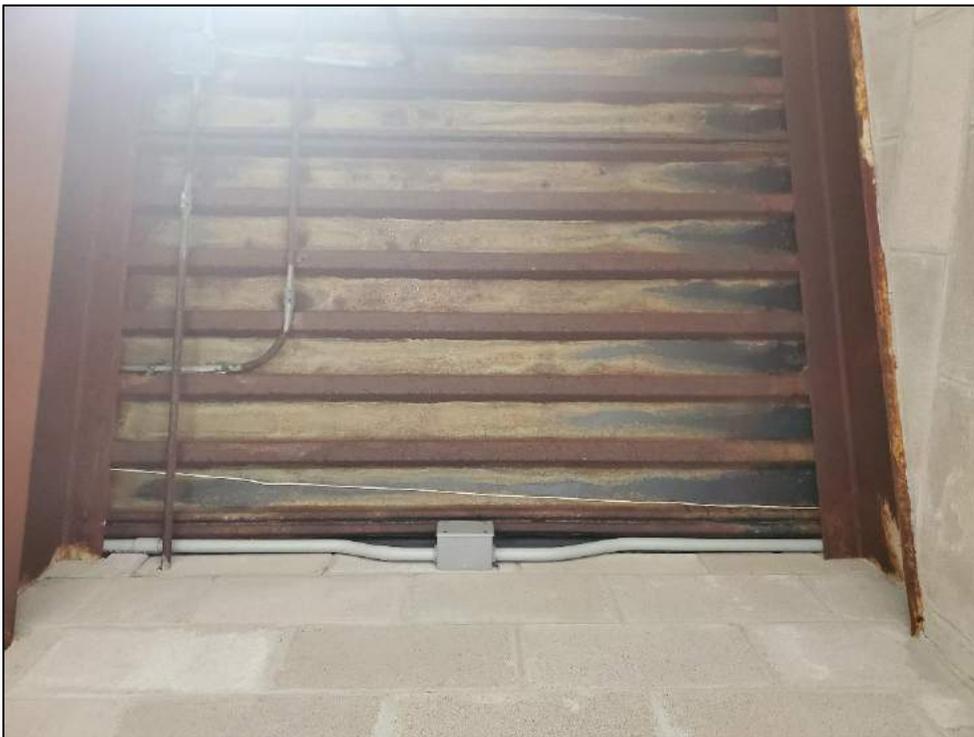
Extensive coating failure and corrosion of steel decking in filter room.

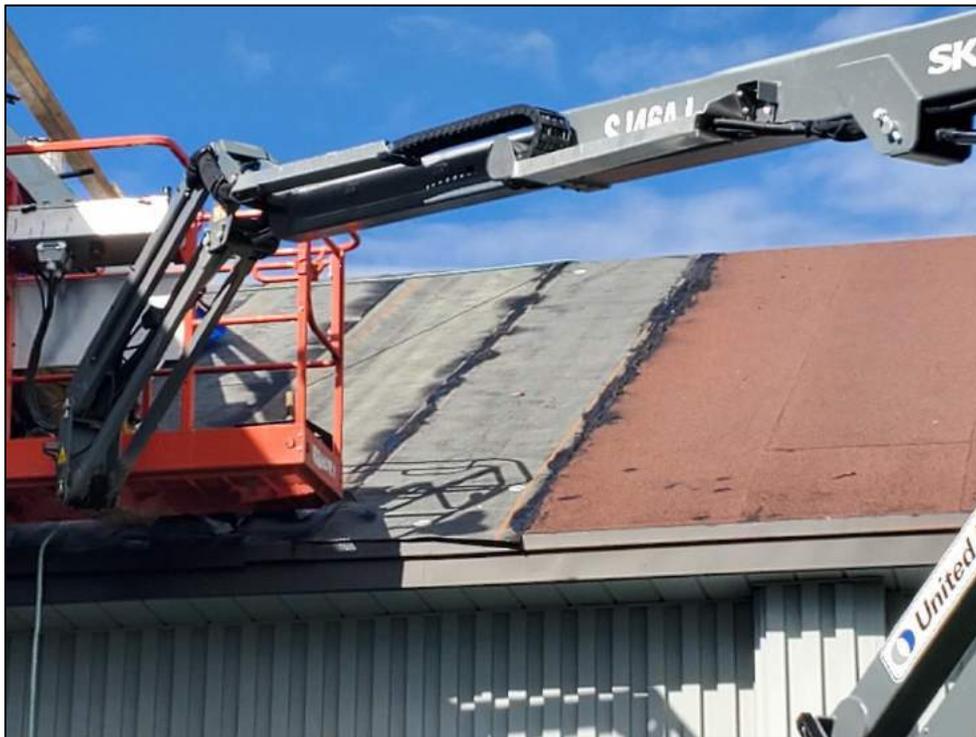
Roof in process of being replaced.

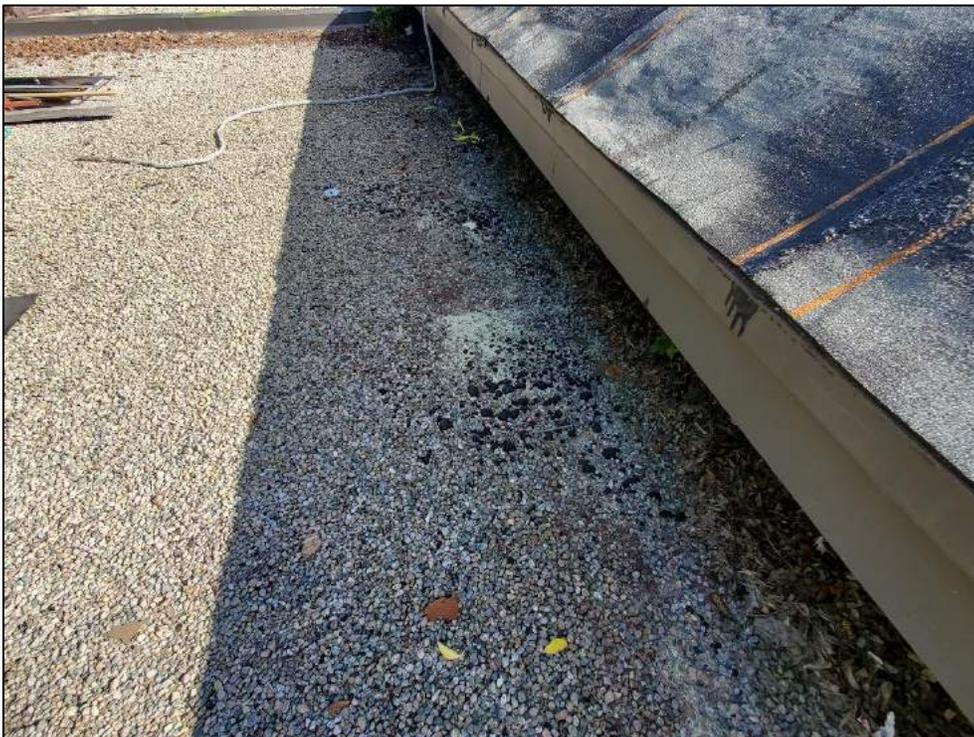
Displaced gravel and damaged tar coating due to runoff from upper roof.

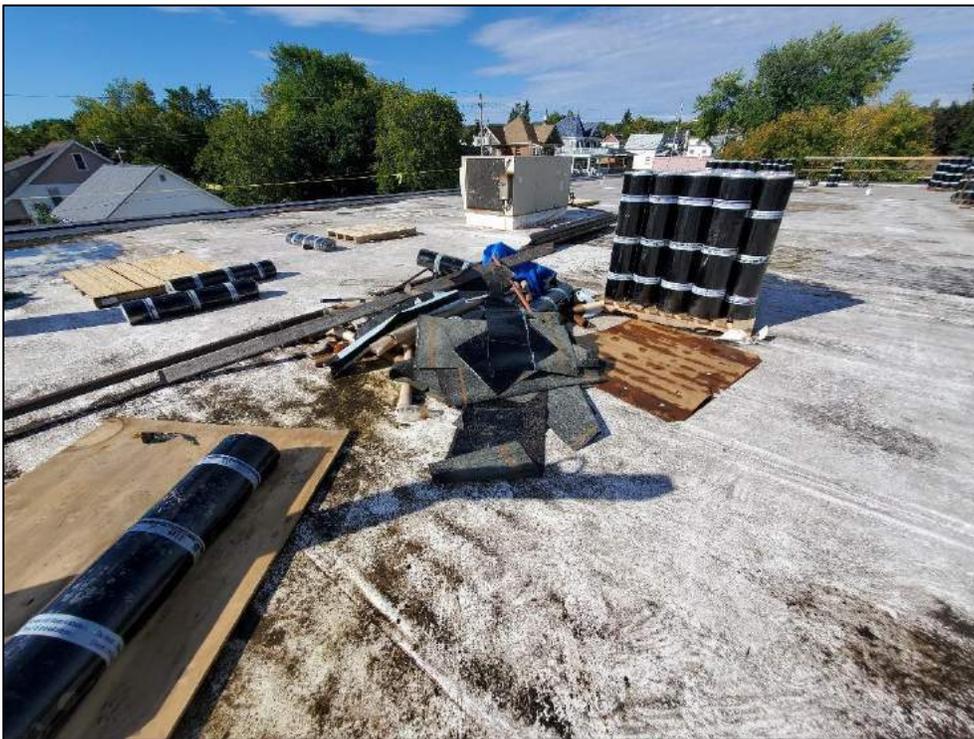
Construction debris on couth upper roof with new EDPM coating.

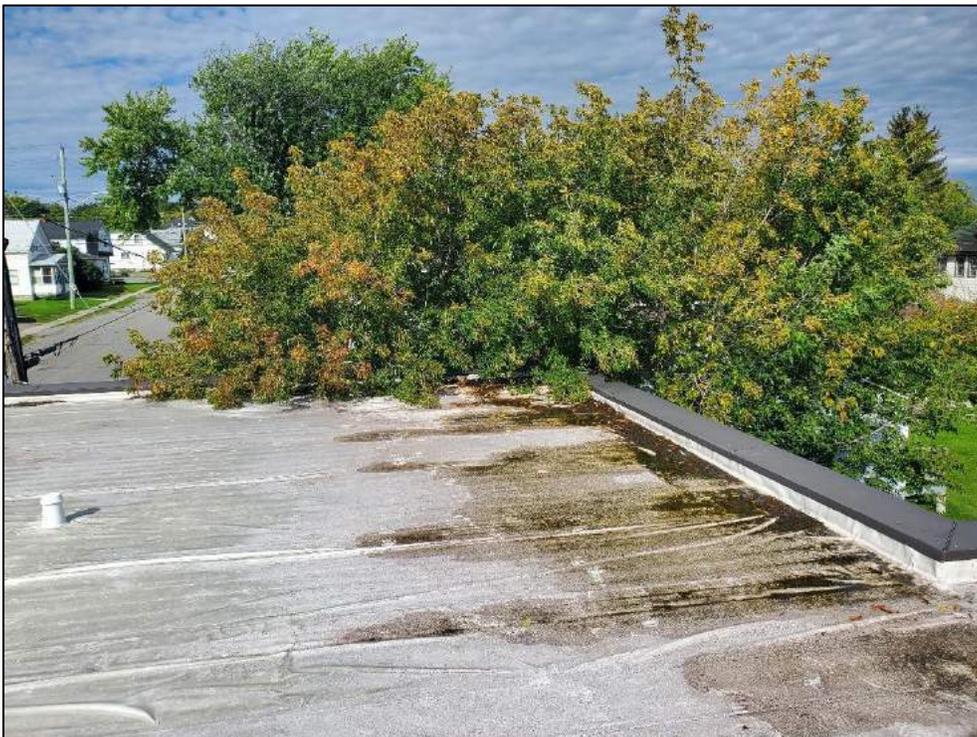
Overgrown tree at south.
