**The Corporation of the City of Temiskaming Shores
Regular Meeting of Council
Tuesday, December 20, 2022 – 6:00 p.m.
City Hall – Council Chambers – 325 Farr Drive**

Table 1 - Additional investigation required.....	Error! Bookmark not defined.
Table 2 - Recommended 10-Year Capital Bridge and Culvert Program.....	3

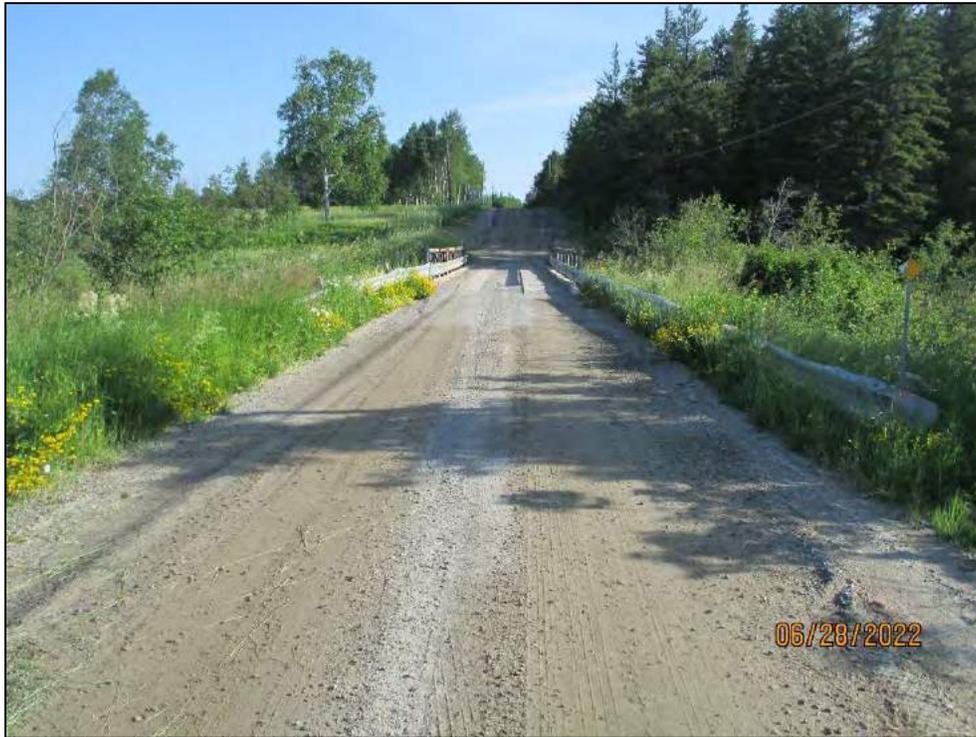
Roadway looking north

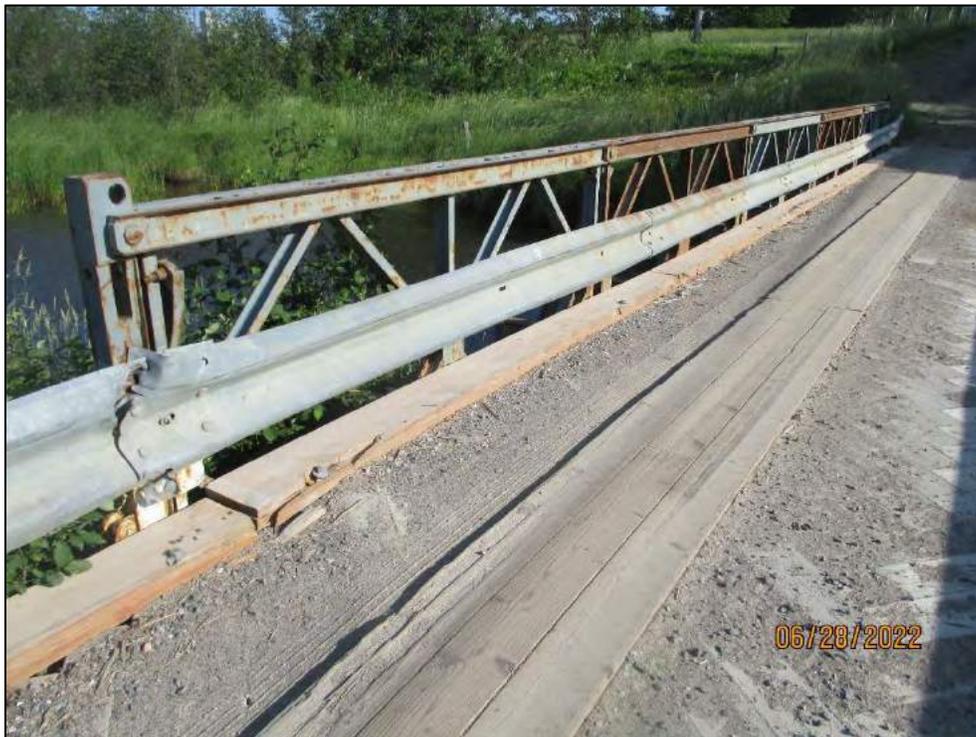
West Truss / Barrier (Typ.)

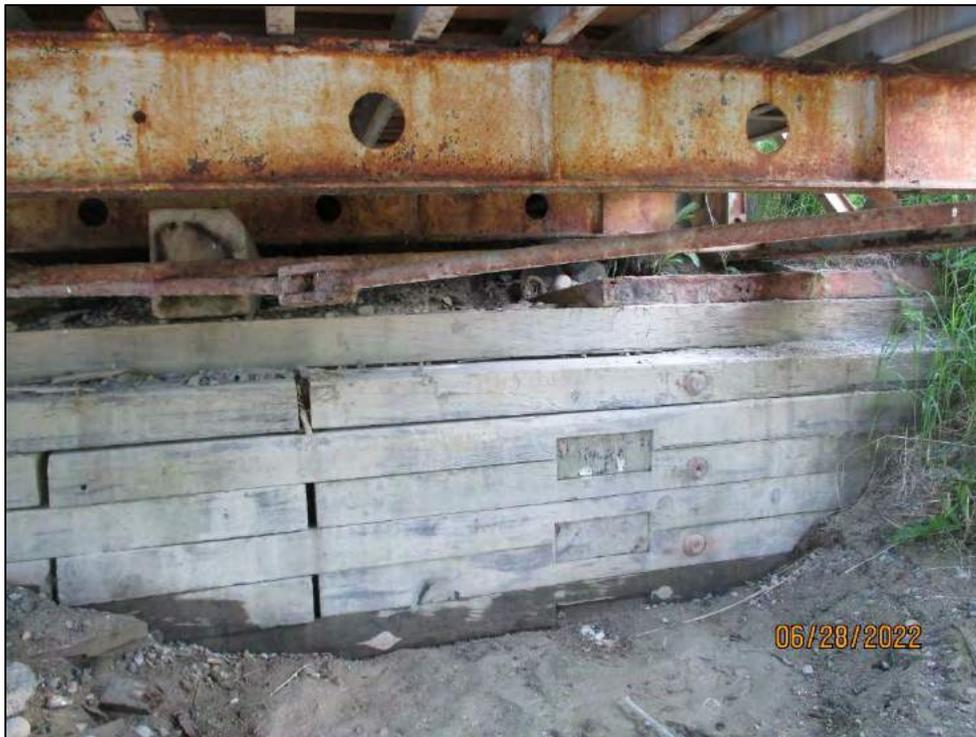
North Abutment (Timber Crib)

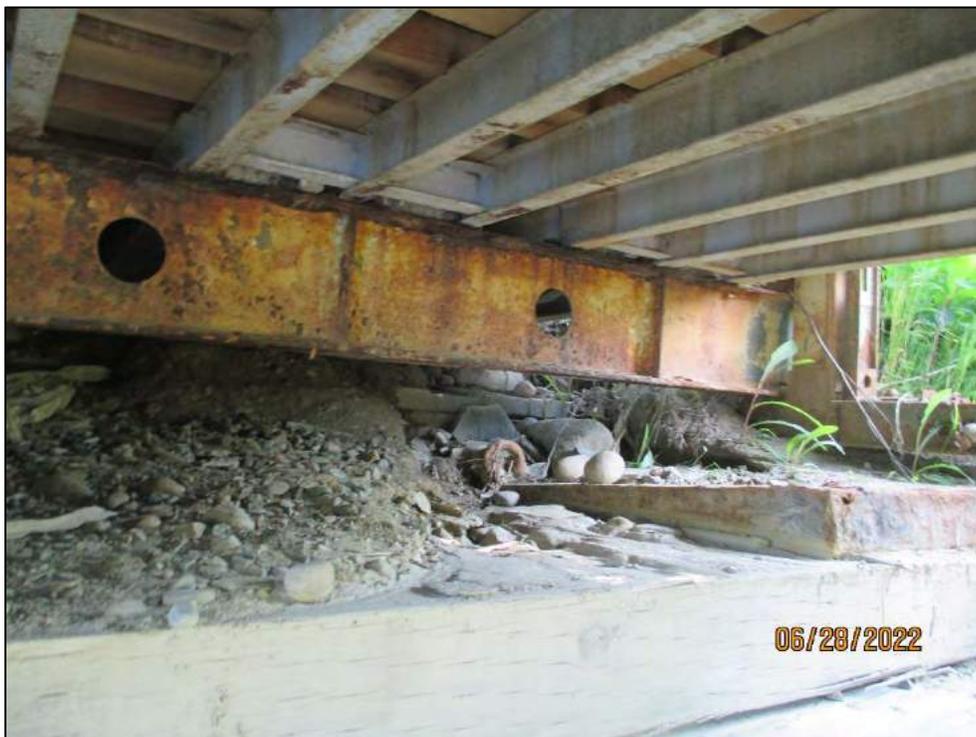
Transom / Floor Beam (Typ.)

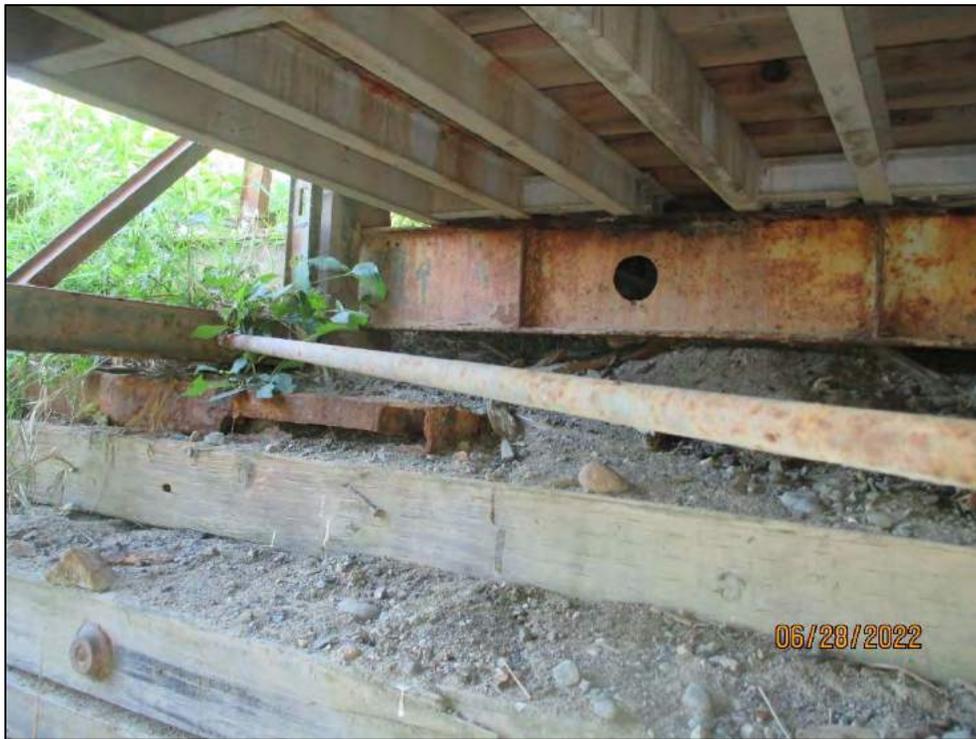
N/W Bearing (Typ.)

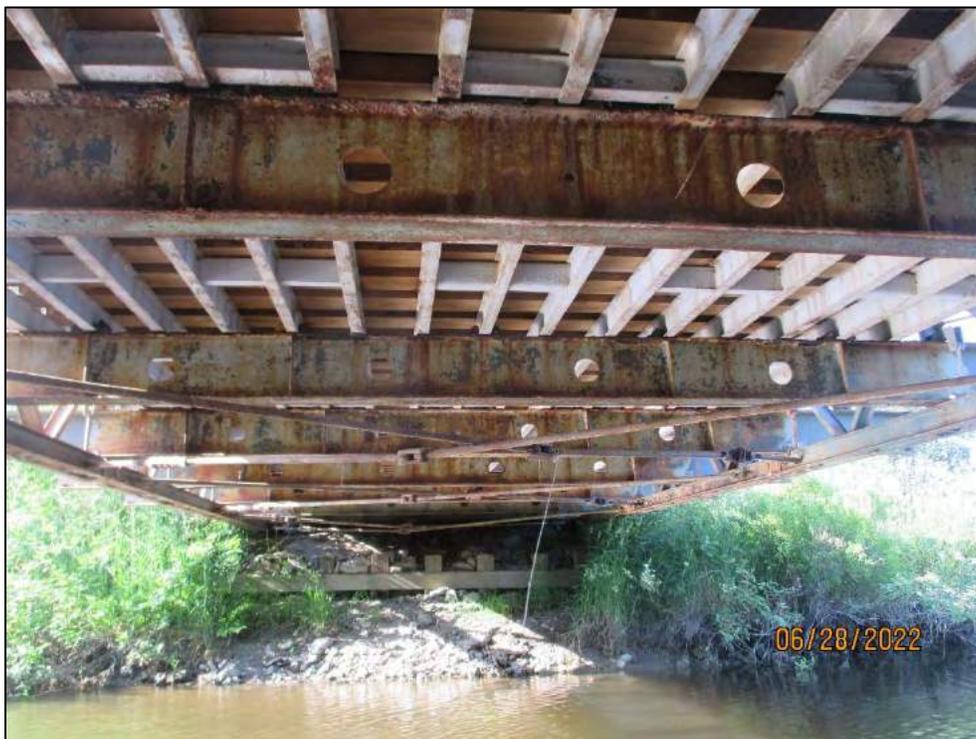
Underside of Bridge (Stringers & Bracing) – Typ.

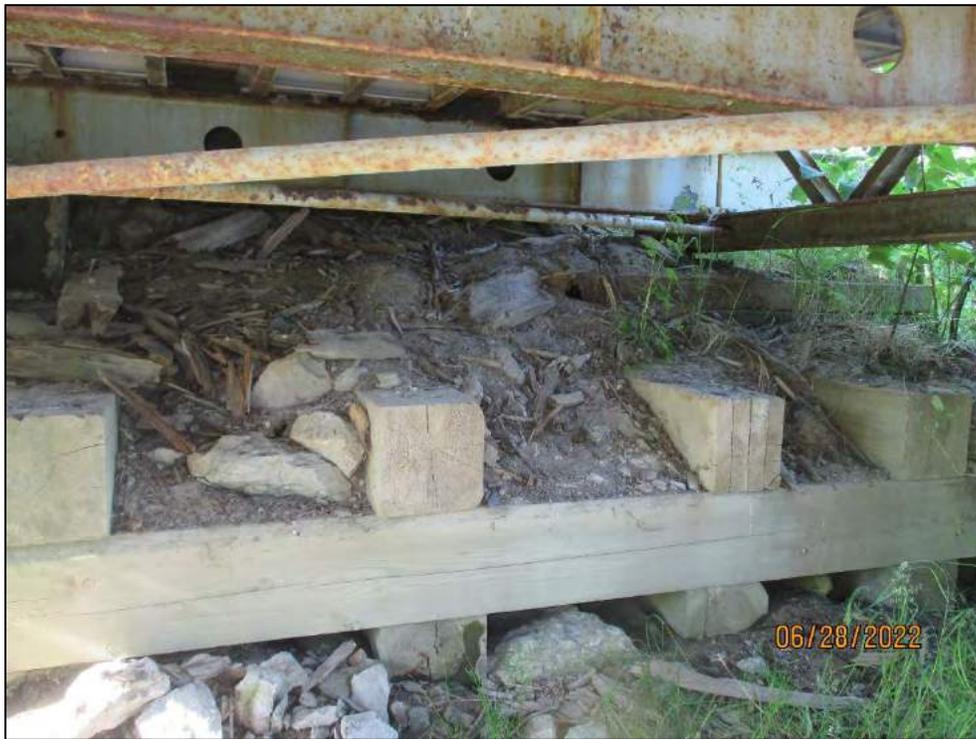
South Abutment (Rock-Filled Timber Crib)

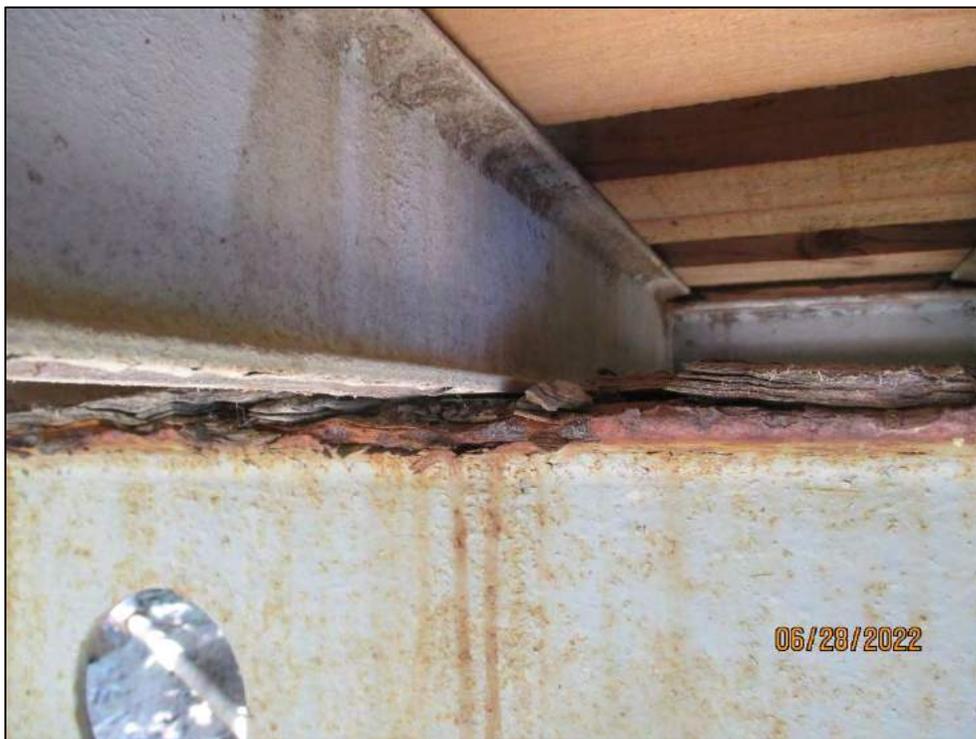
Transom / Floor Beam – Top Flange Corrosion (Typ.)

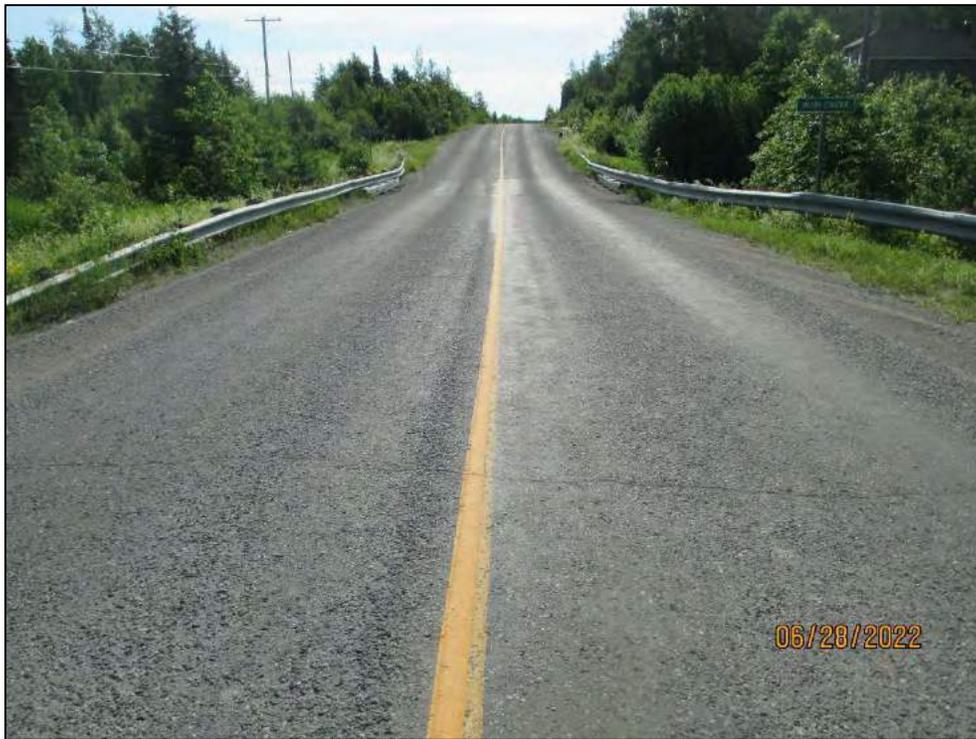
Roadway looking east

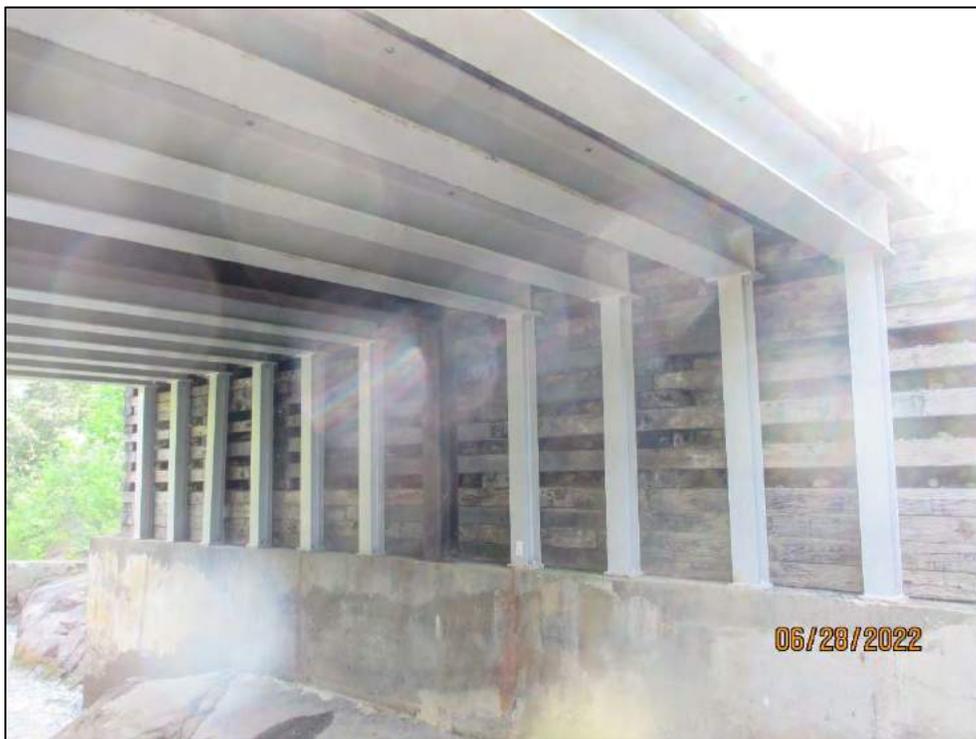
New Frames (2021)

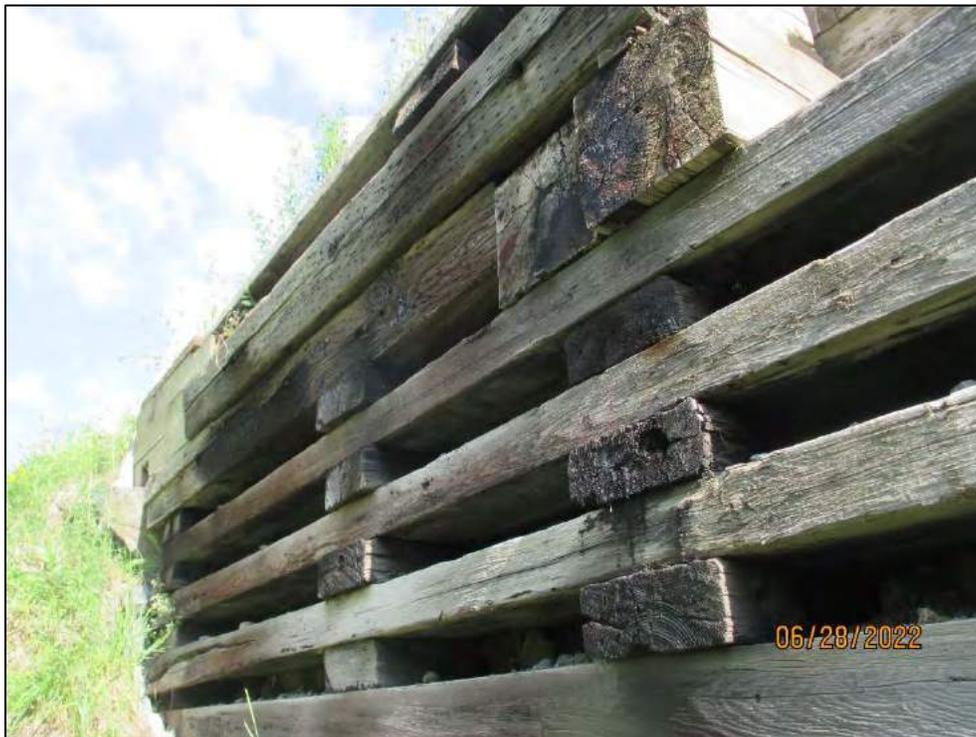
Bulging upper section of retaining wall

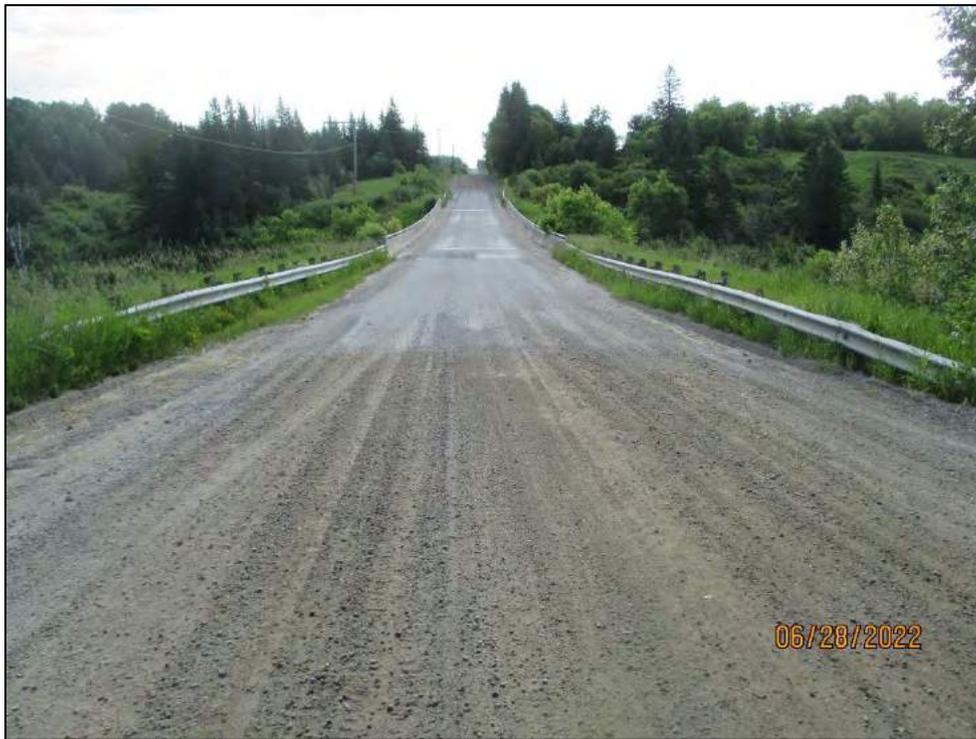
Roadway looking east

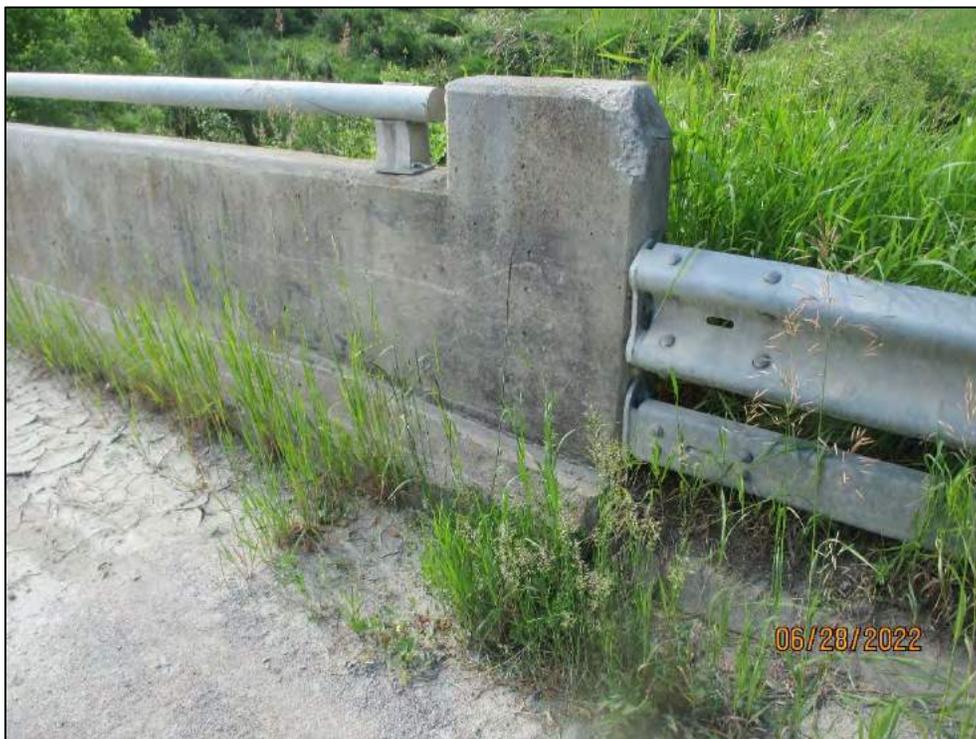
SBGR / Barrier Connection (Typ.)

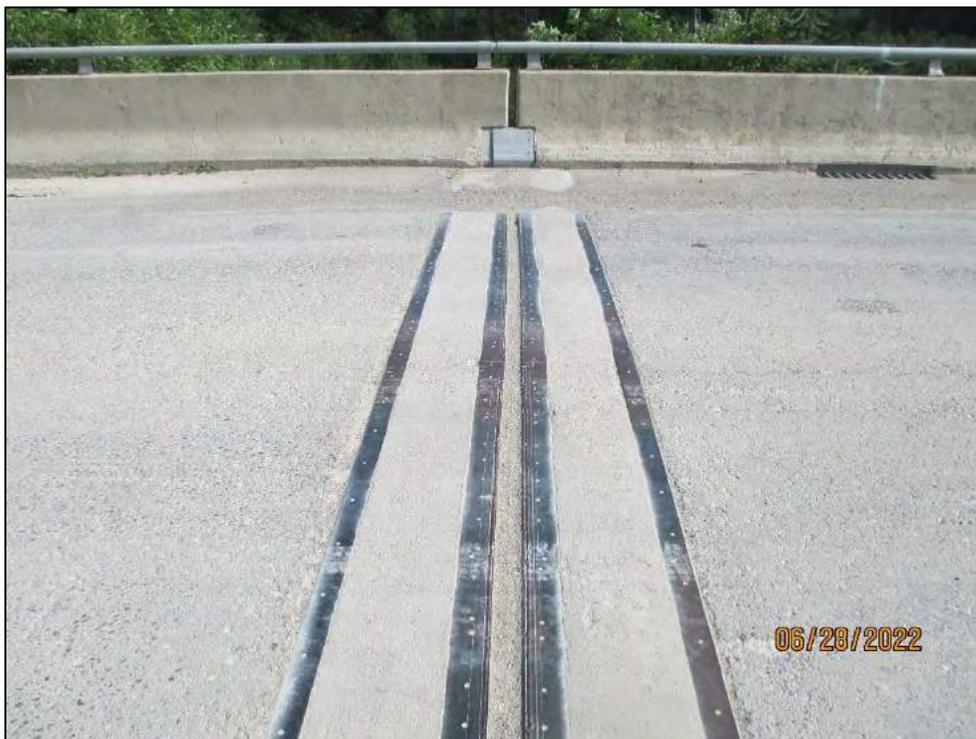
Expansion Joint (Typ.)

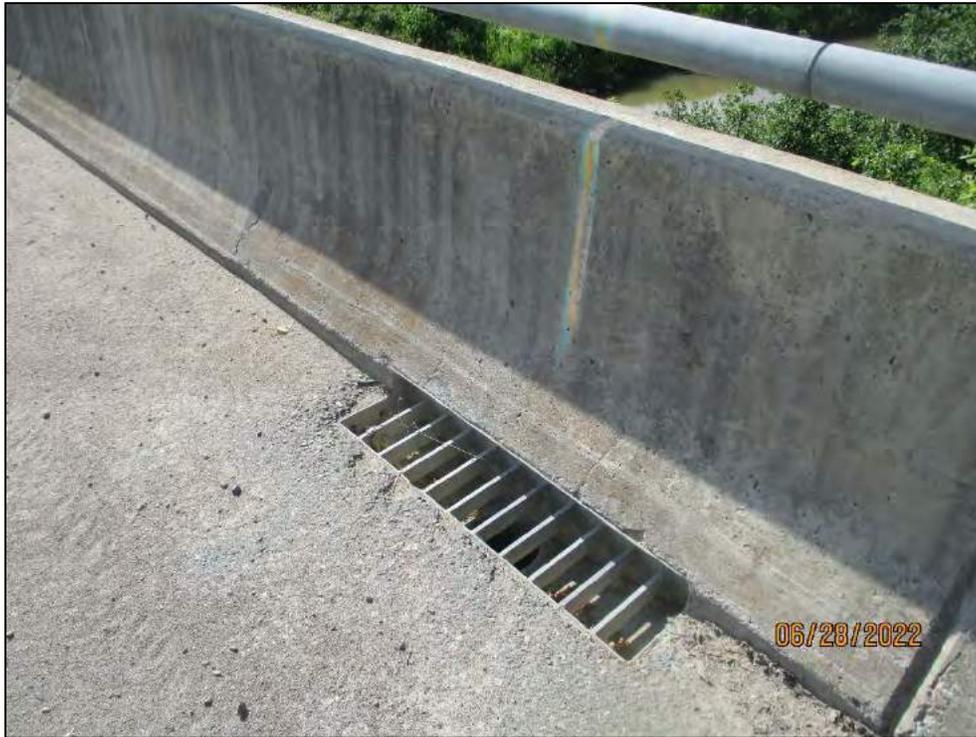
Deck Drain and Barrier (Typ.)

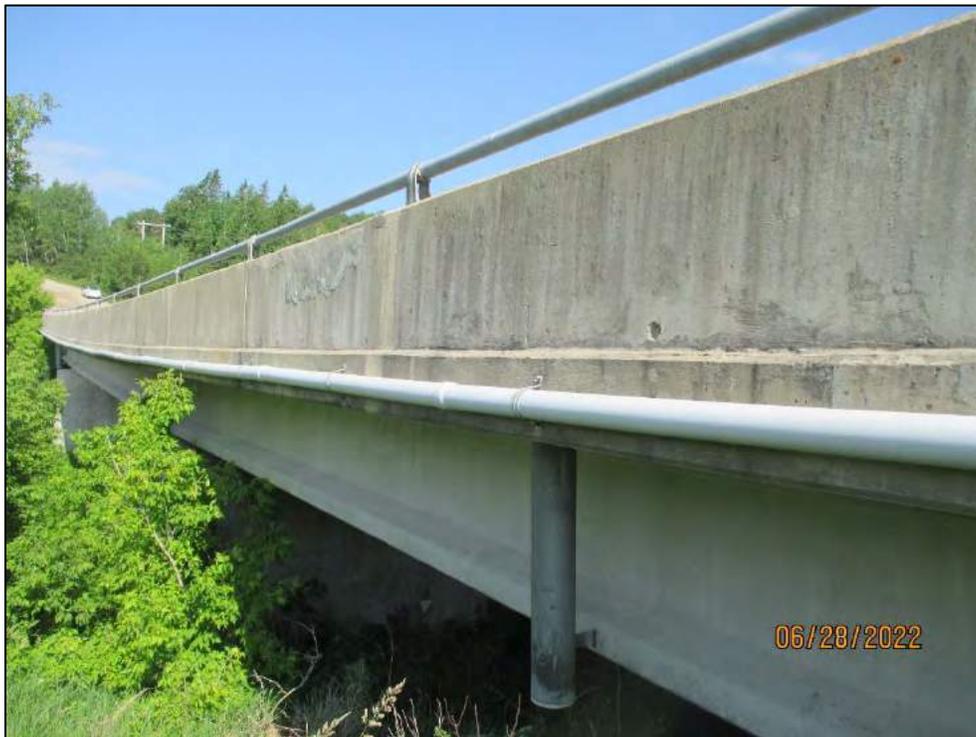
South Elevation (Utility Duct)

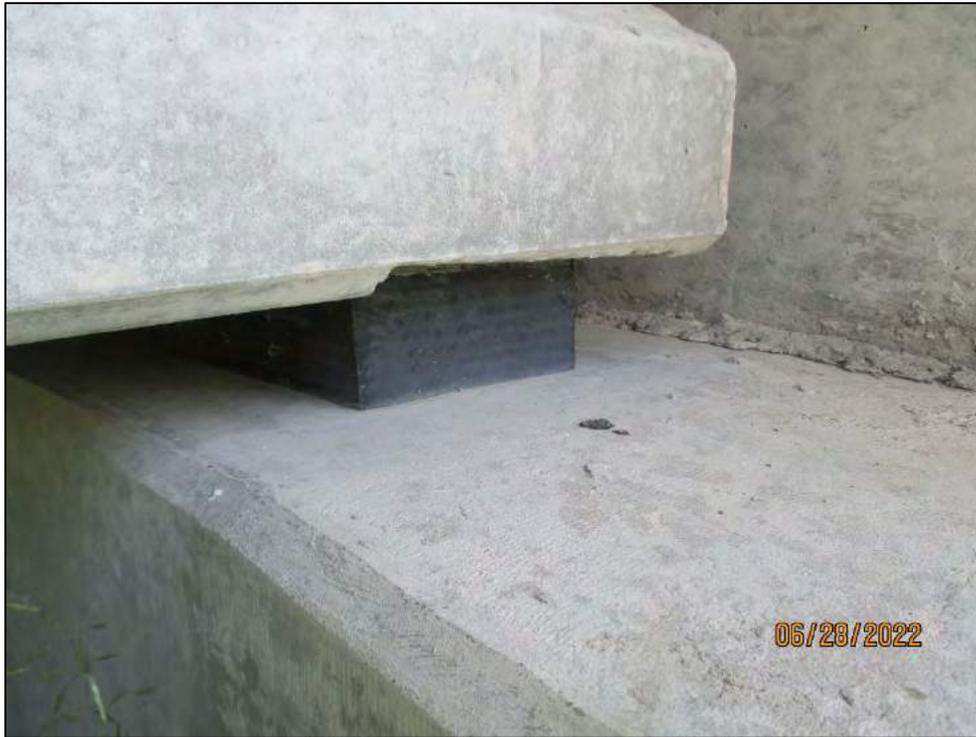
Girder End / Bearing (Typ.)

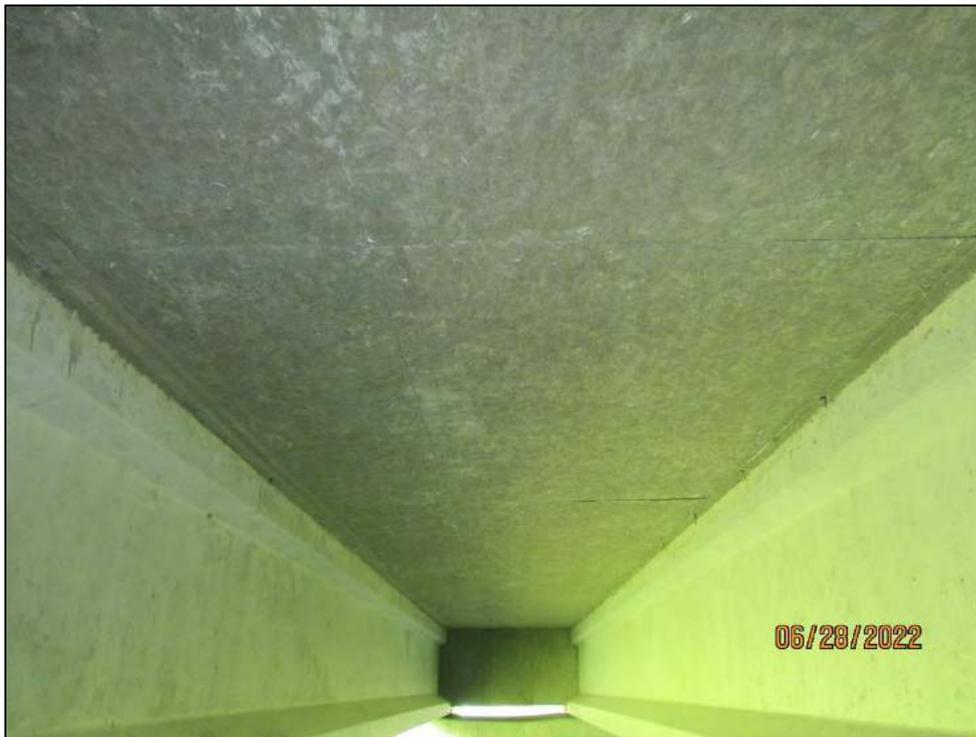
Deck Soffit - Interior (Typ.)

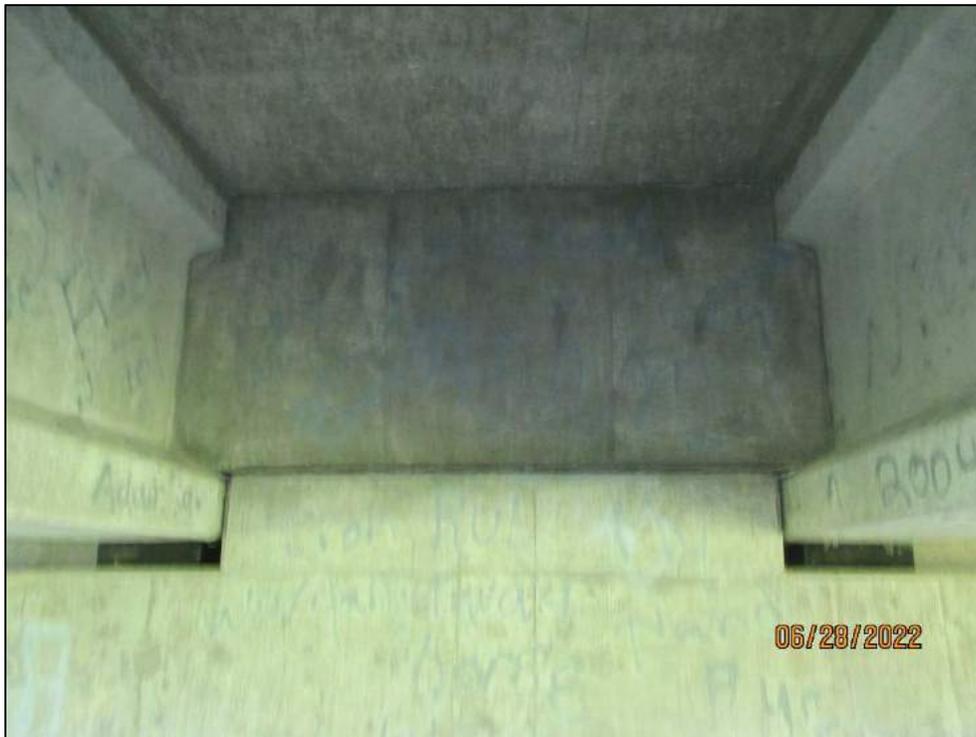
Diaphragm / Abutment (Typ.)

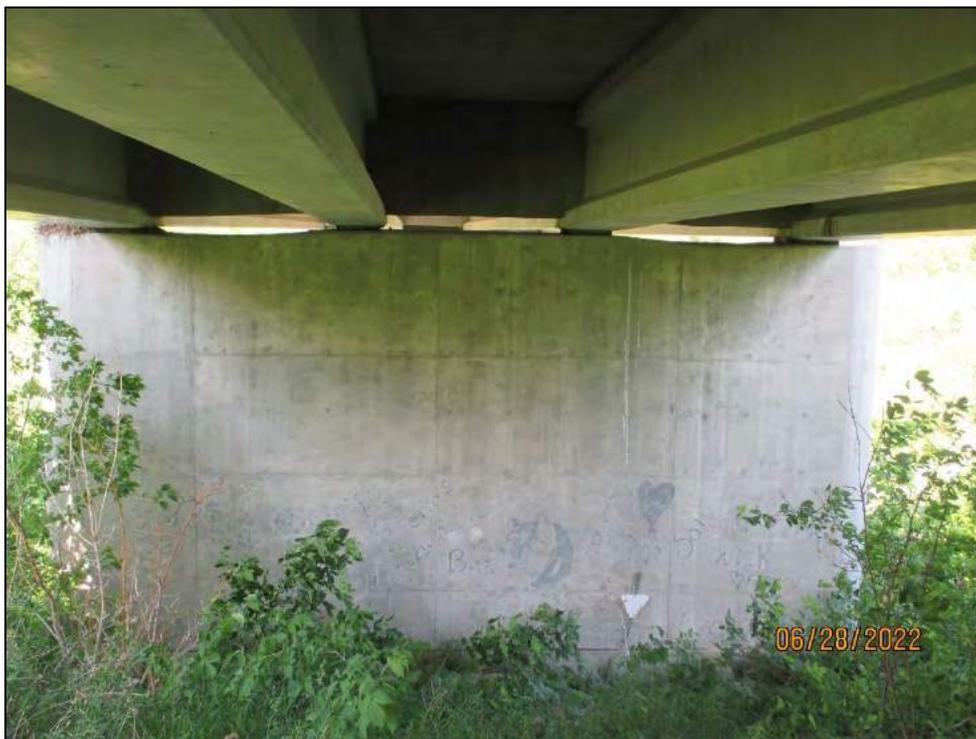
Pier Face (Typ.)

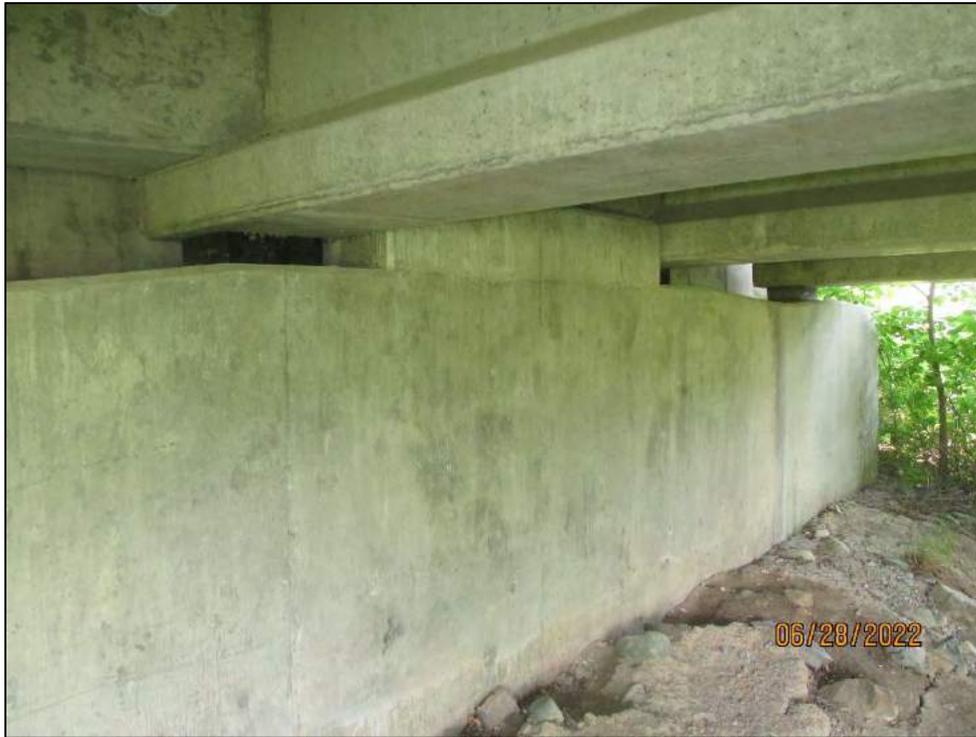
West Abutment

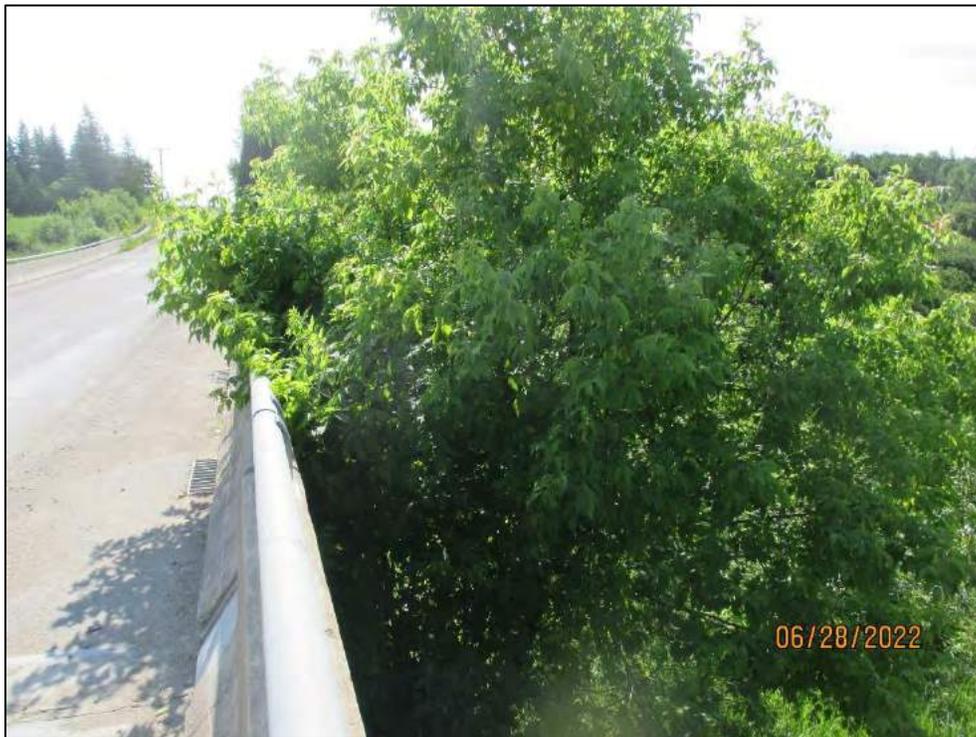
Tree at S/W (Remove)

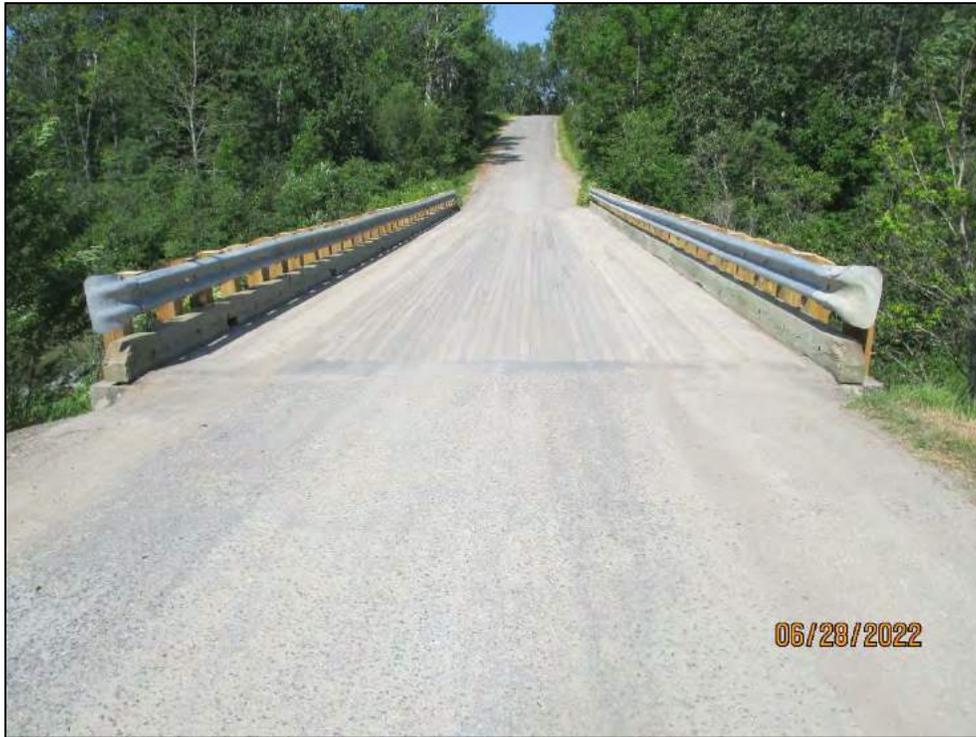
Roadway looking west

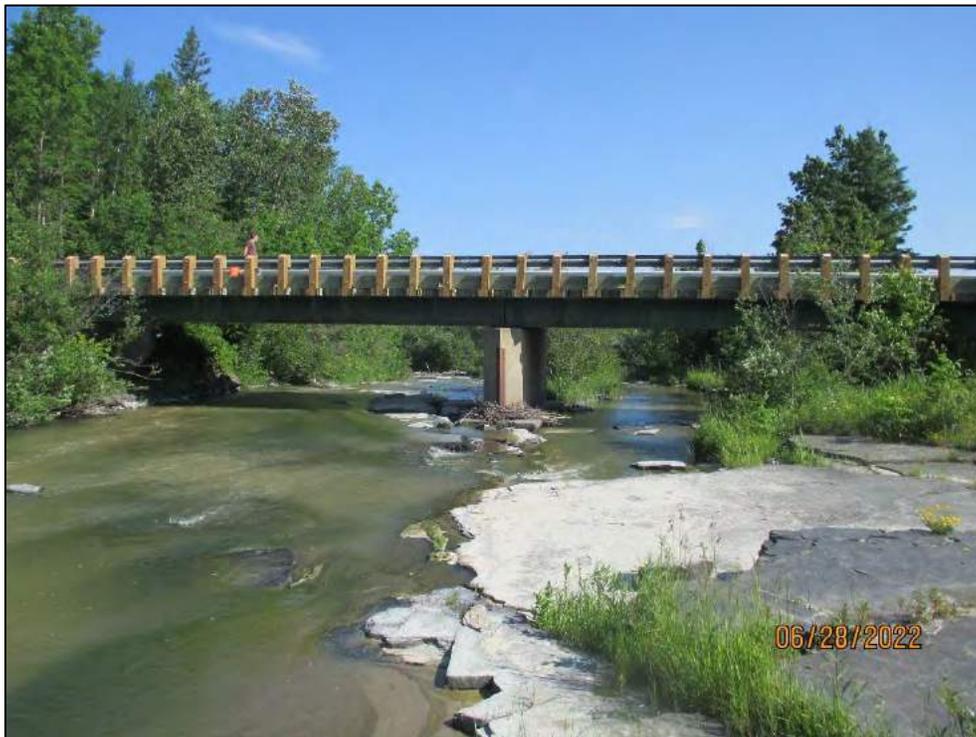
South Elevation

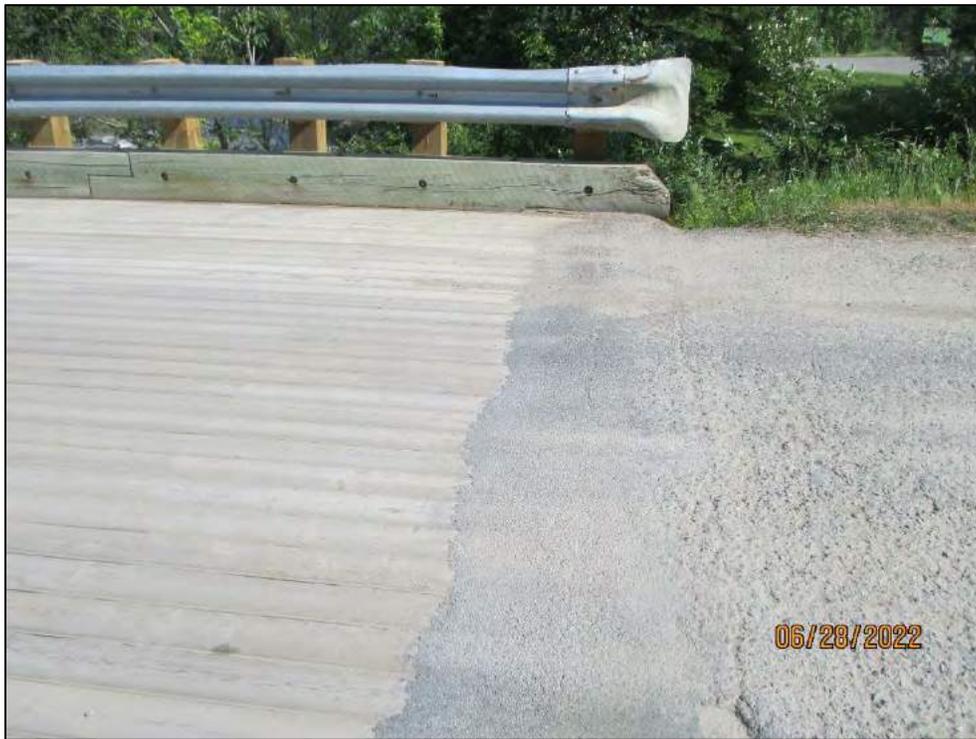
Deck End / Approach Interface (Typ.)

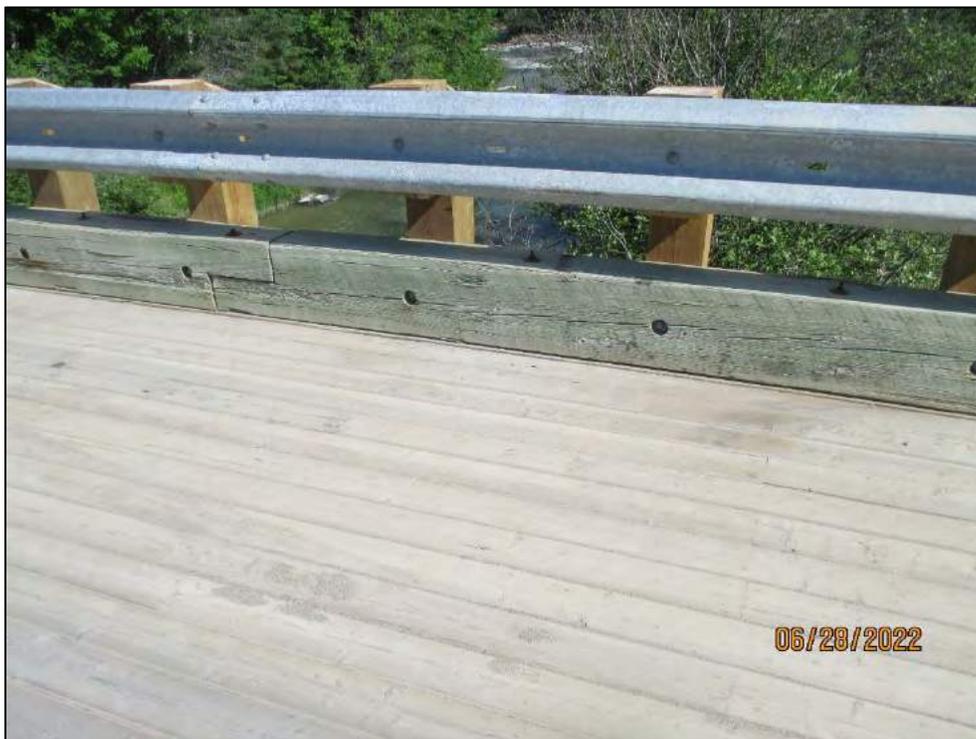
Deck Top – Curb – Barrier (Typ.)

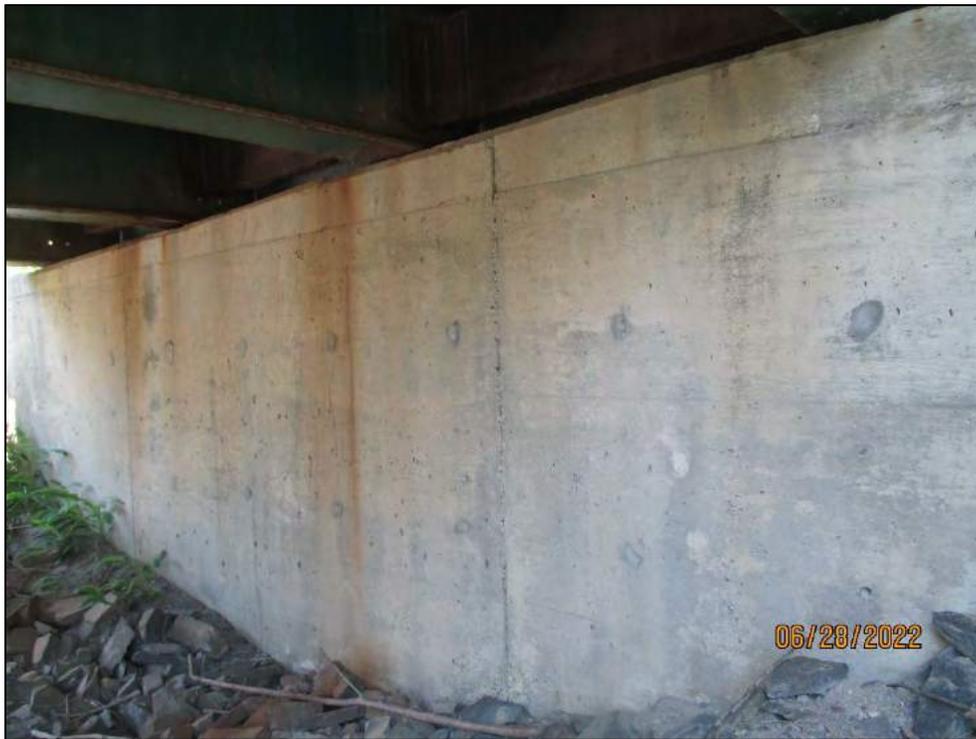
West Abutment

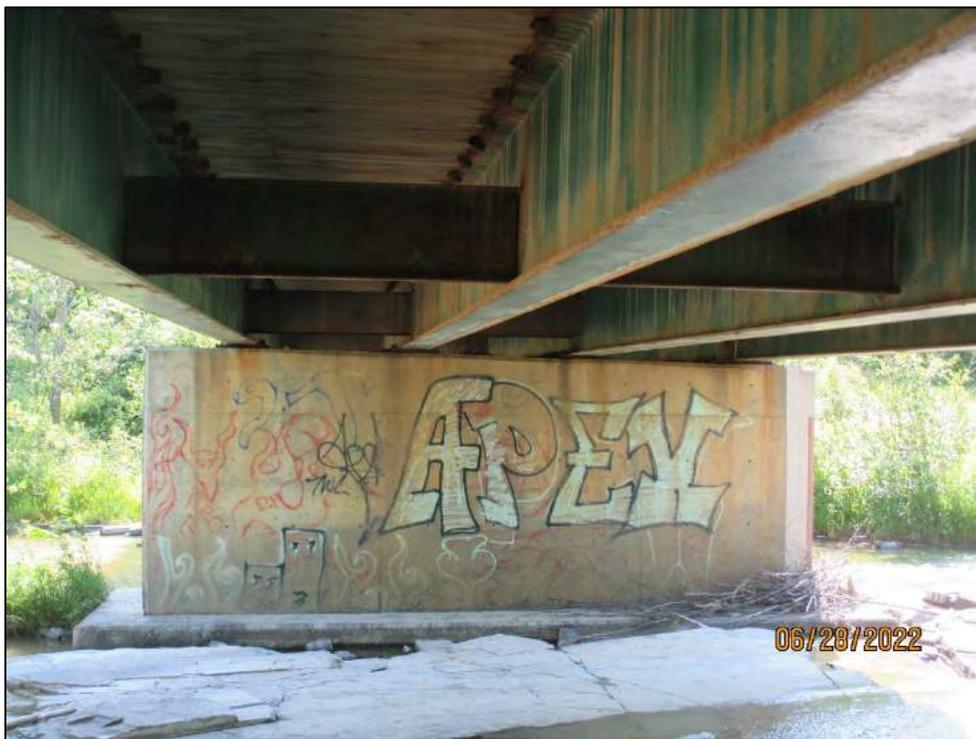
Pier Face (Typ.)

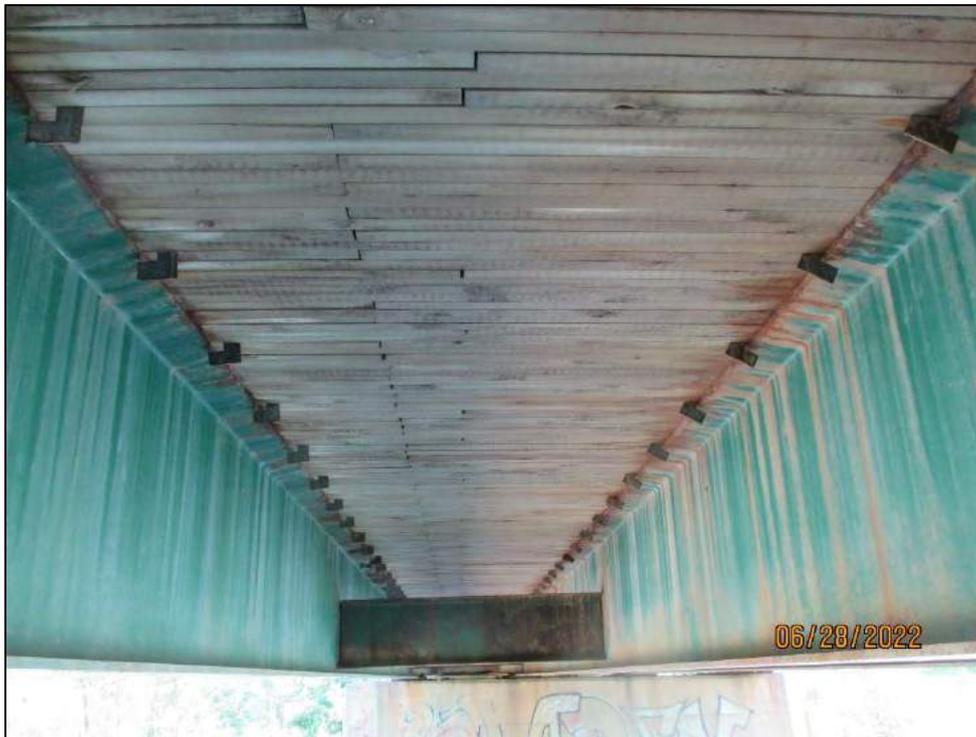
Deck Soffit / Girders (Typ.)

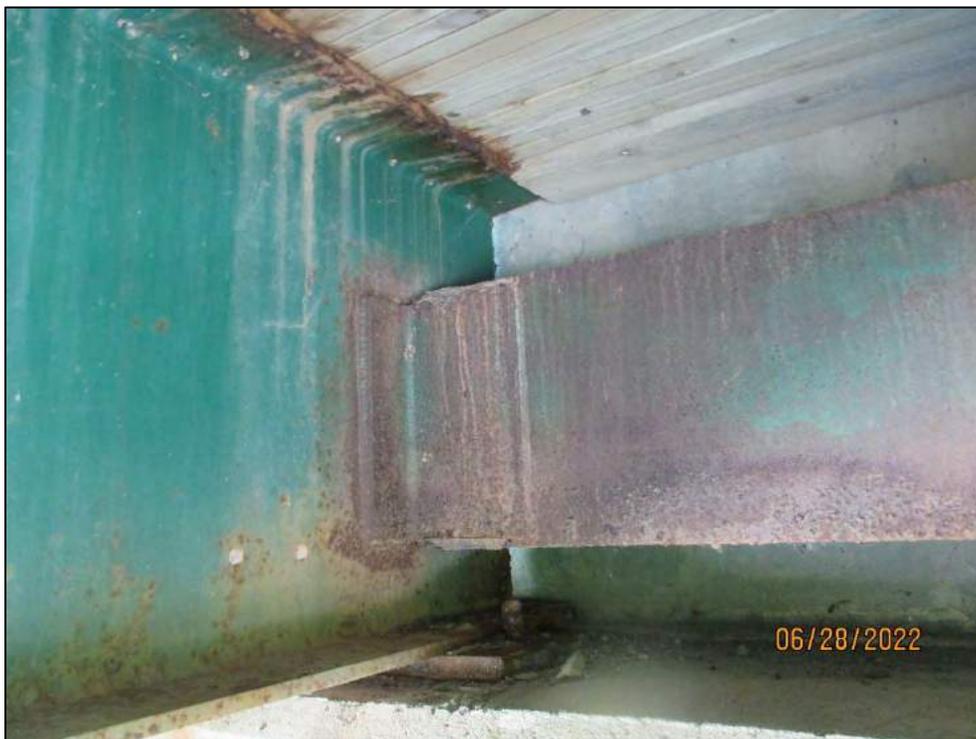
Diaphragm (Typ.)

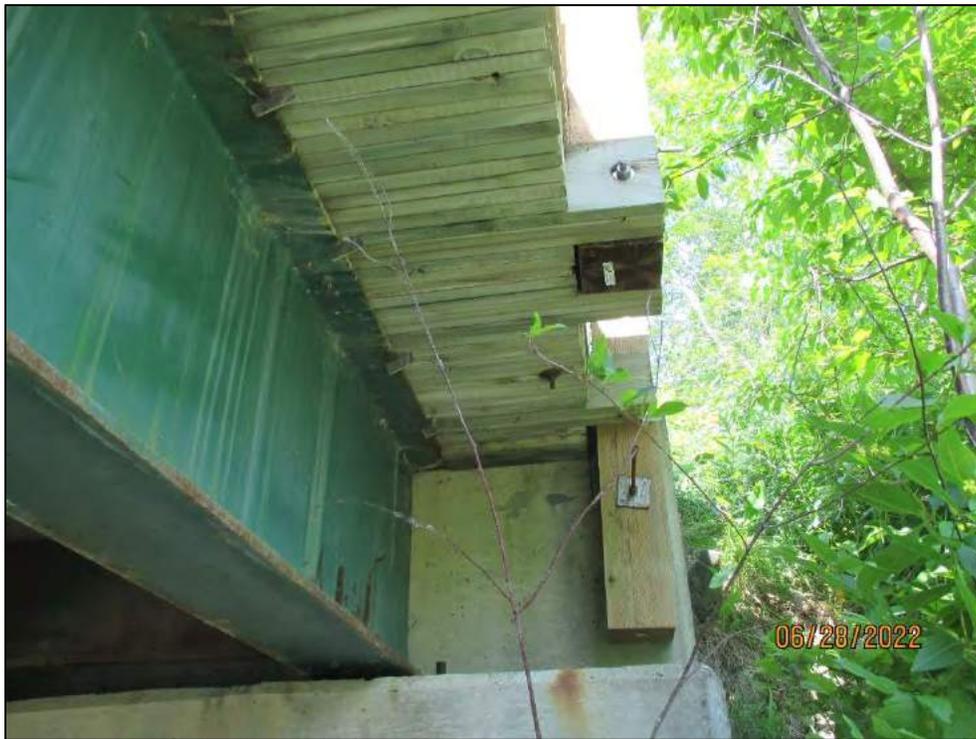
Exterior deck cantilever (Post mount)

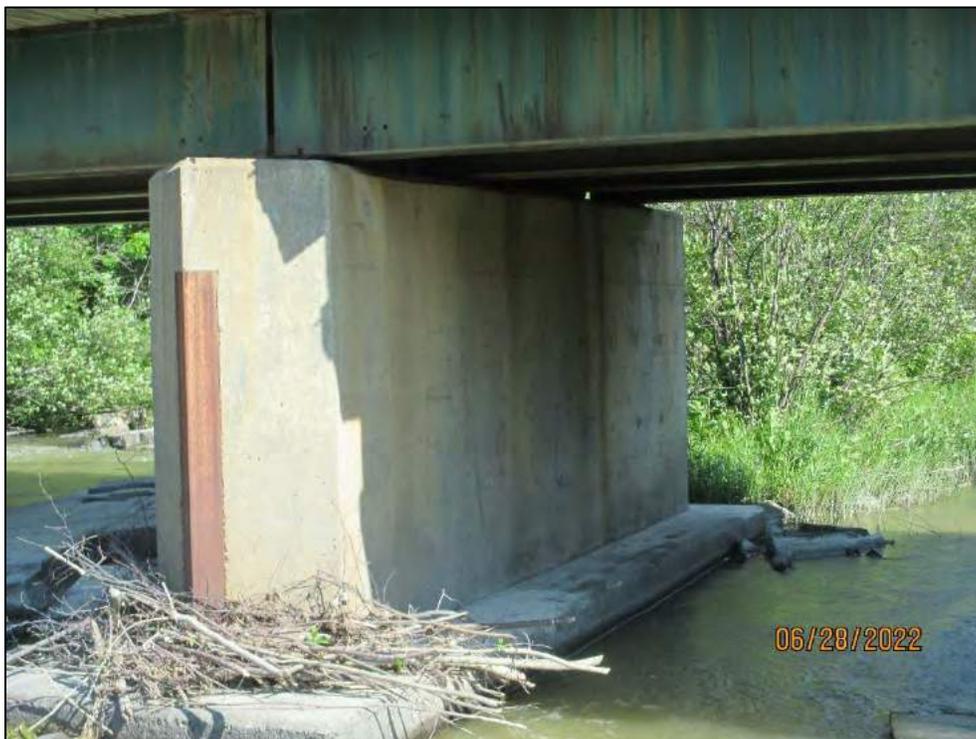
Pier Nosing (Debris)
