**The Corporation of the City of Temiskaming Shores
Regular Meeting of Council
Tuesday, December 20, 2022 – 6:00 p.m.
City Hall – Council Chambers – 325 Farr Drive**

Table 1 - Additional investigation required.....	Error! Bookmark not defined.
Table 2 - Recommended 10-Year Capital Bridge and Culvert Program.....	3

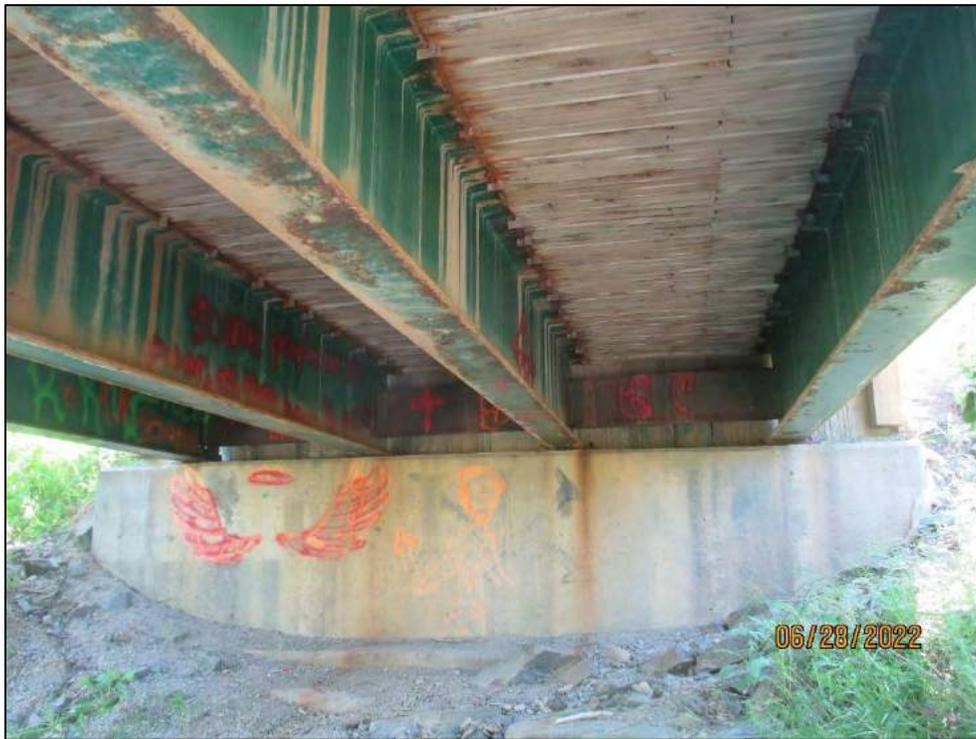
East Abutment

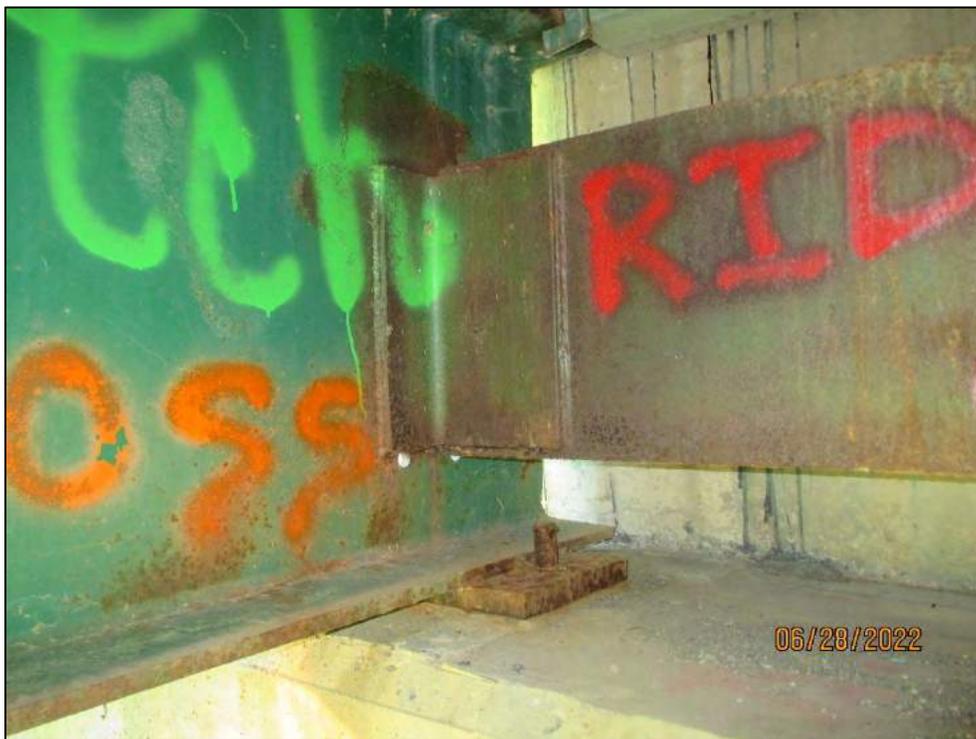
Bearing (Typ.)

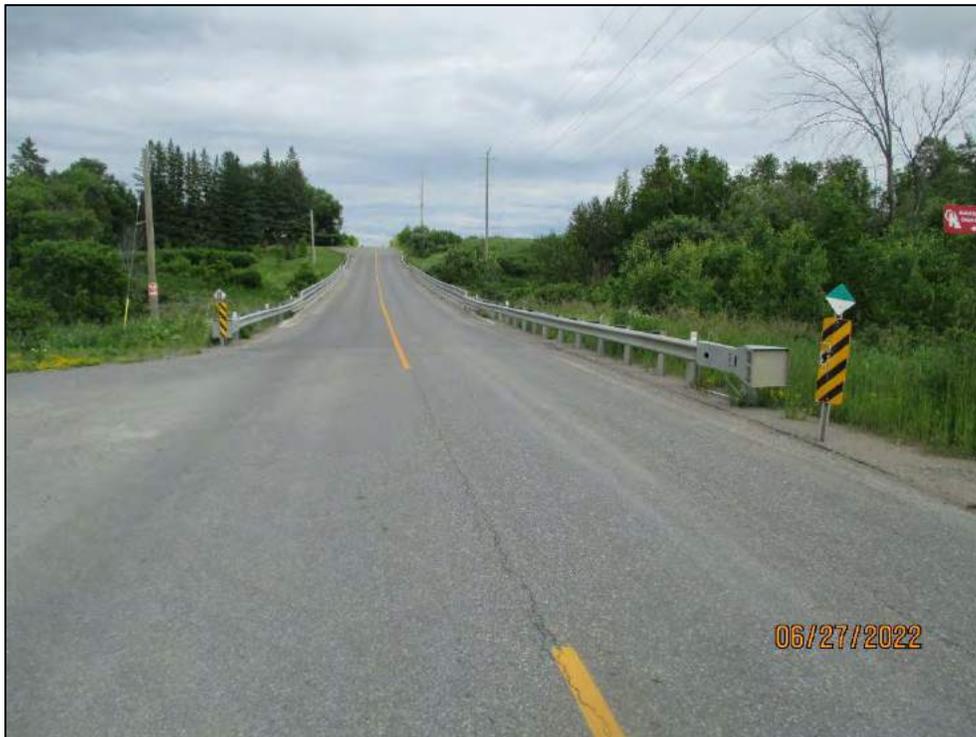
Roadway looking East

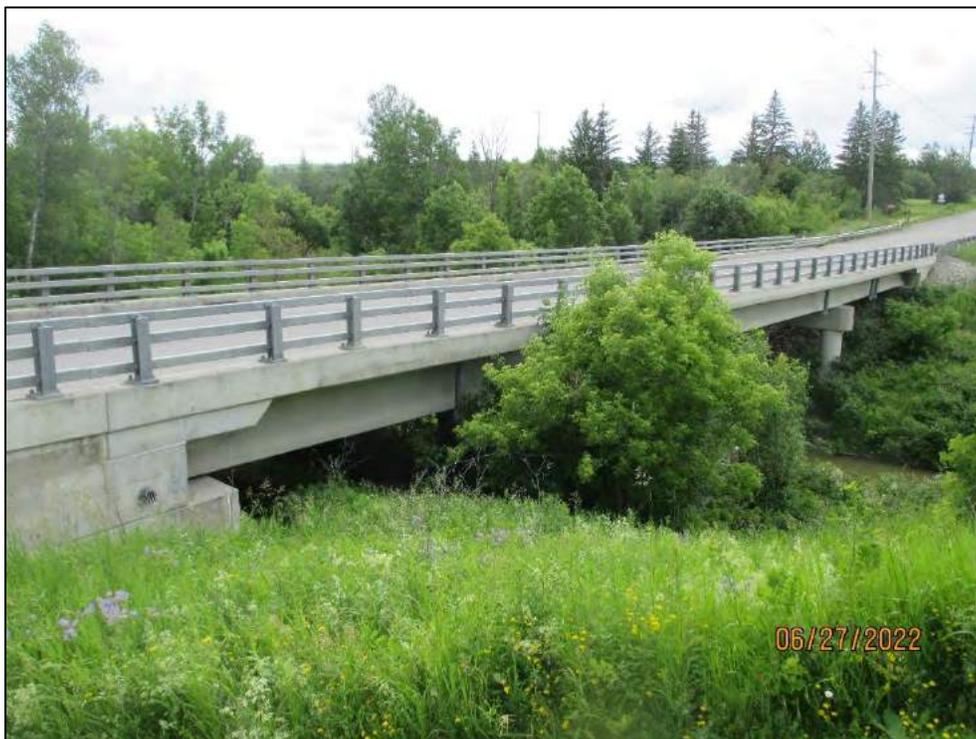
North Elevation

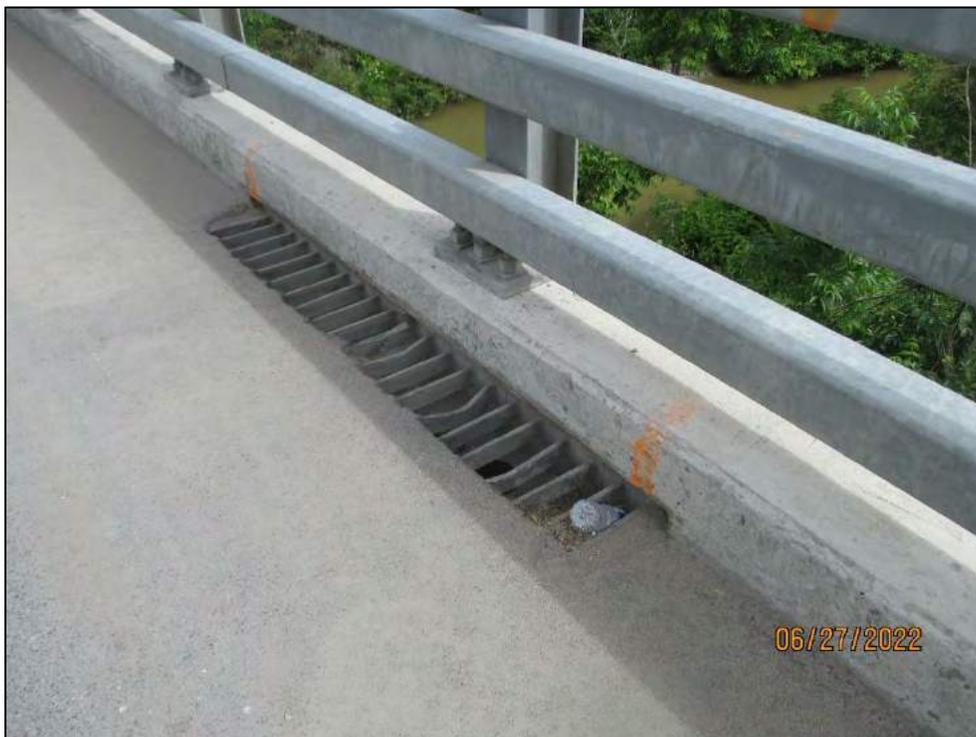
Deck Drain (Double Shown) – Curb – Barrier (Typ.)

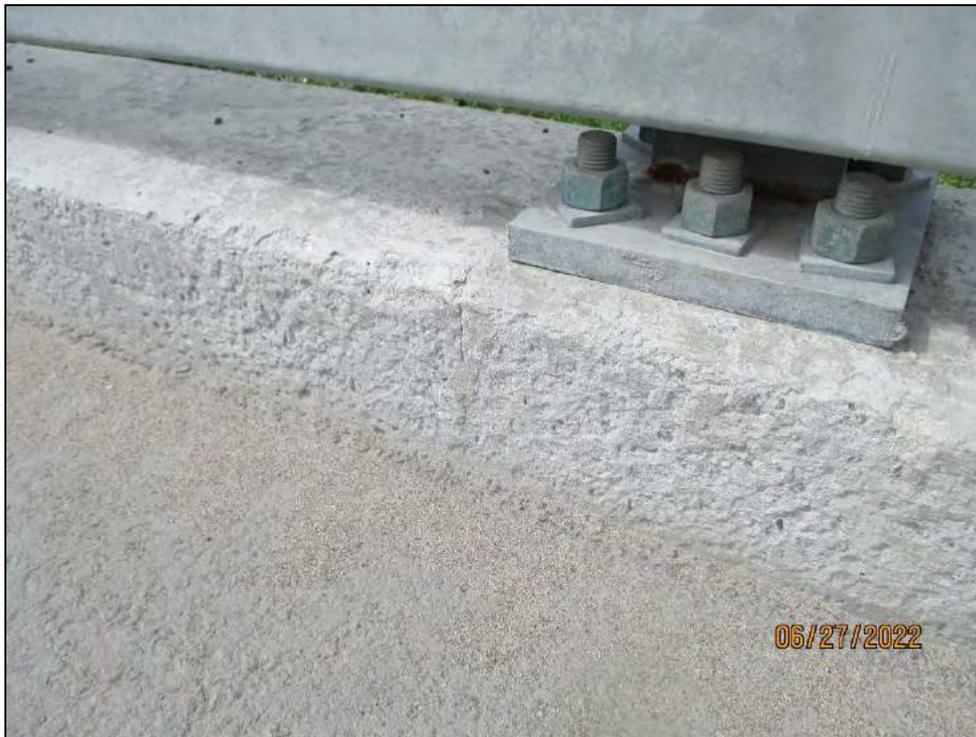
Concrete Scaling – North Curb (Typ.)

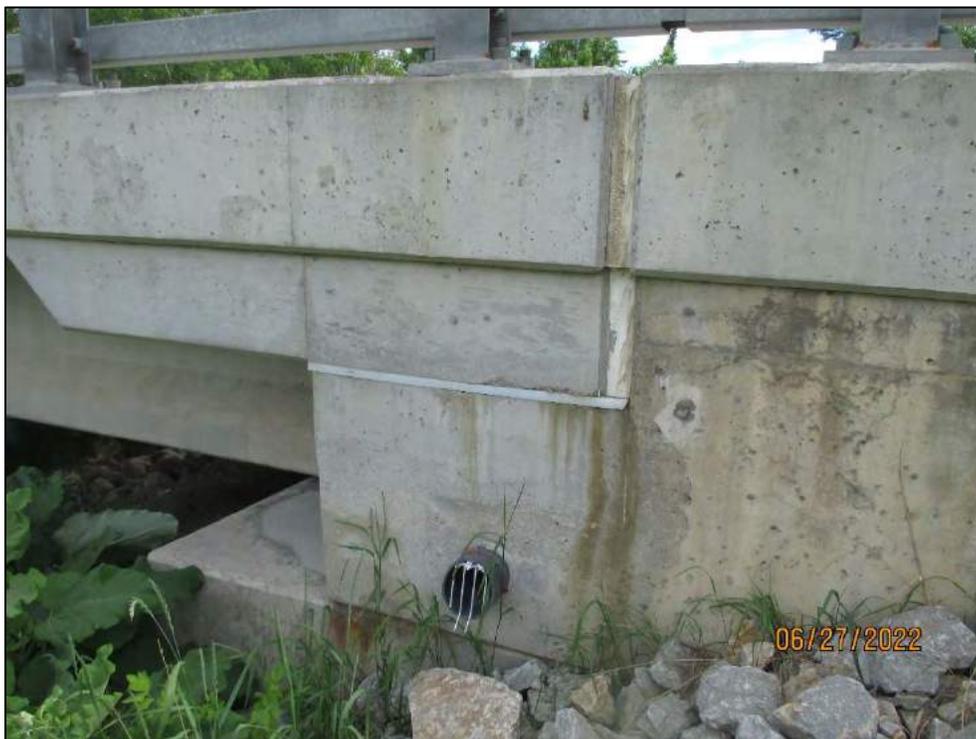
Deck End / Wingwall Details (Typ.)

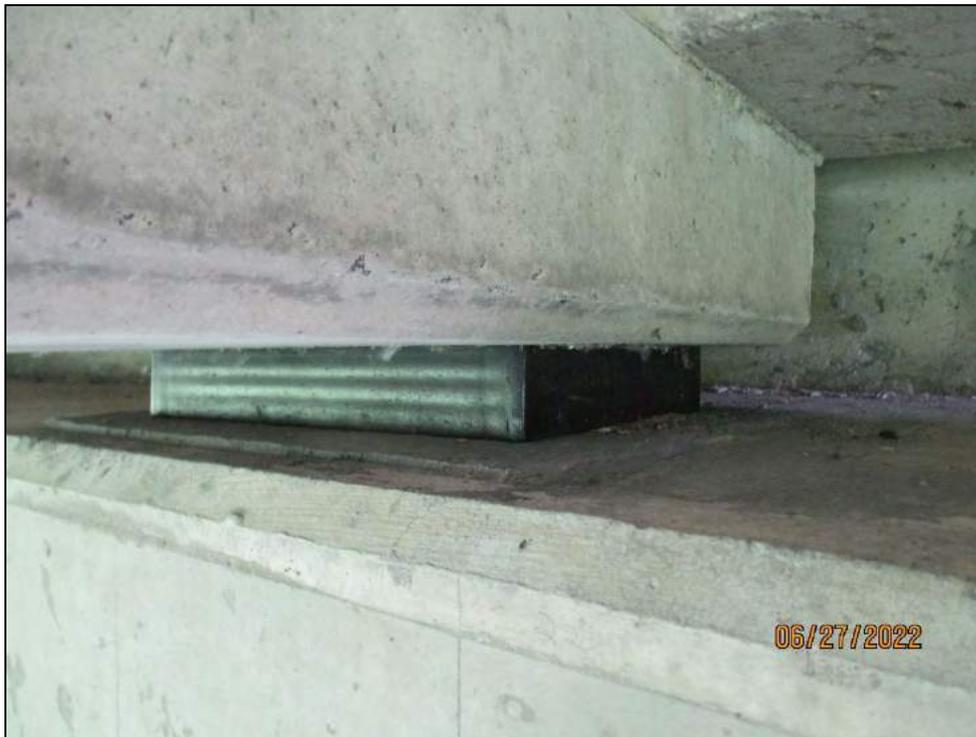
Abutment Bearing (Typ.)

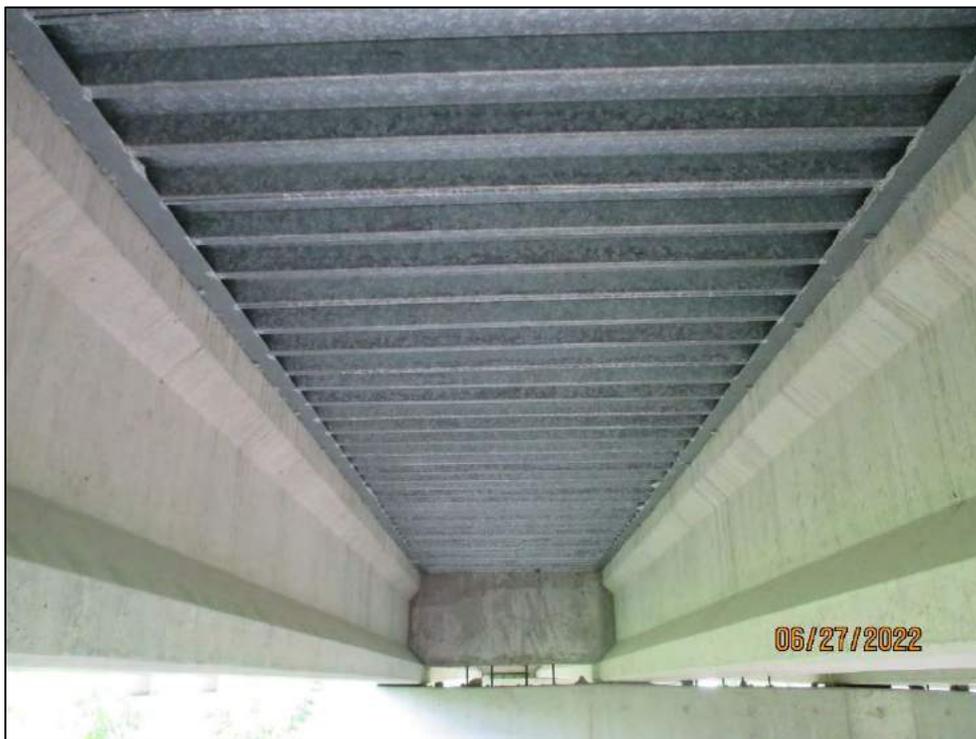
Deck Soffit (Interior) – Note: Stay-In-Place Form (Typ.)

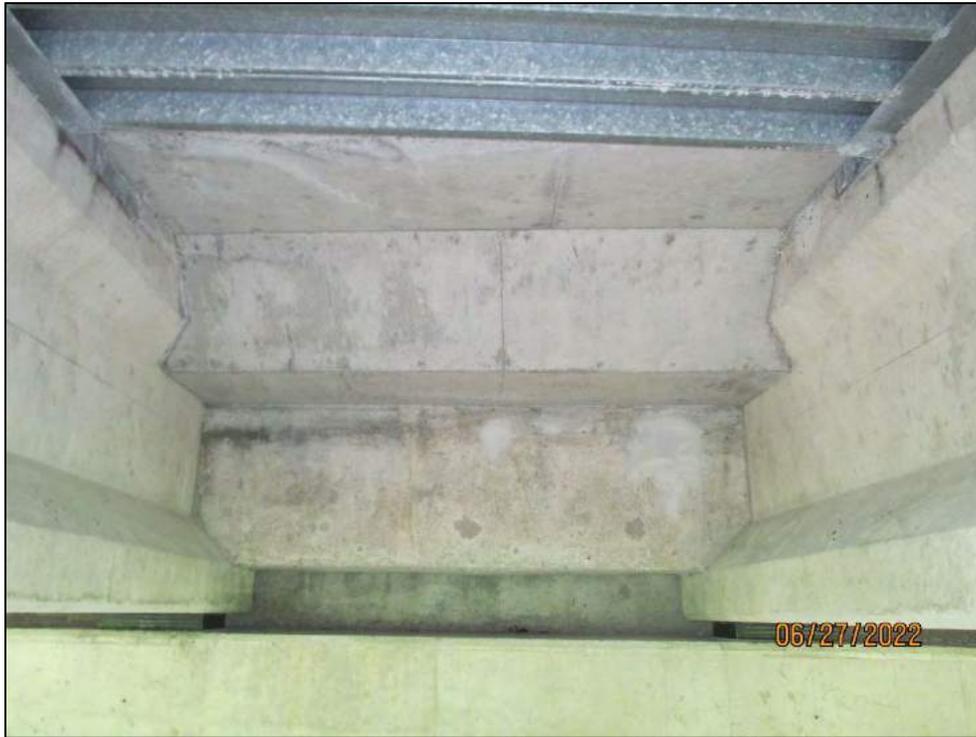
Deck End Diaphragm (Typ.)

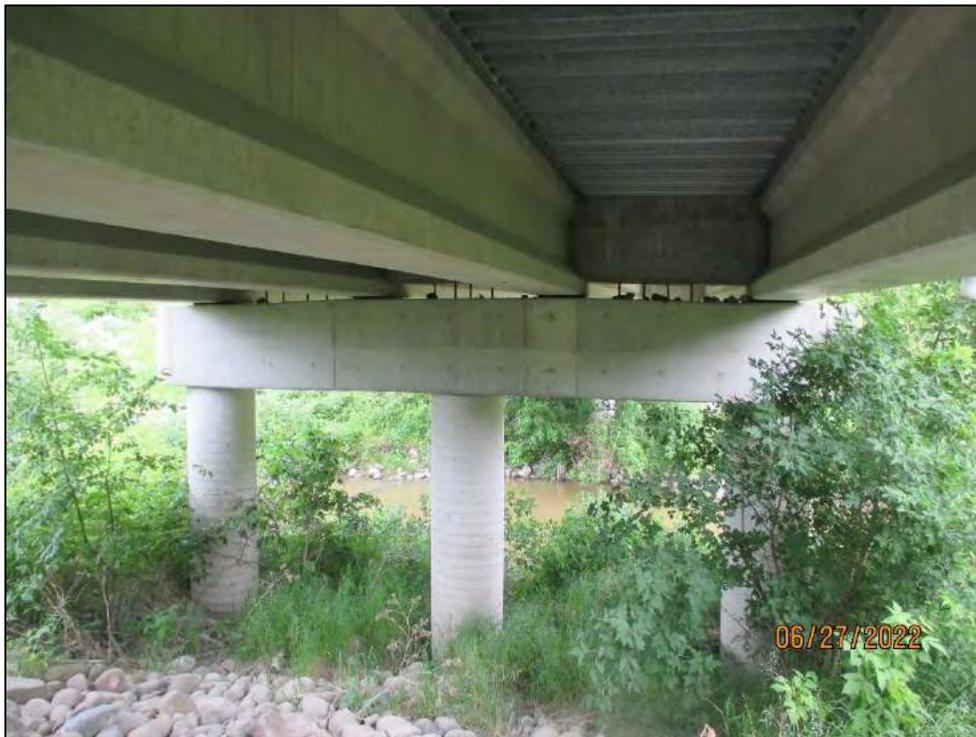
Pier Bent (Typ.)

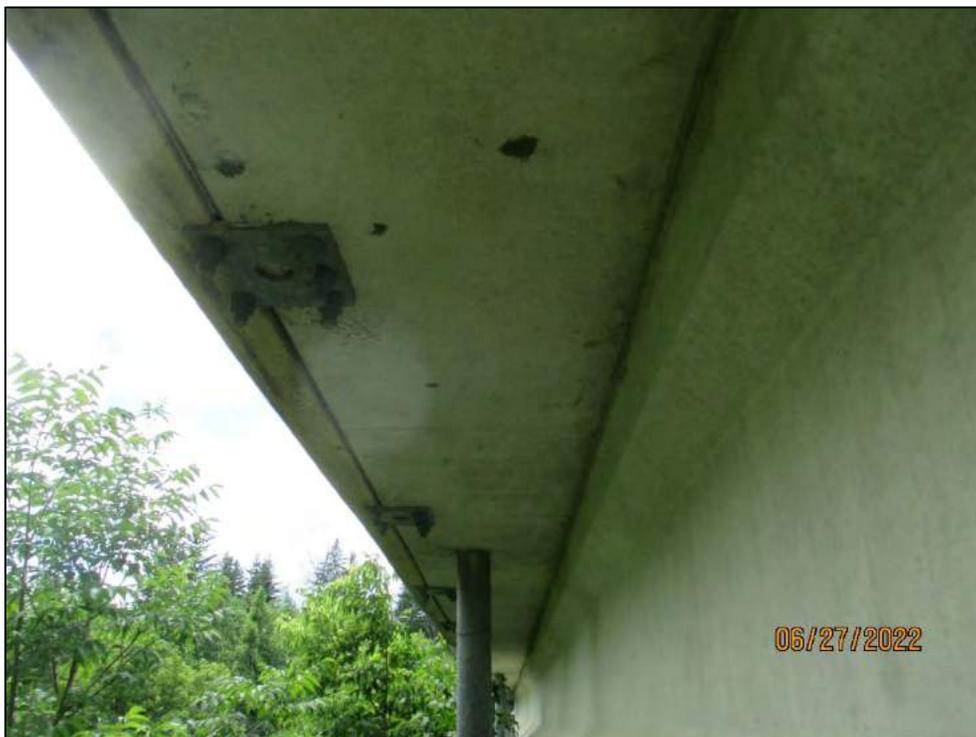
Deck Exterior Soffit – Note: Barrier Anchorages (Typ.)

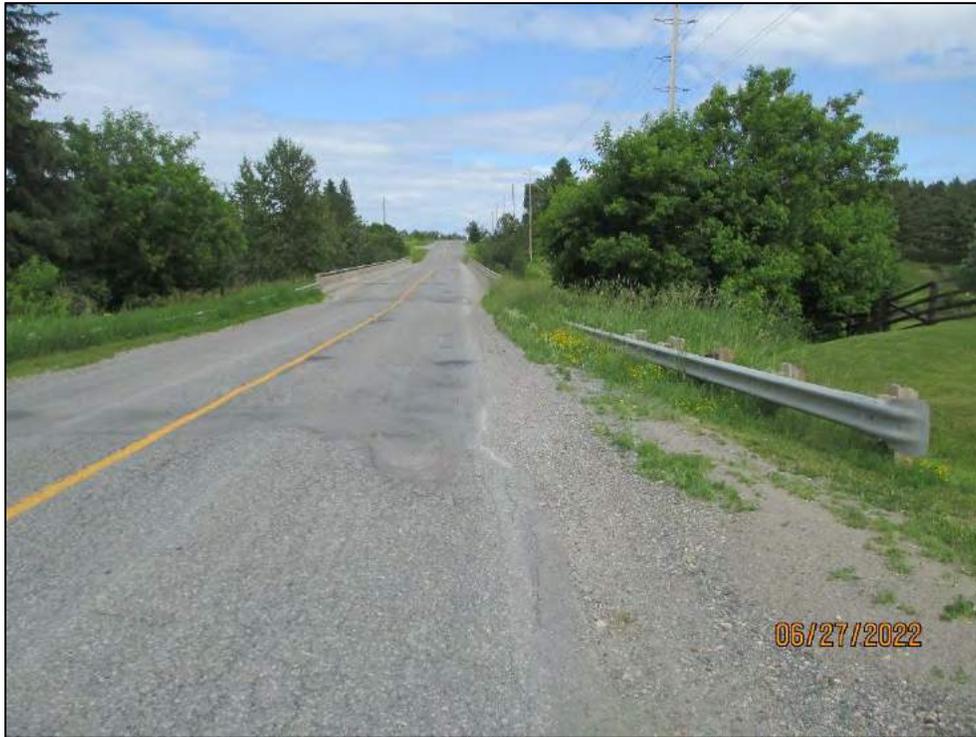
Roadway looking East

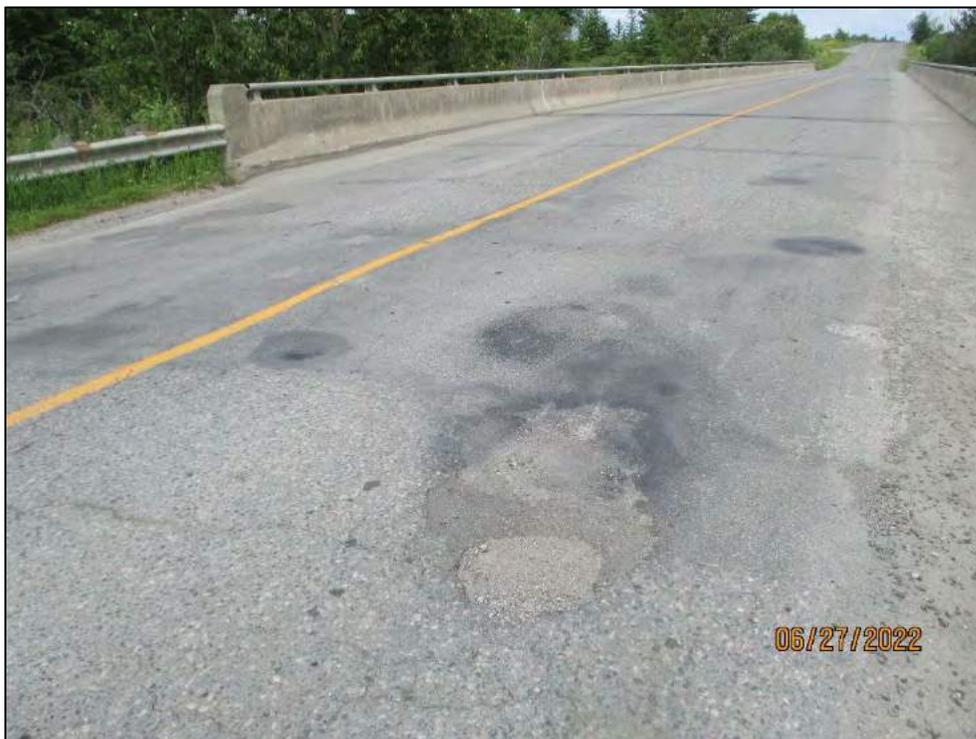
Bridge Approach (West End) – Typ.

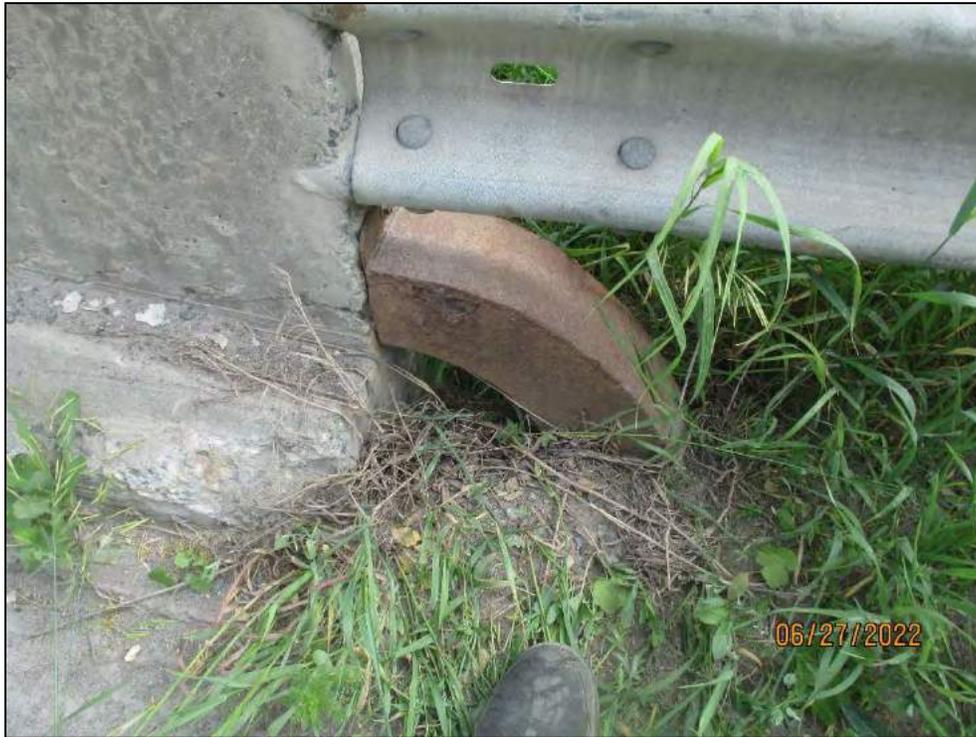
Utility Duct Sweep – South Wingwalls (Each End)

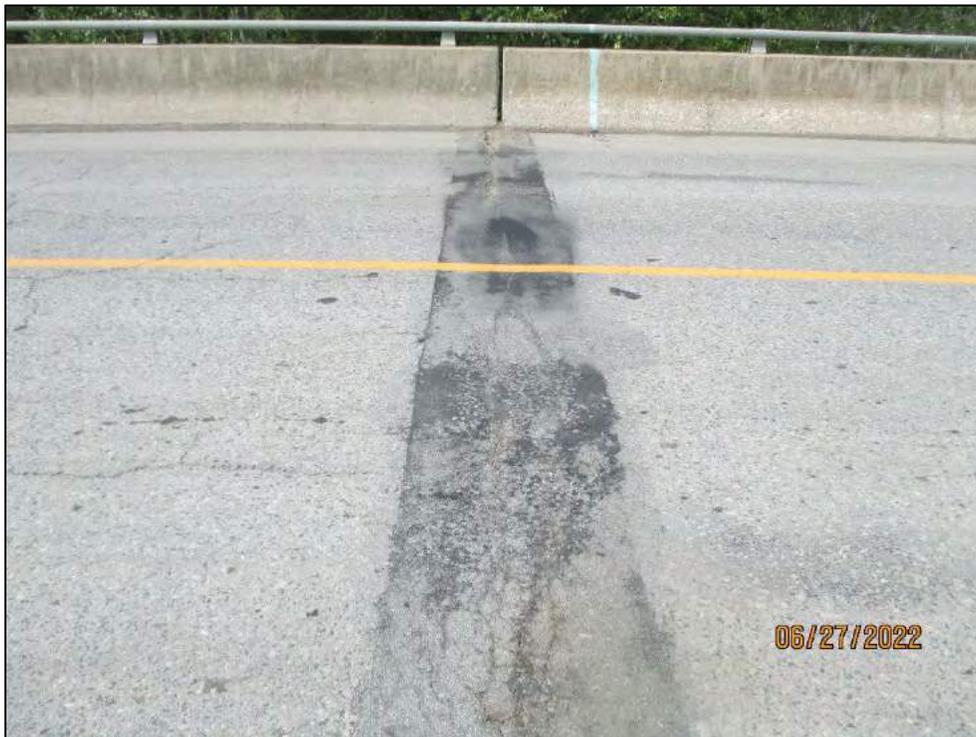
Expansion Joint (Typ.)

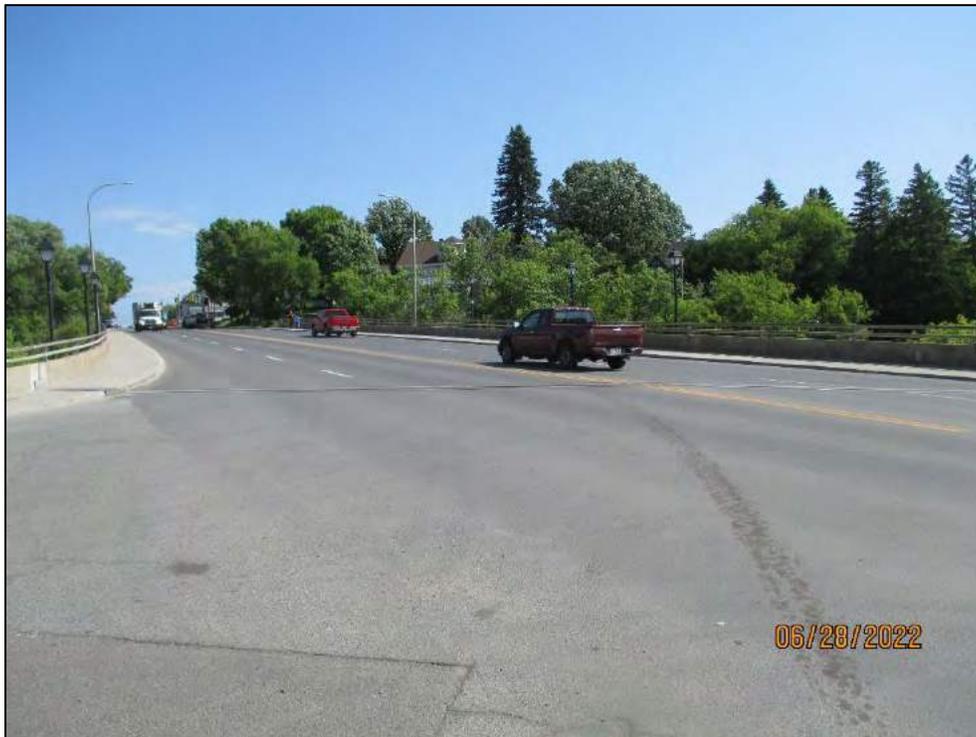
Roadway looking north

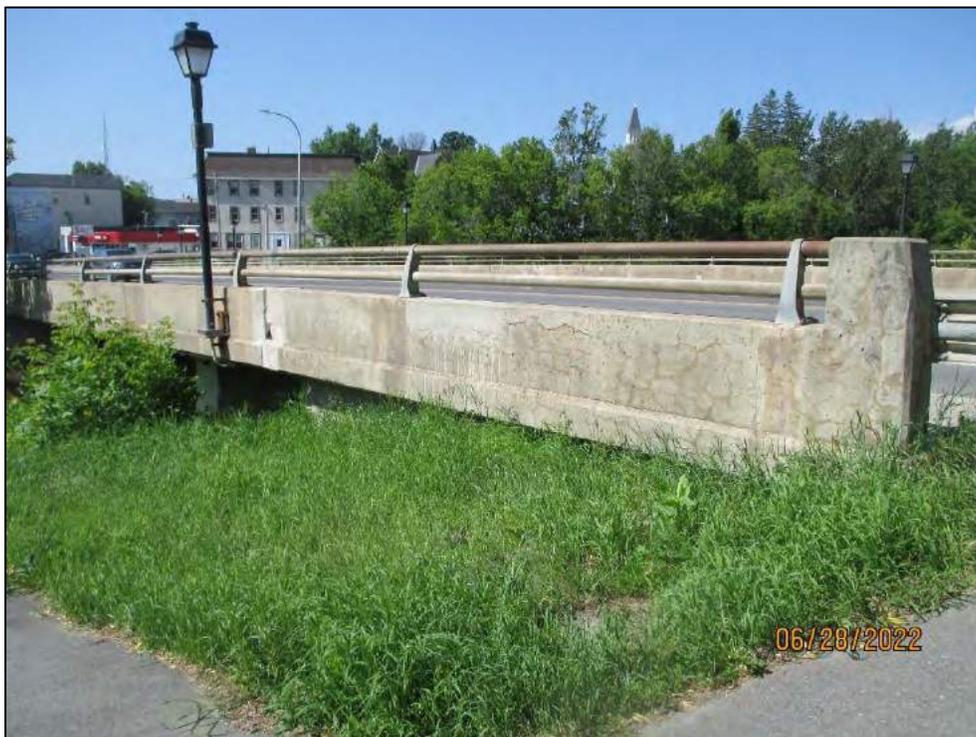
East elevation

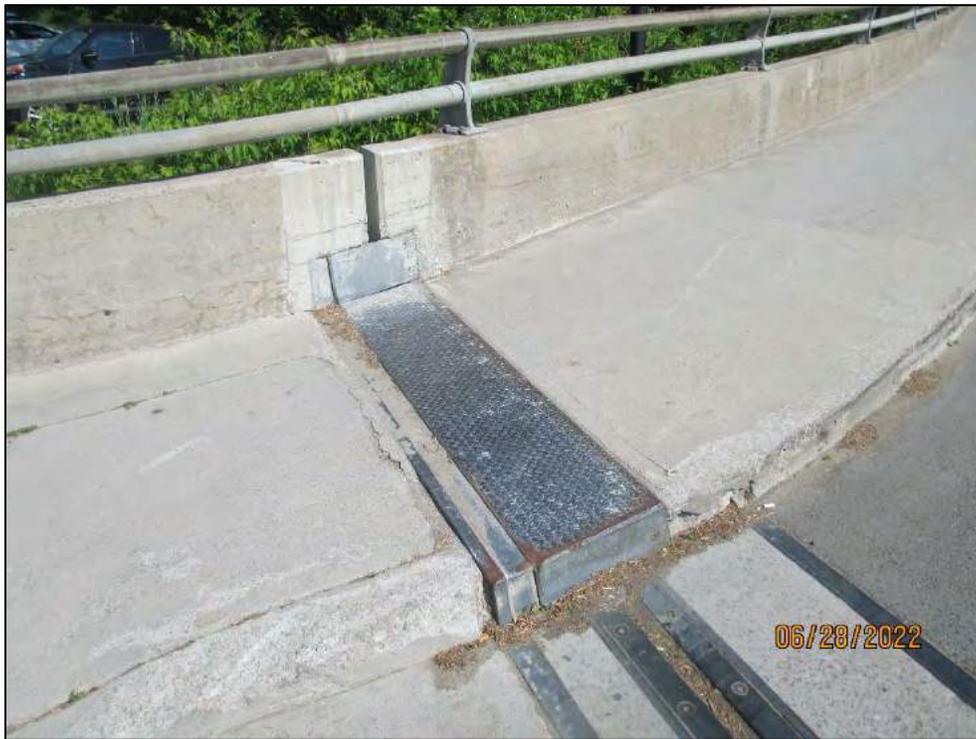
Expansion Joint (Cover Plate) – S/W

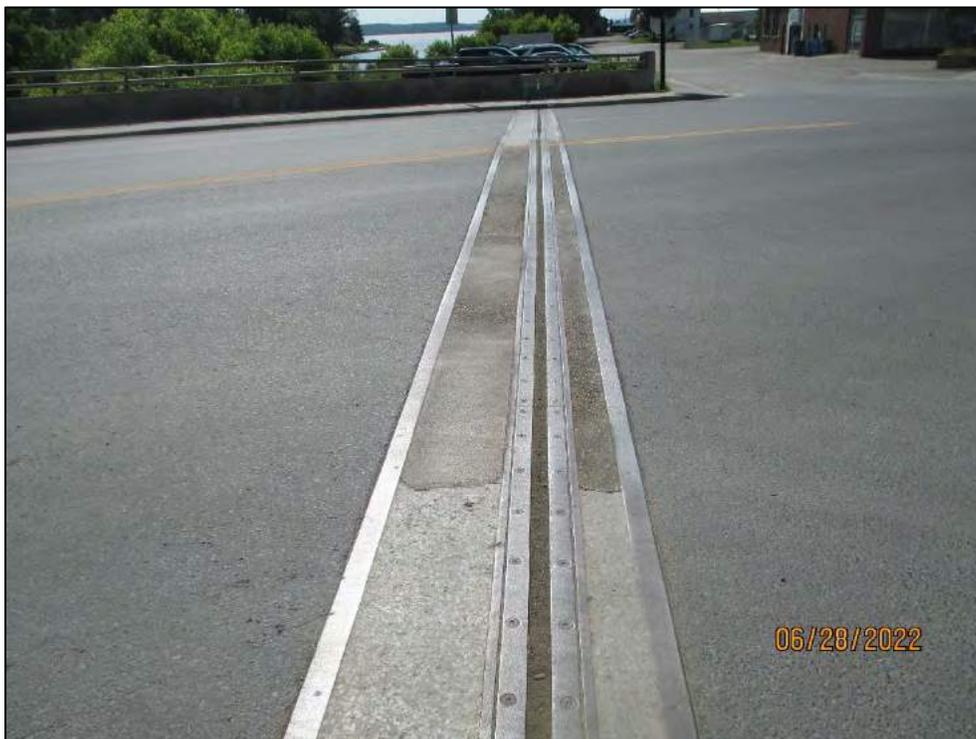
Expansion Joint (South)

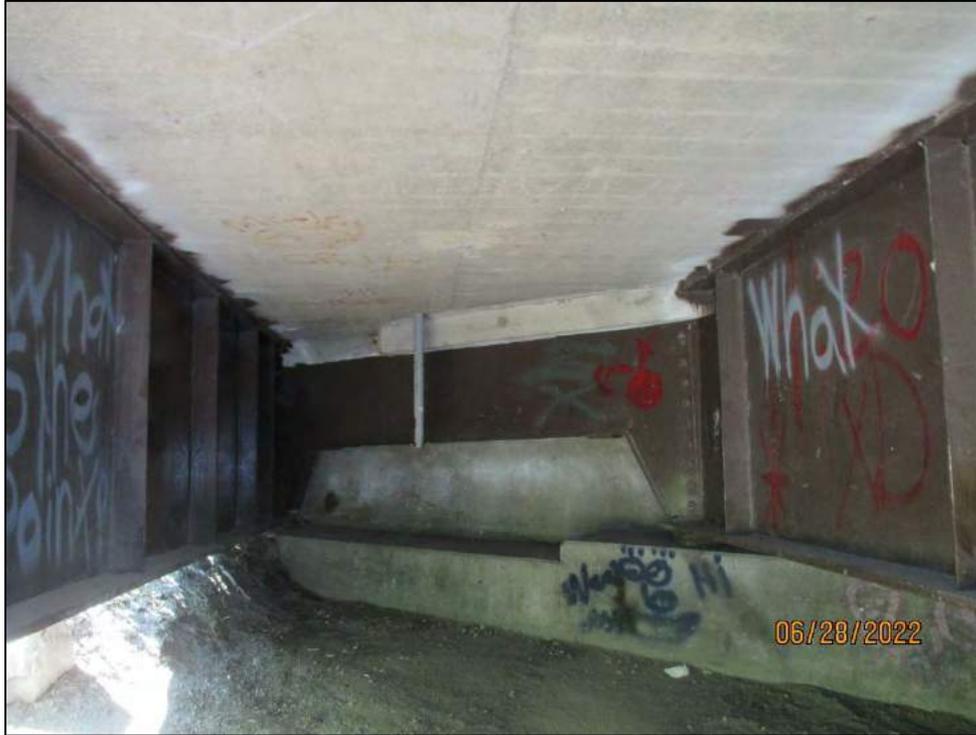
Deck End Soffit (Interior) – Typ.

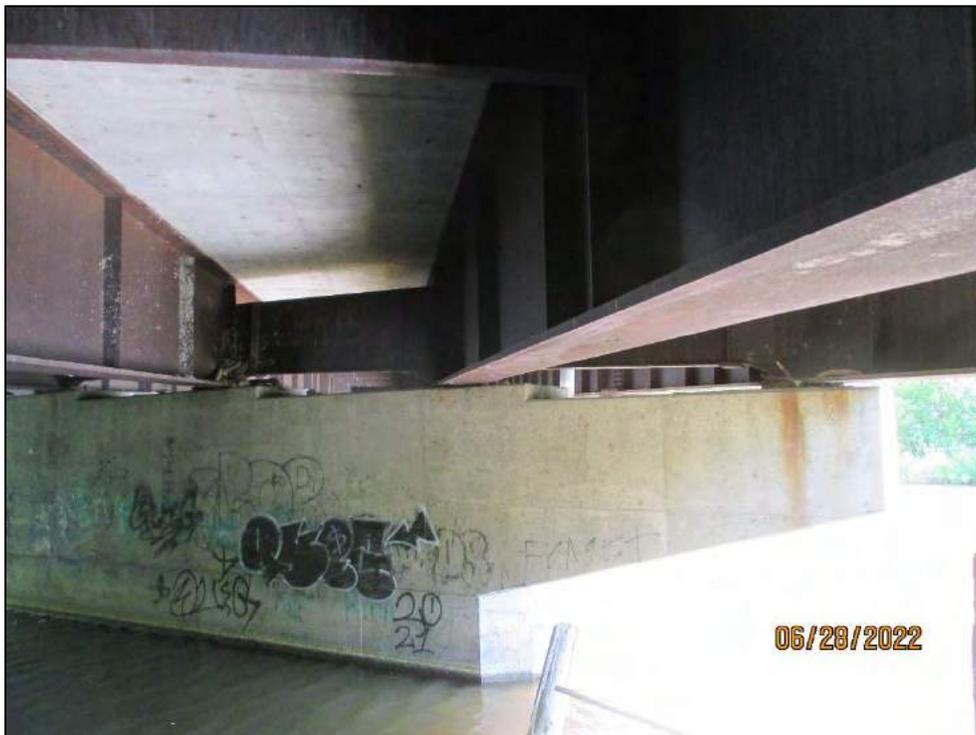
Pier (S/E)

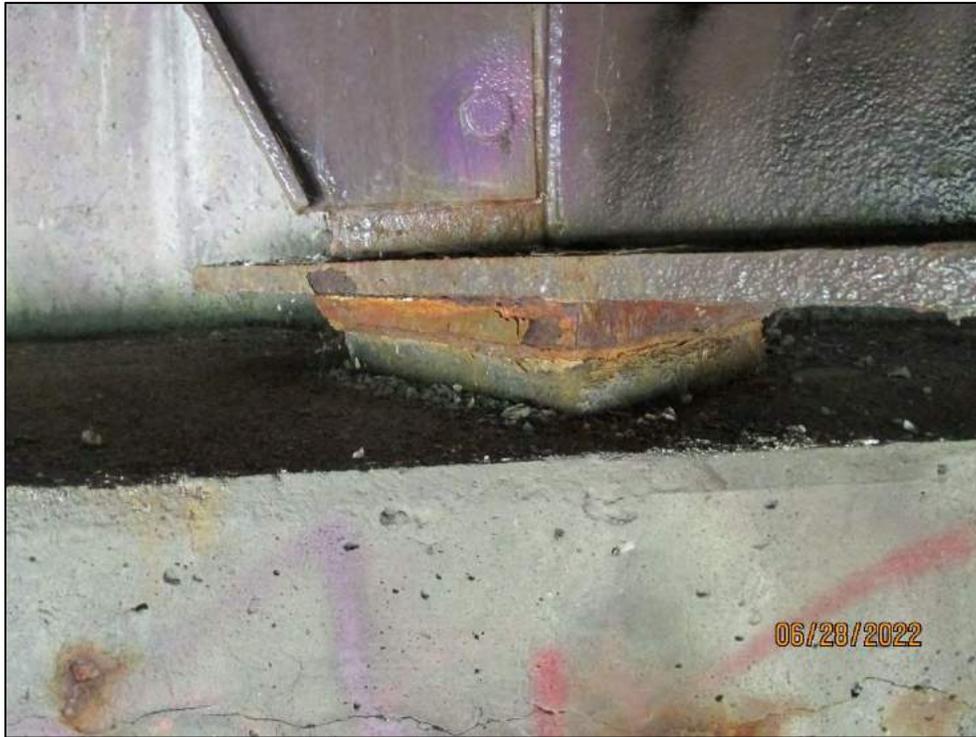
Abutment Bearing (South) – Typ.

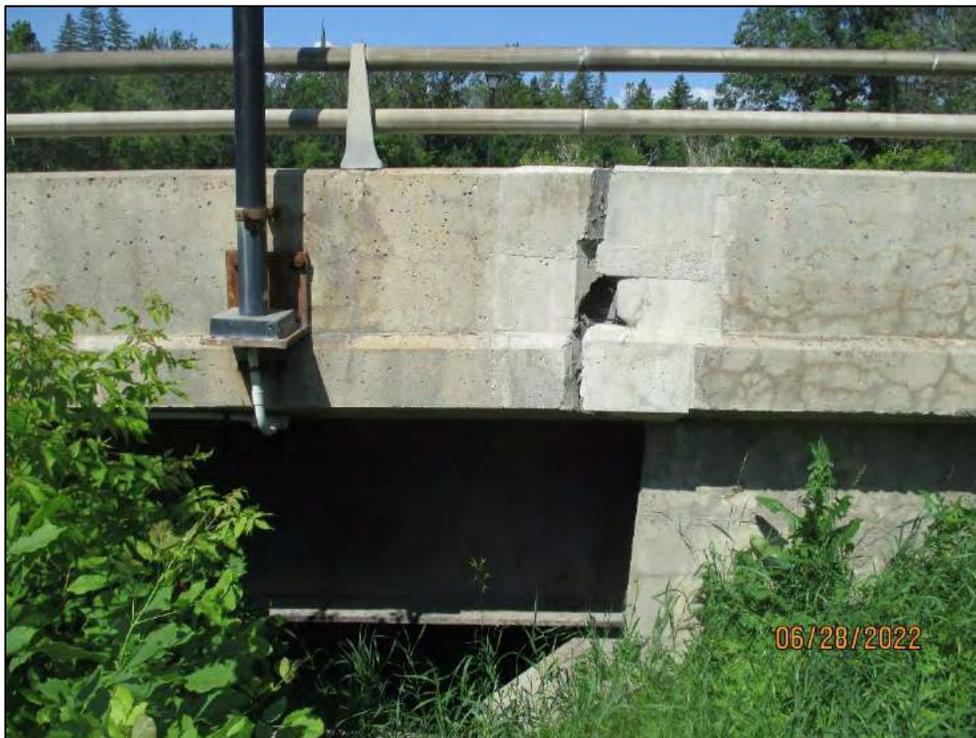
Parapet / Expansion Joint (Typ.)

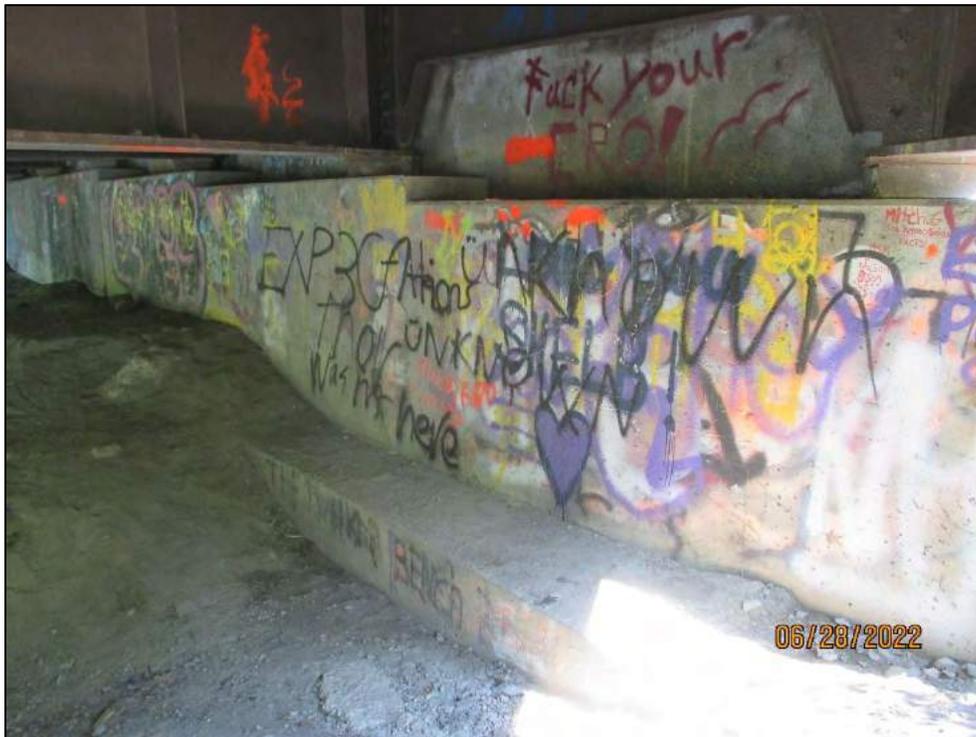
North Abutment

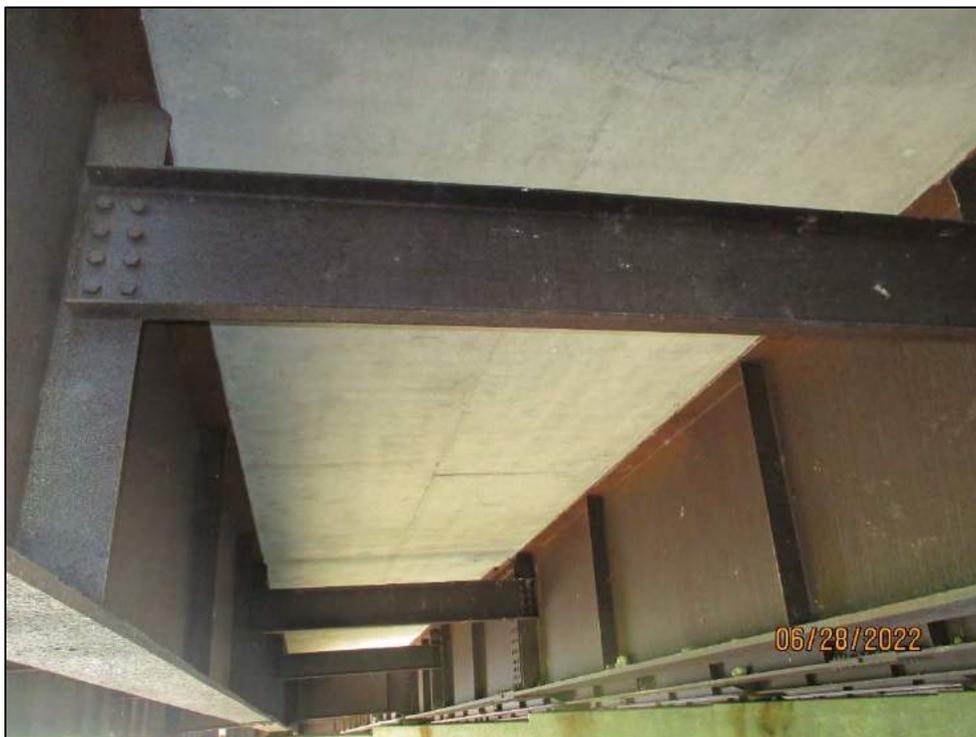
Deck Soffit (Interior) – Typ.

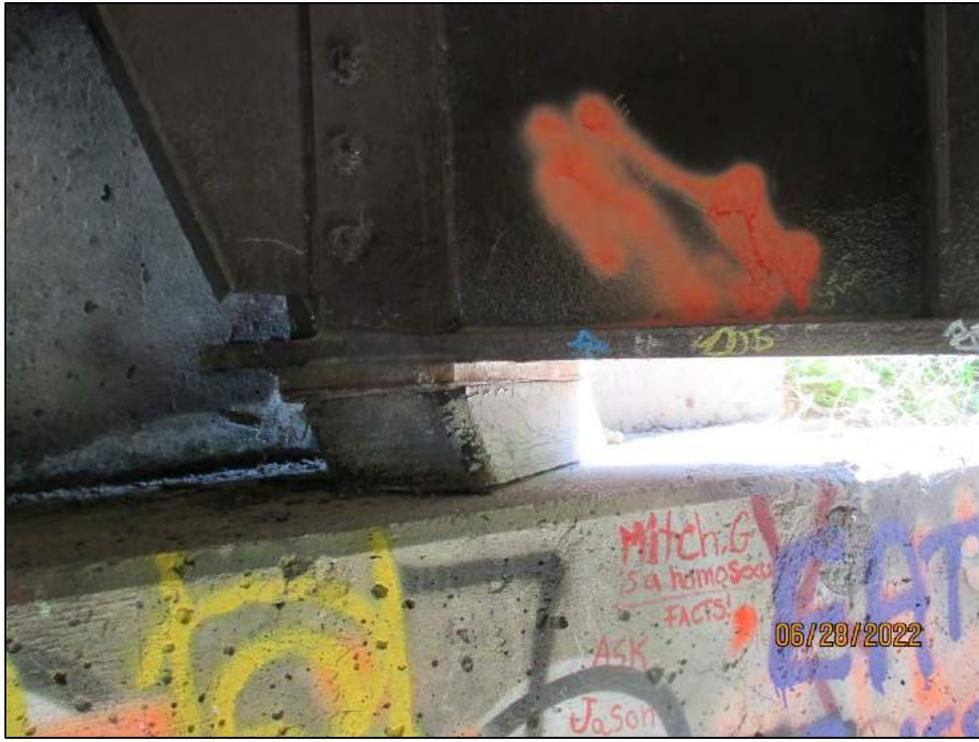
Bearing at N/E

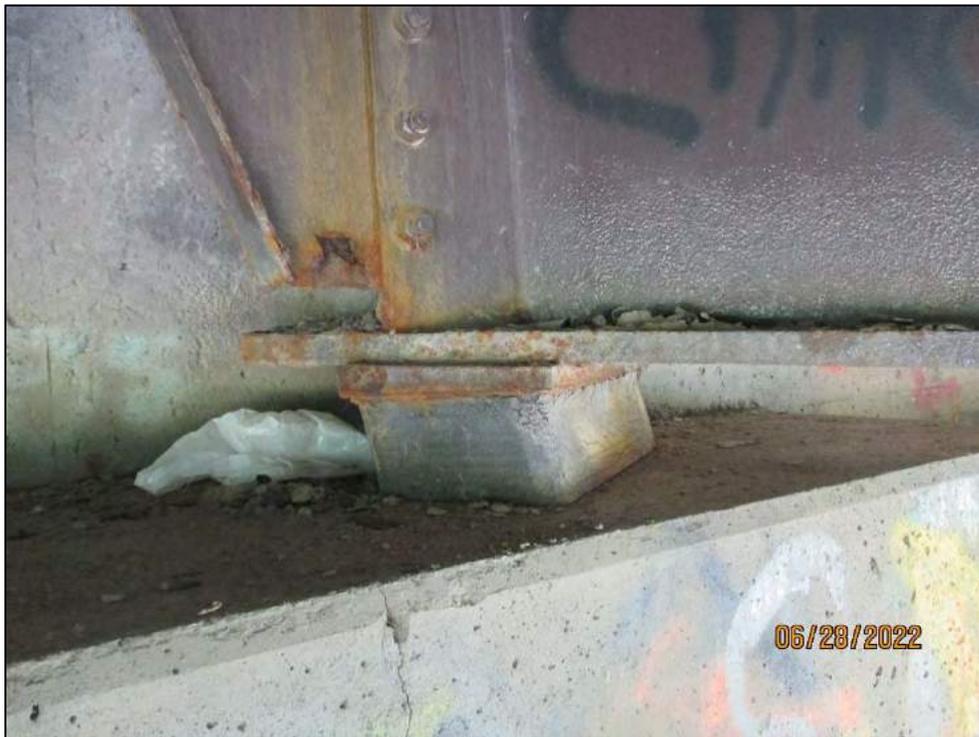
North Abutment Bearing (Typ.)

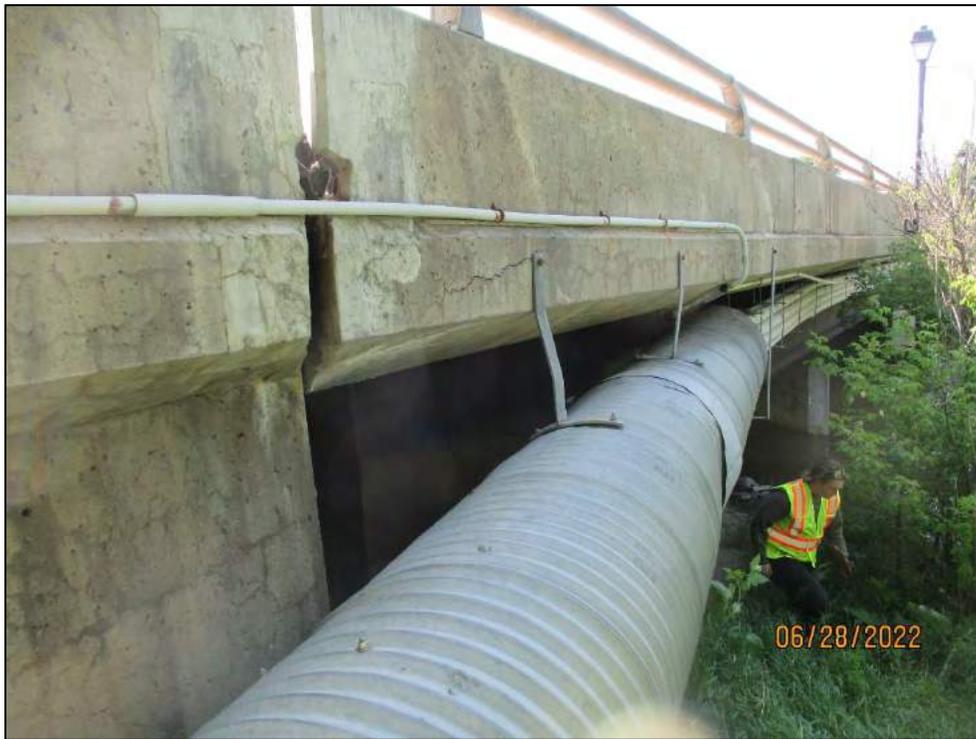
Utility Duct (N/W looking south)

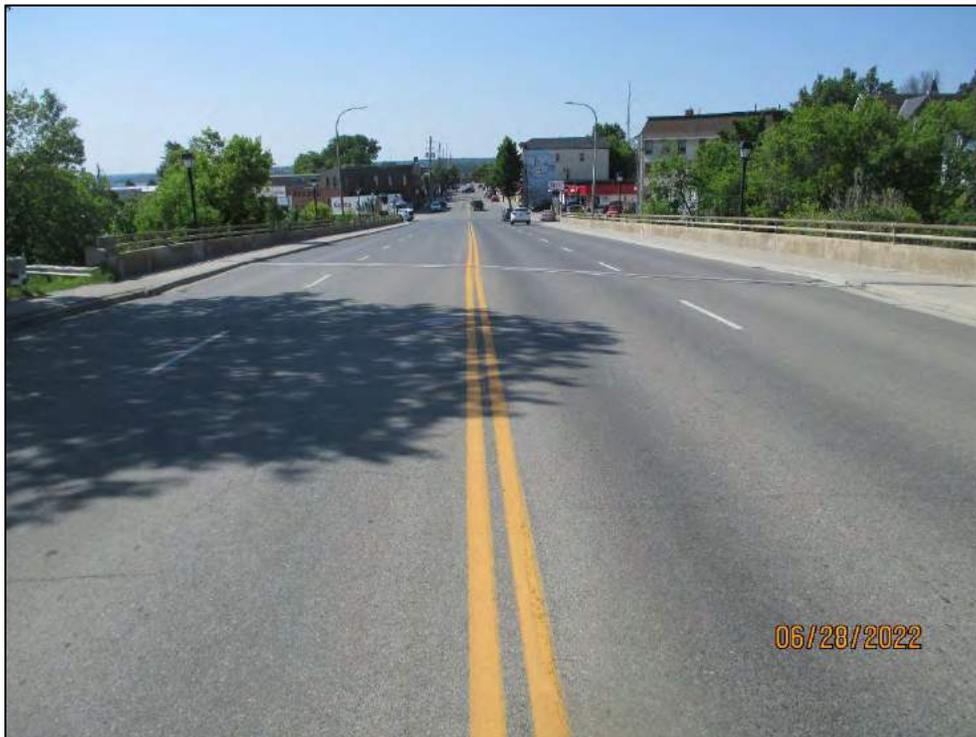
Roadway looking south

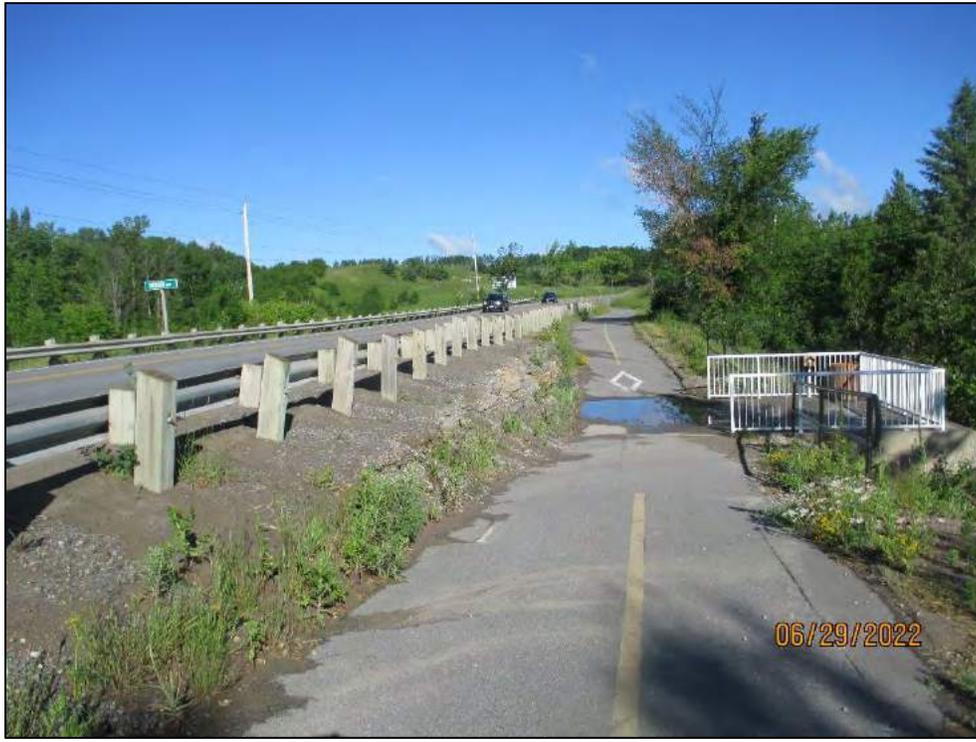
Roadway looking west

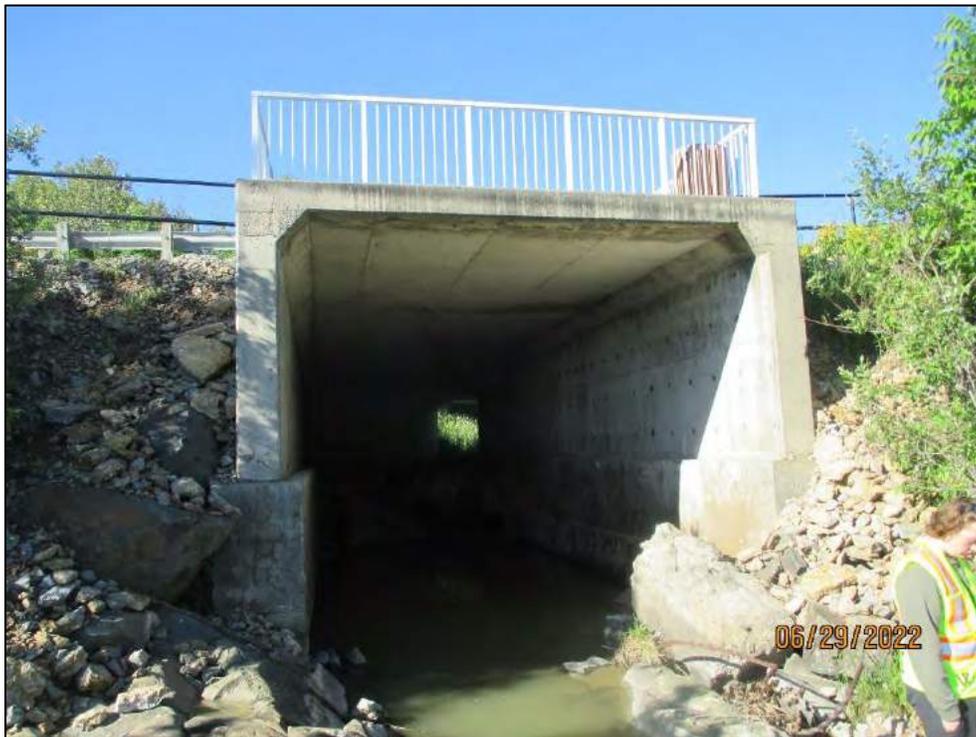
North (Outlet) Elevation
