**The Corporation of the City of Temiskaming Shores
Regular Meeting of Council
Tuesday, December 20, 2022 – 6:00 p.m.
City Hall – Council Chambers – 325 Farr Drive**

Table 1 - Additional investigation required.....	Error! Bookmark not defined.
Table 2 - Recommended 10-Year Capital Bridge and Culvert Program.....	3

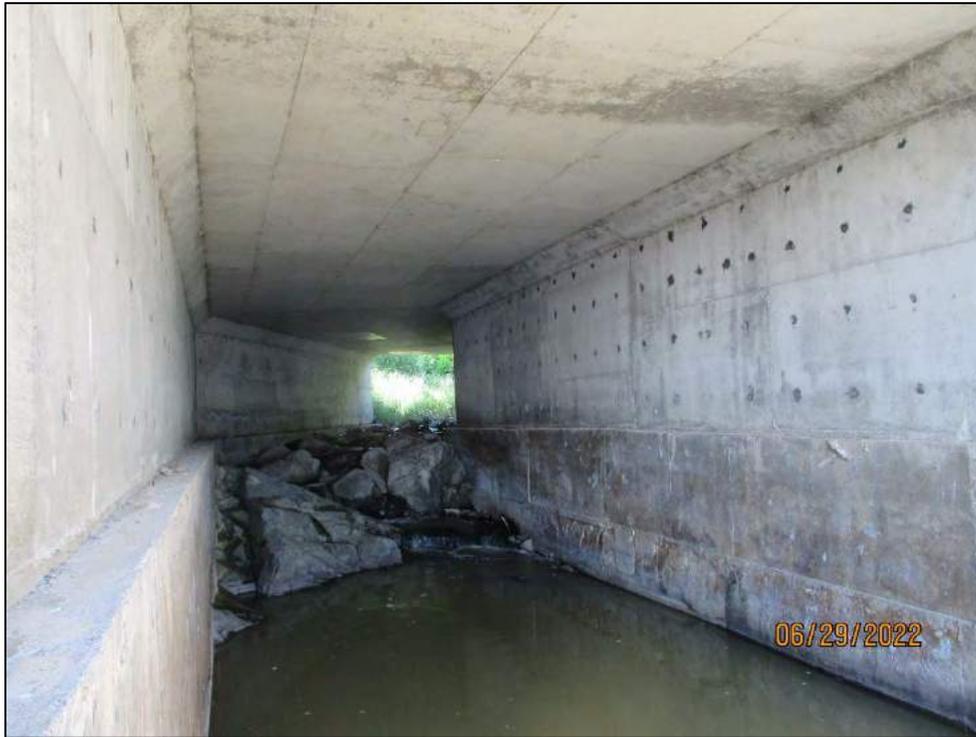
Culvert Barrel (Typ.)

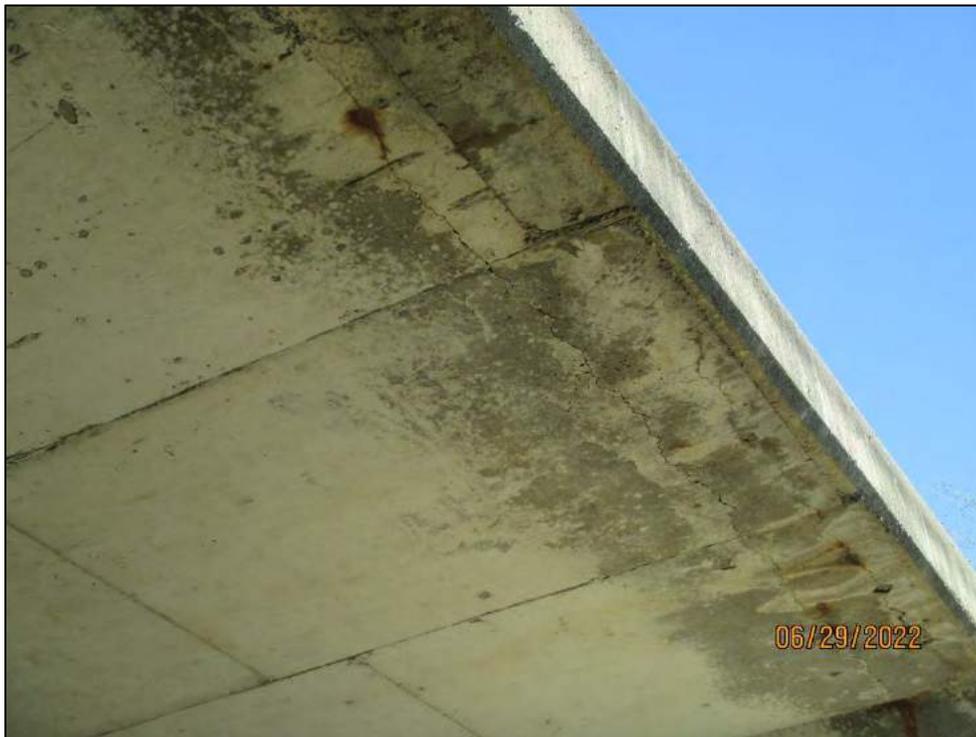
Culvert Soffit (Outlet)

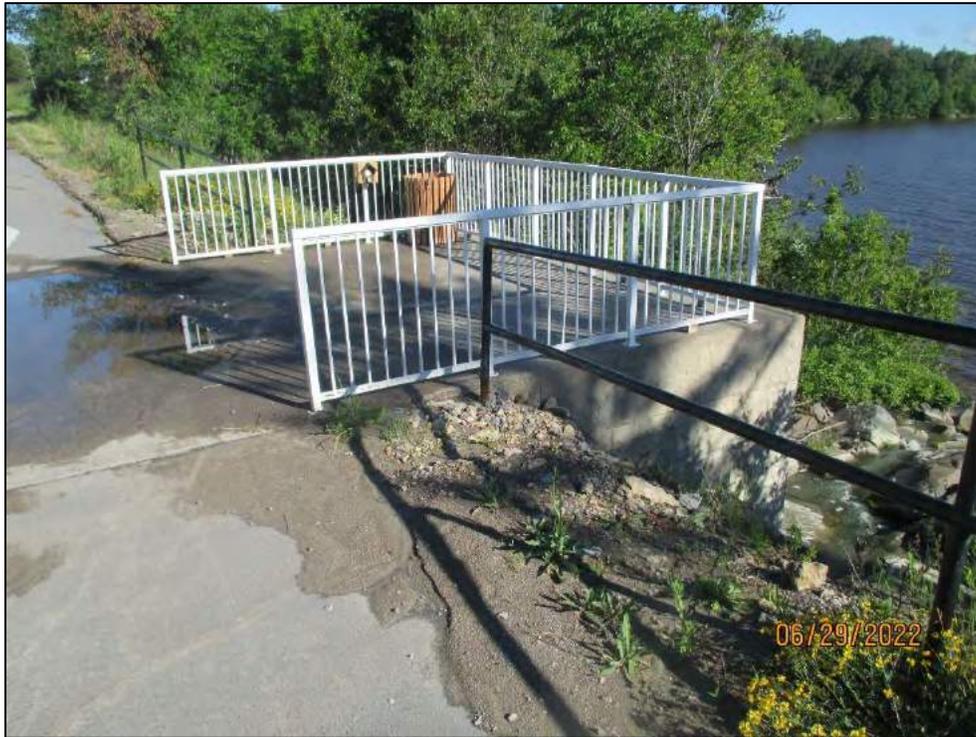
Railings at Lookout (and along path)

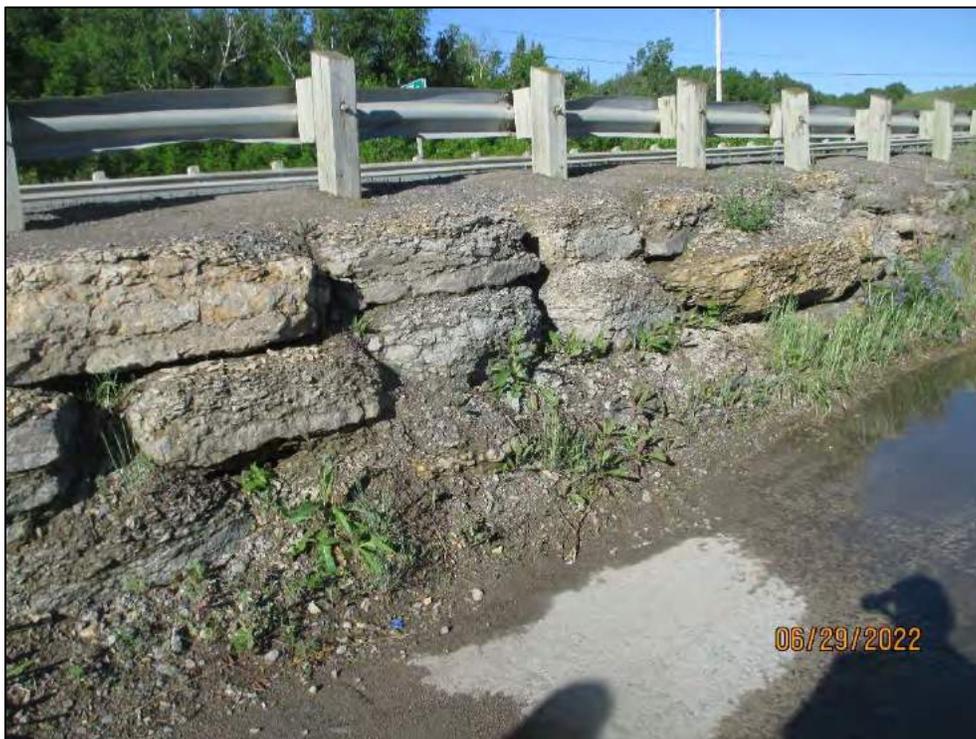
Retaining Wall (between road and path)

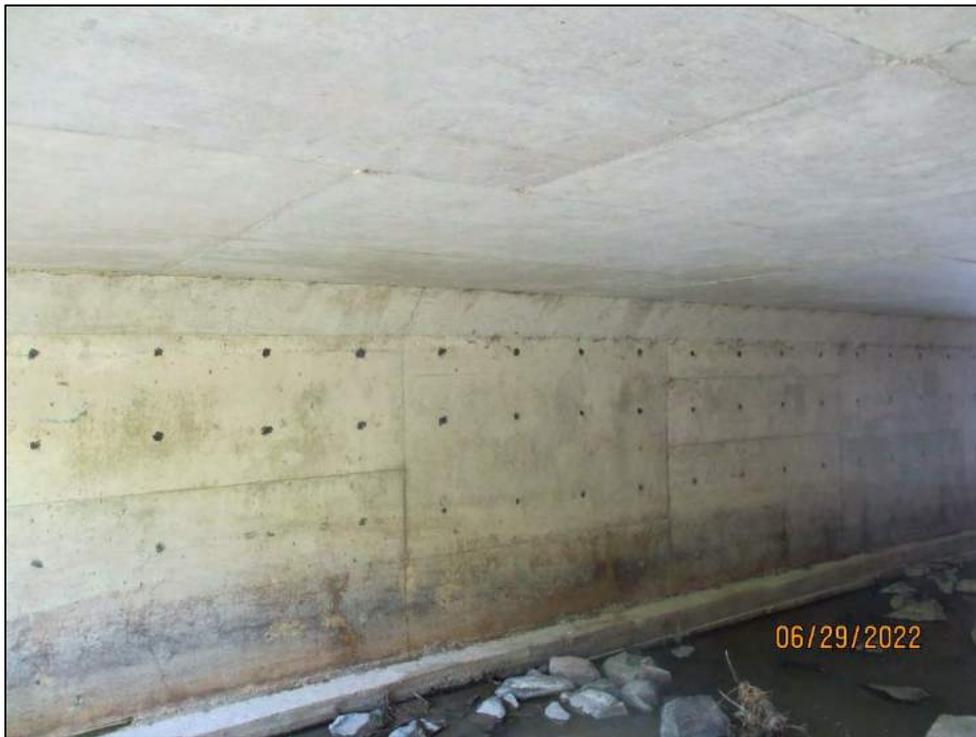
Culvert Barrel (Typ.)

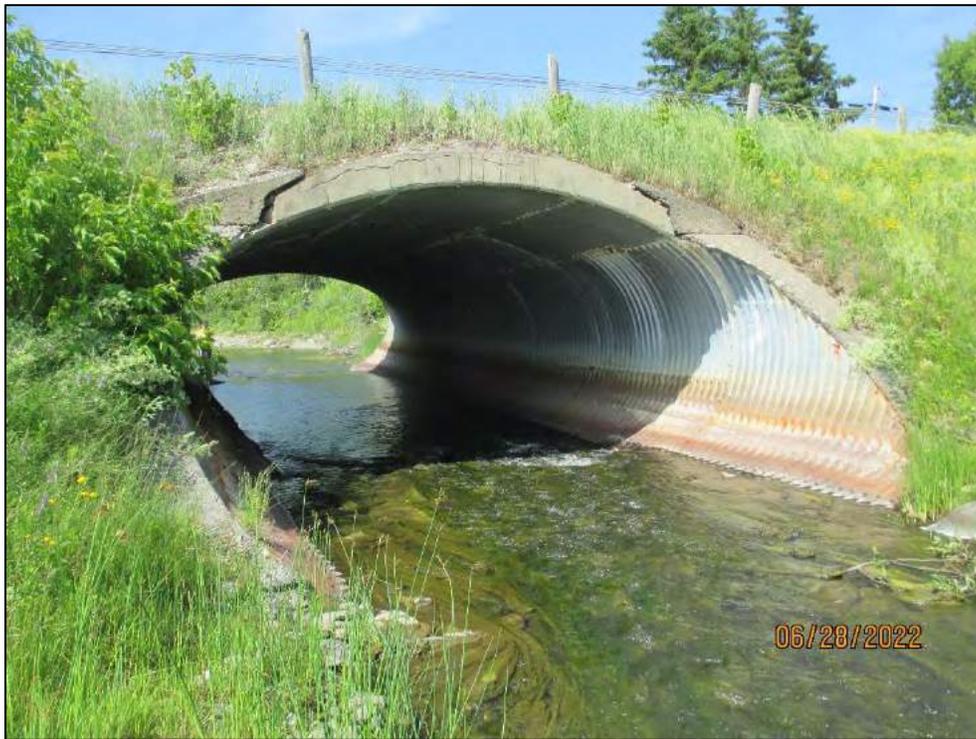
South Elevation (Inlet)

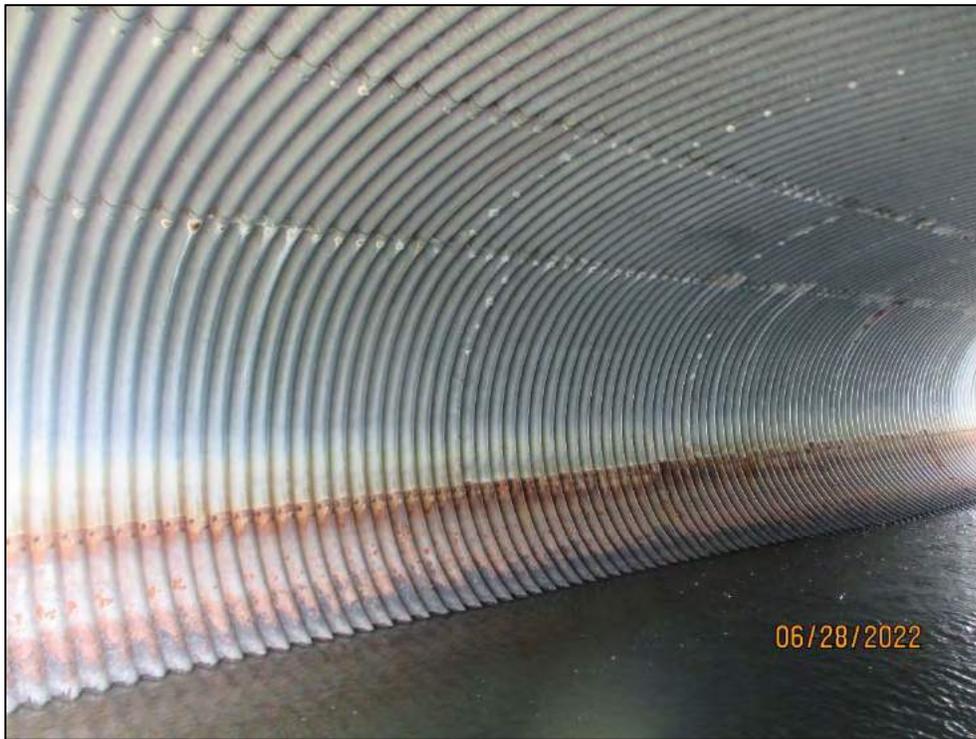
Barrel Condition (Typ.)

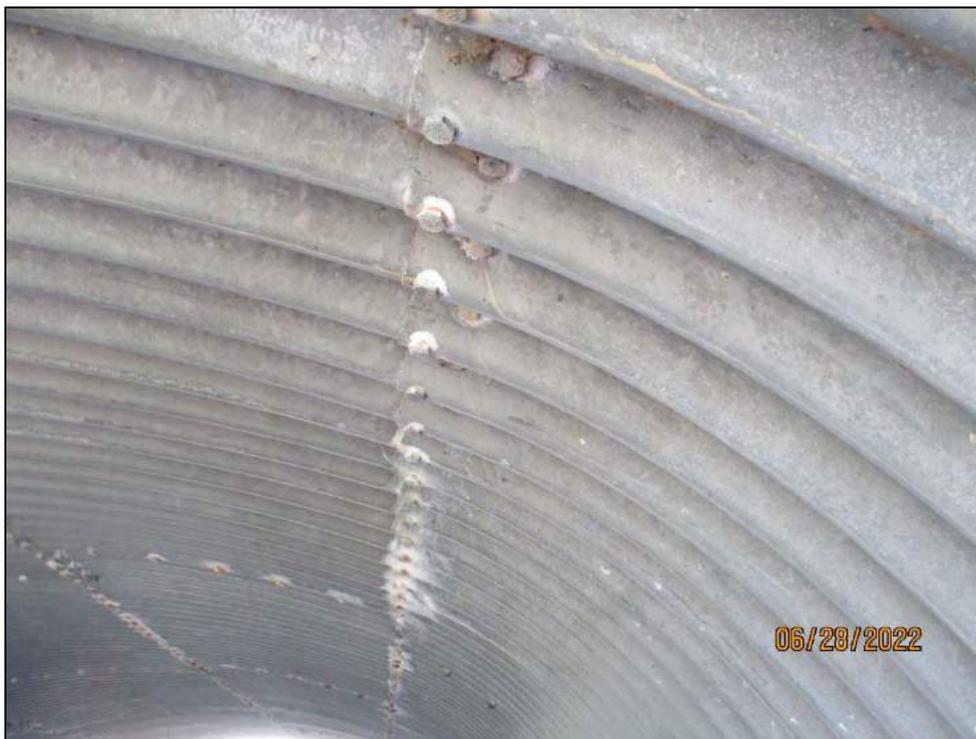
Barrel Obvert (Bolt Seam) – Typ.

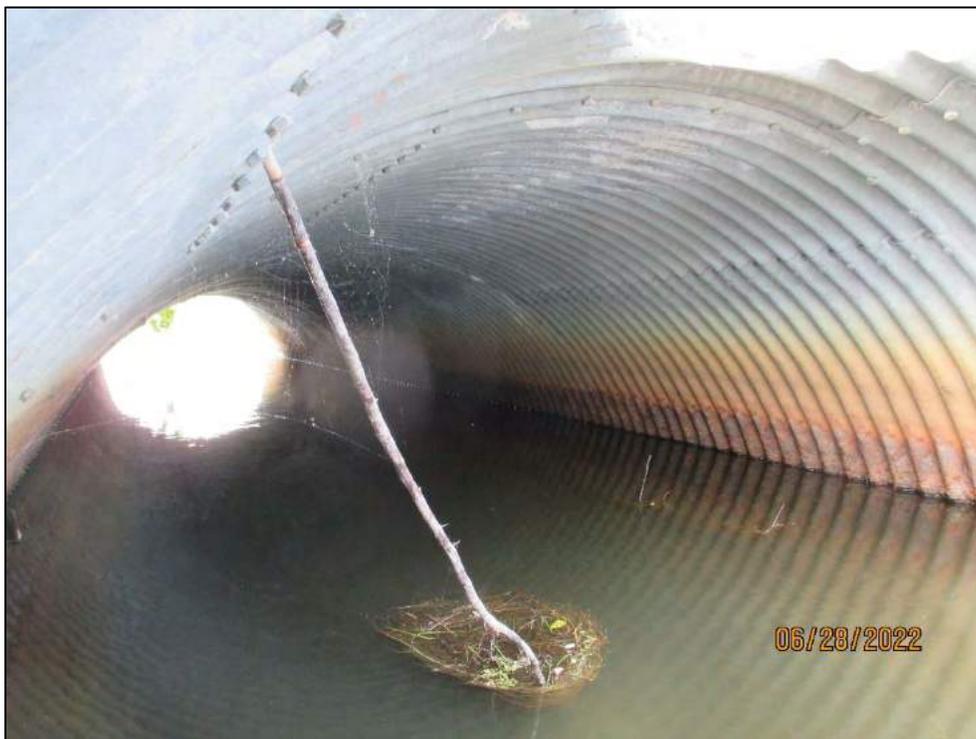
Culvert Barrel (Typ.)

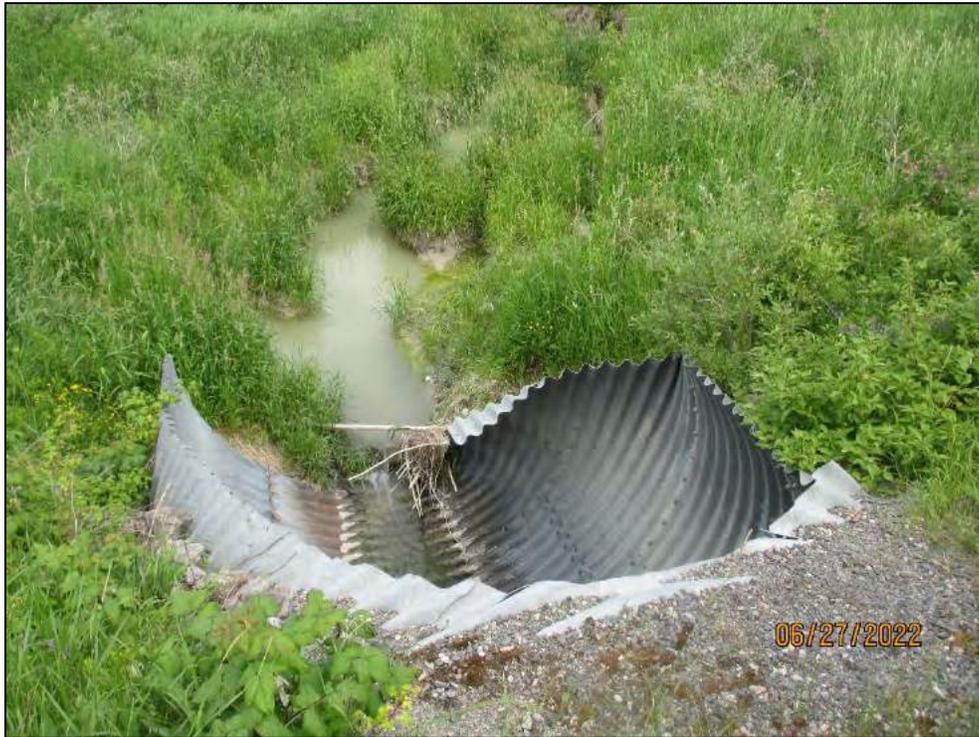
East (Inlet) Projecting End

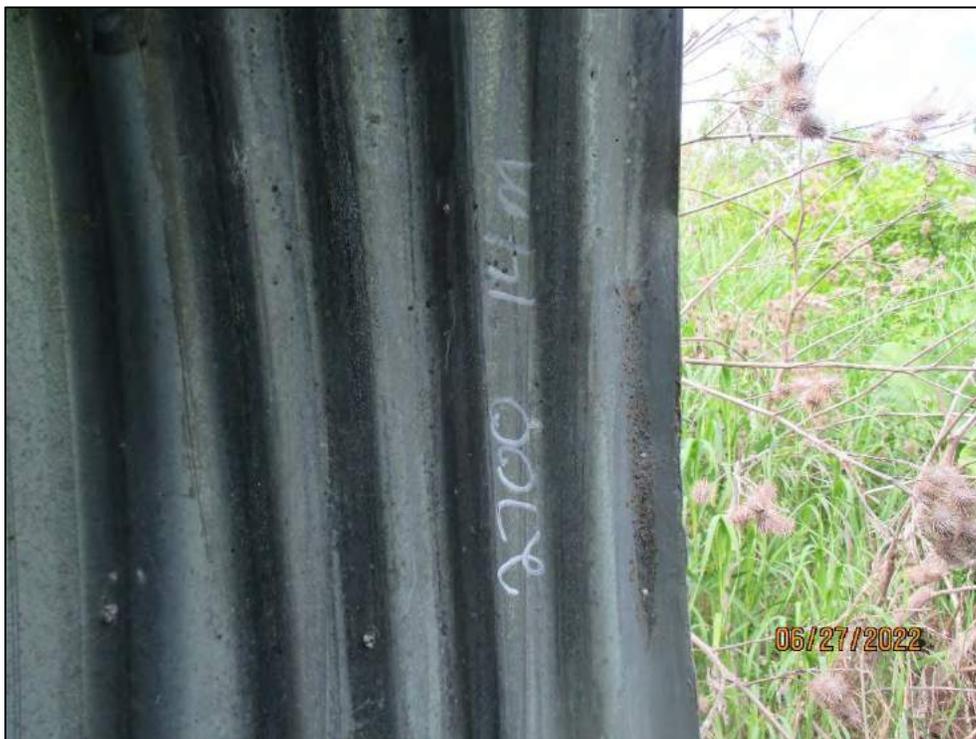
Culvert Barrel (2700mm Dia. – 2.8mm Thickness)

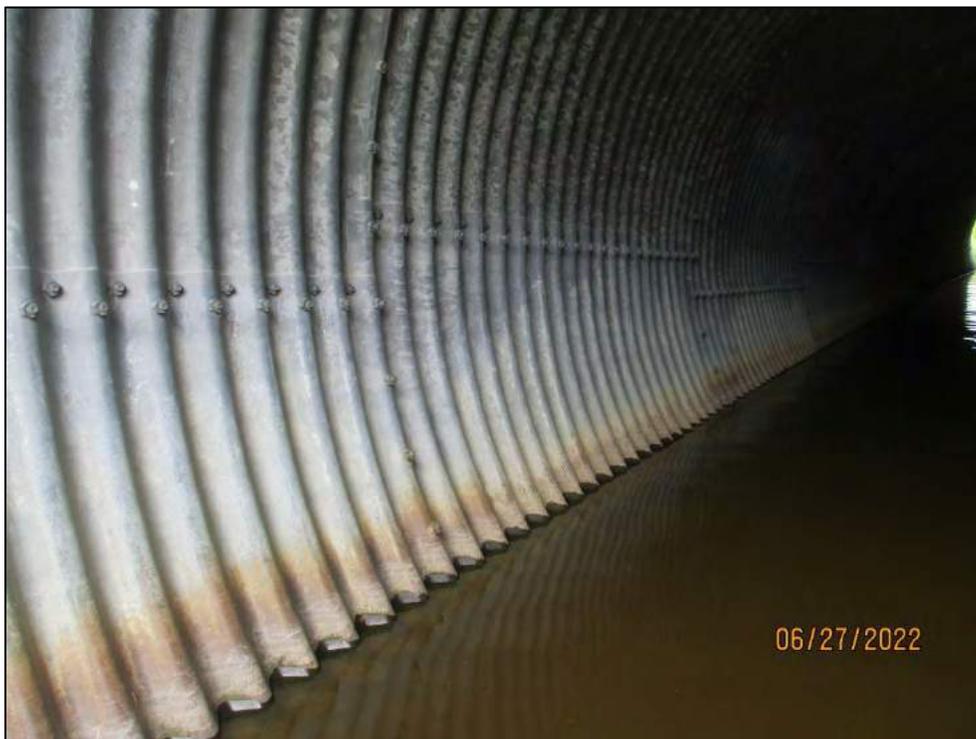
Culvert Barrel (along South-East Wall)

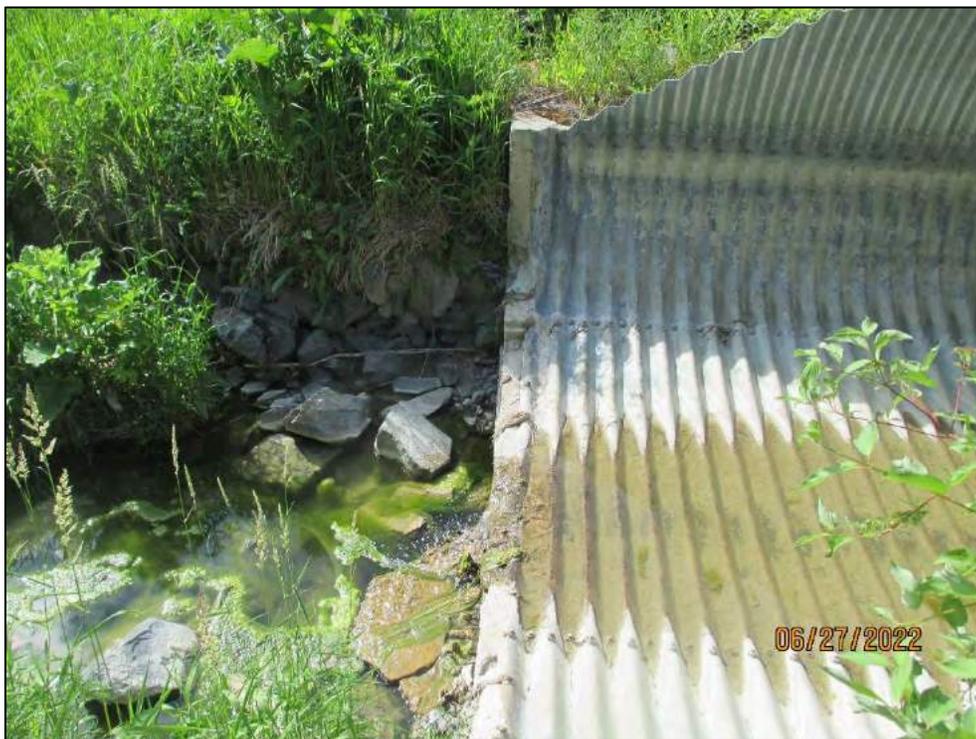
South Cut-Off Wall and Creek Scour at Outlet

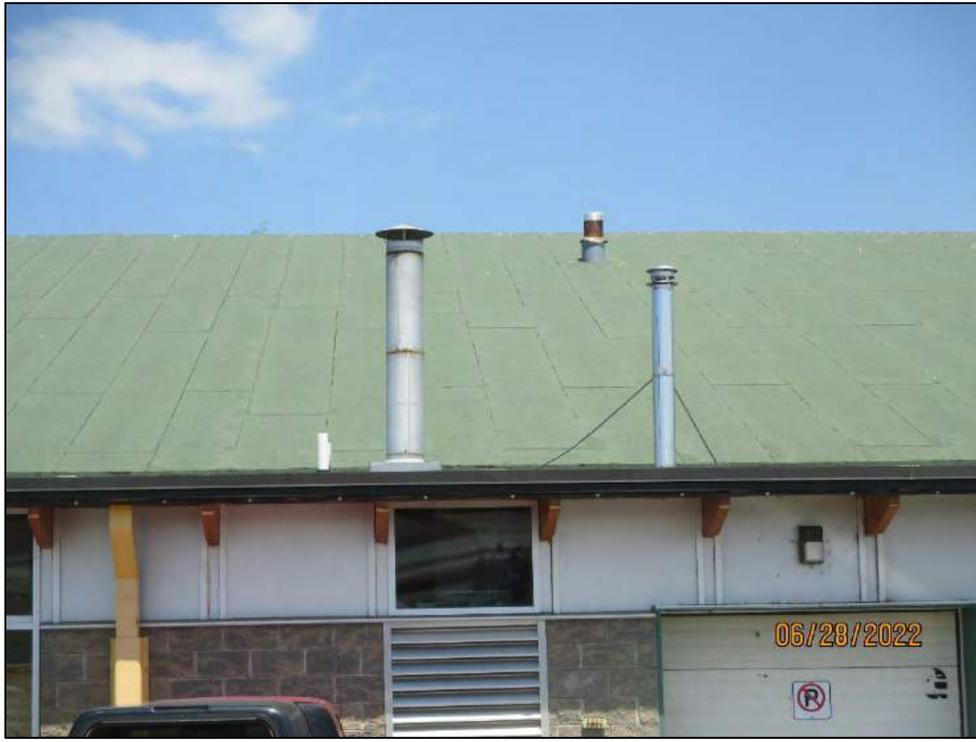
Roof (S/Mid.) – Multiple Vents

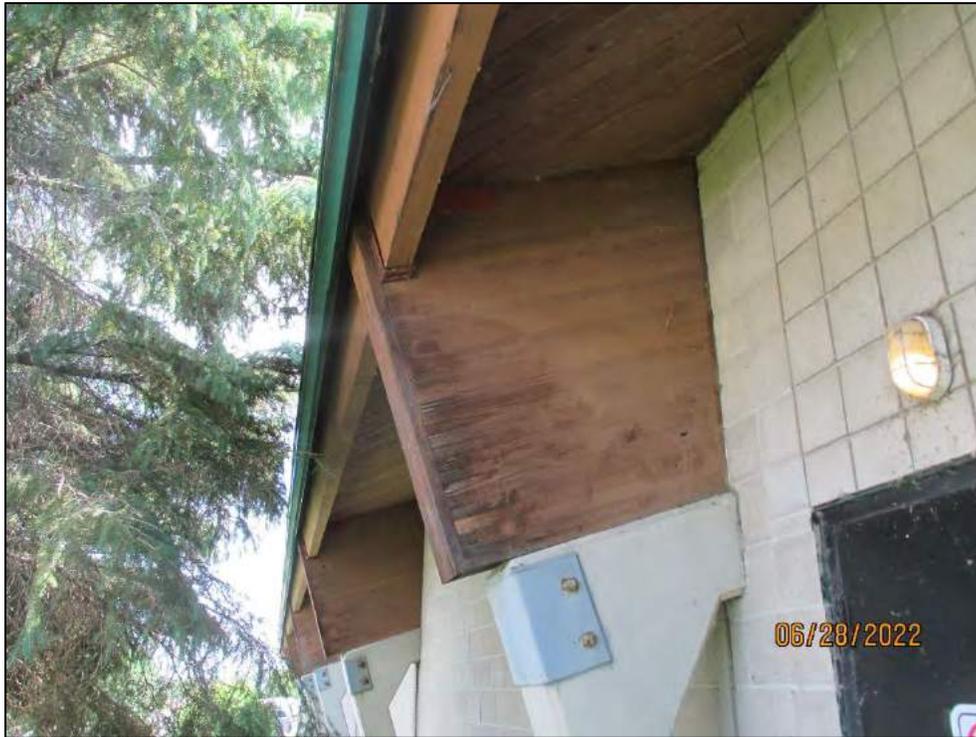
Projecting Glulam Roof Beams – Typ. (North Wall)

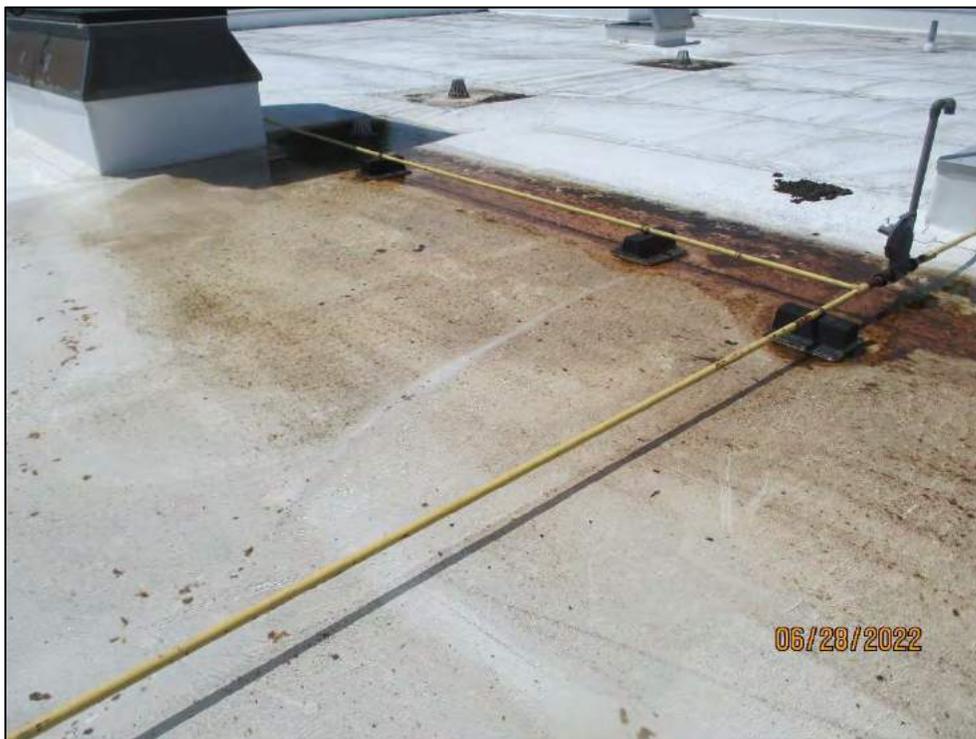
North Roof (water ponding at blocked drain)

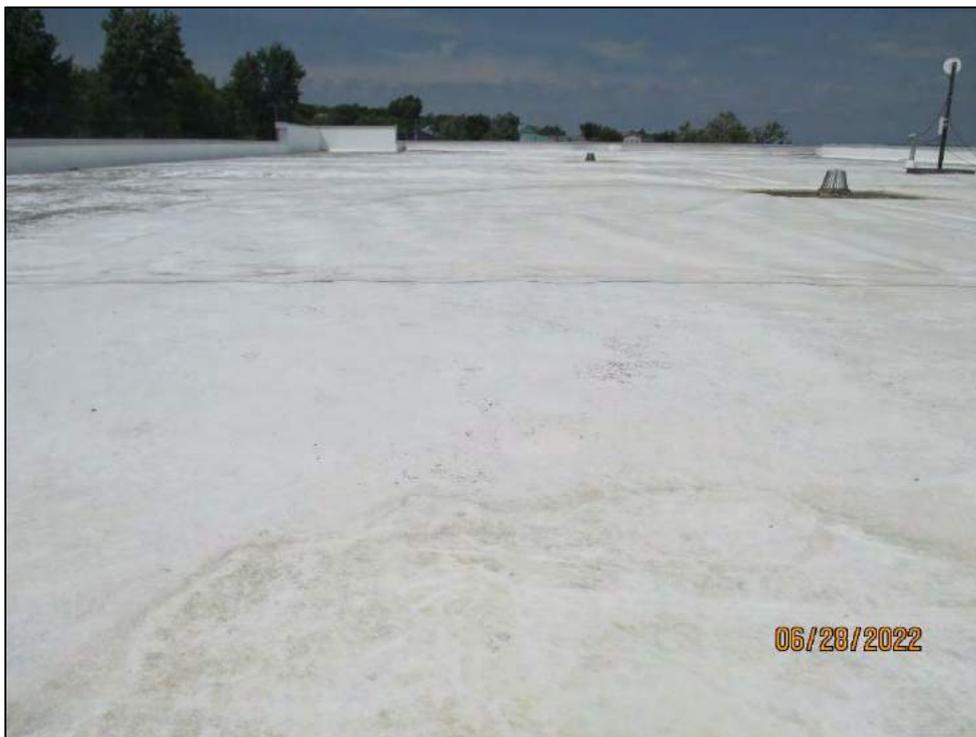
South (Upper) Roof – Uplift of EPDM Fabric (Typ.)

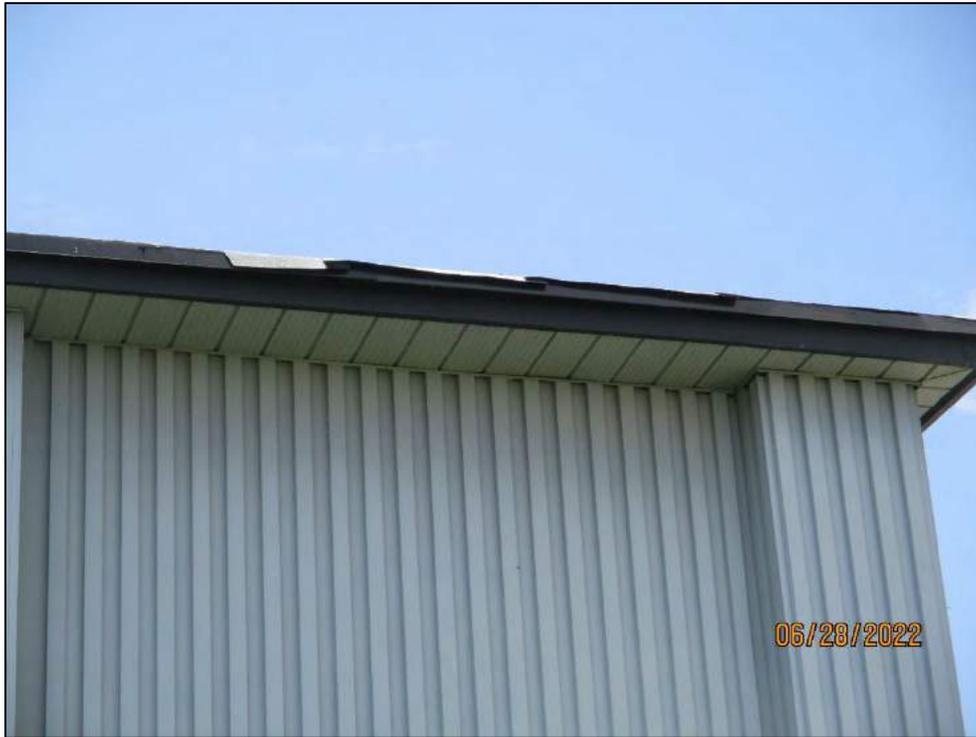
North (Lower) Roof (Untrimmed Roofing along East Edge)

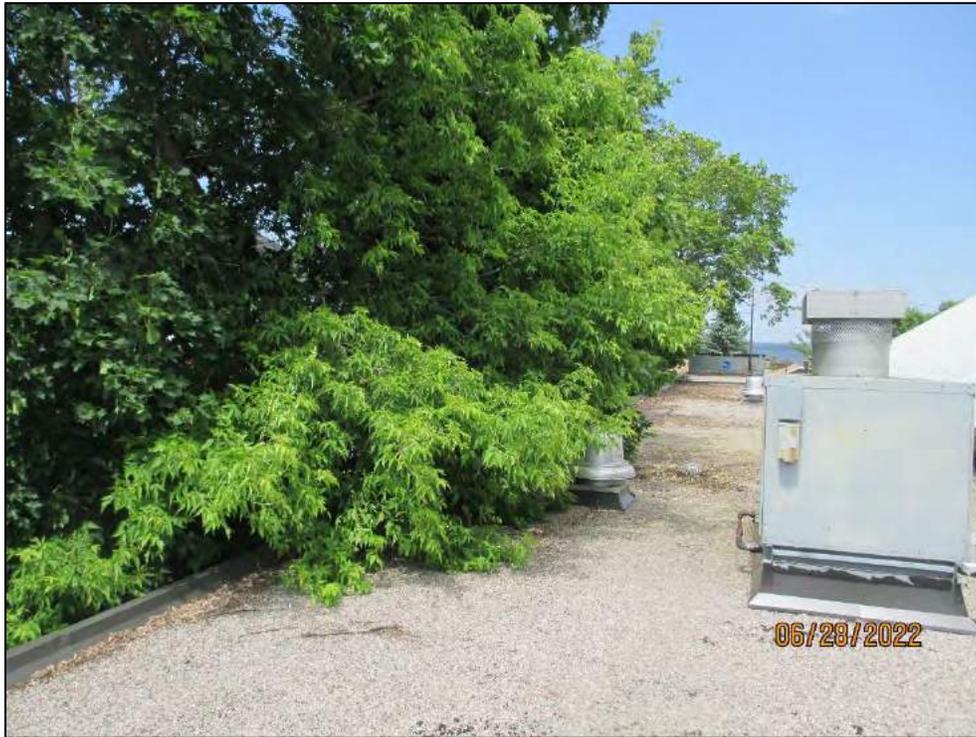
West Flat Roof (looking north) – trees to be trimmed

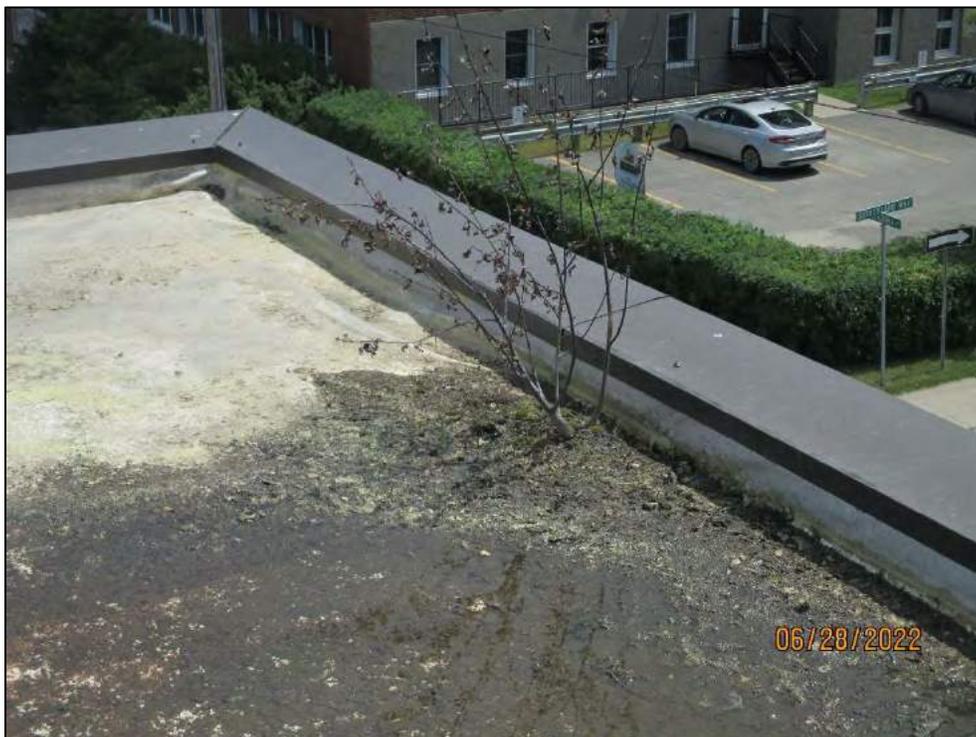
South (Upper) Flat Roof – tree to be removed

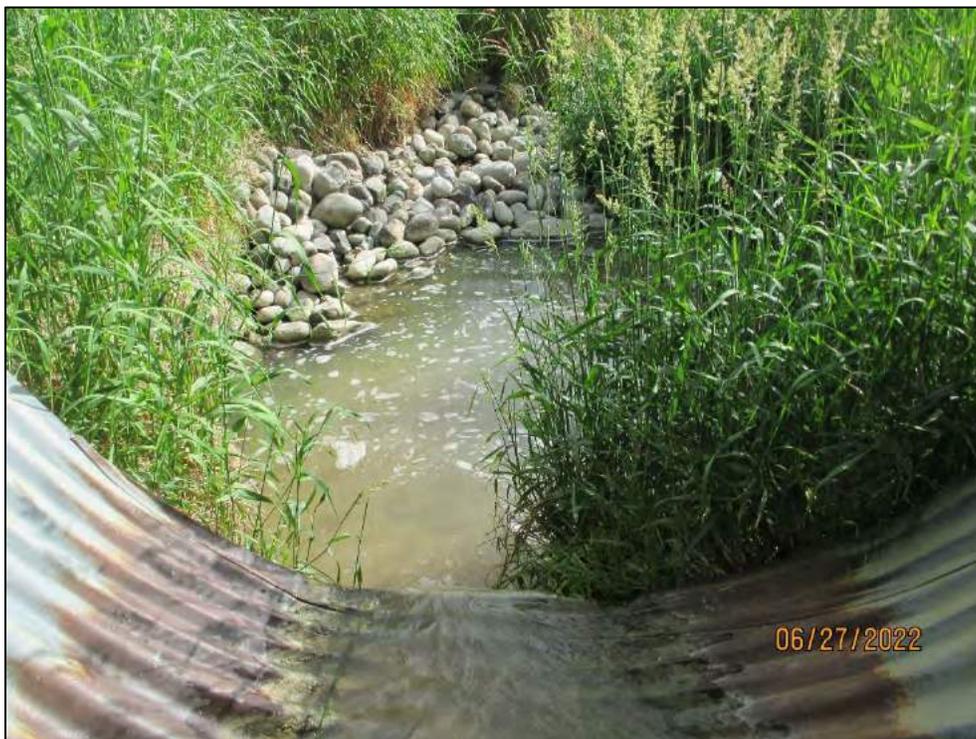
View South from Barrel (deep scour)

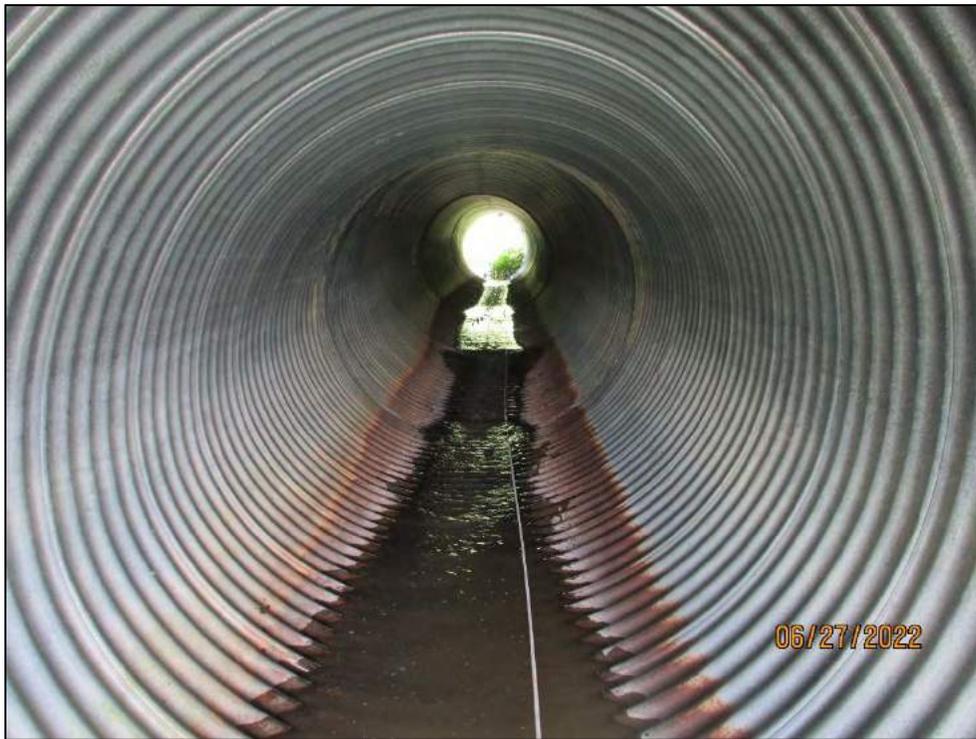
Culvert Barrel (looking North) – Note grade breaks

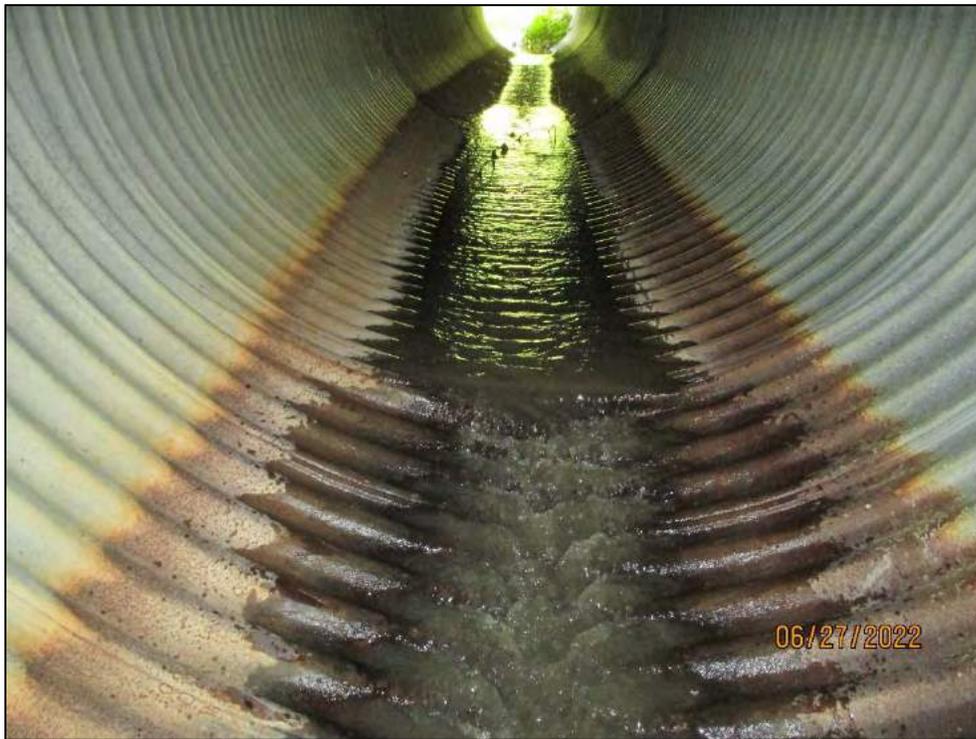
Culvert Barrel (looking North) – Note grade breaks

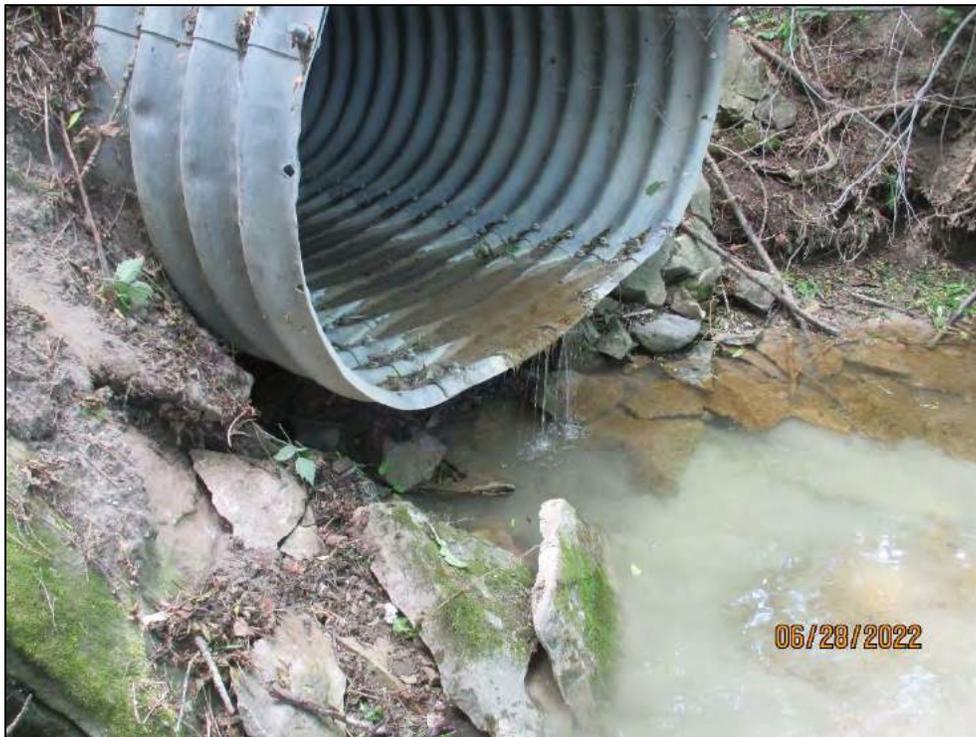
East Barrel (Scour at Outlet)
